# An Analysis of Stream Culvert Fish Passage on the Navy Railroad Line between Bremerton and Shelton, Washington

Battelle Marine Sciences Laboratory  
Sequim, Washington

December 2004

Prepared for:  
Puget Sound Naval Shipyard and Intermediate Maintenance Facility

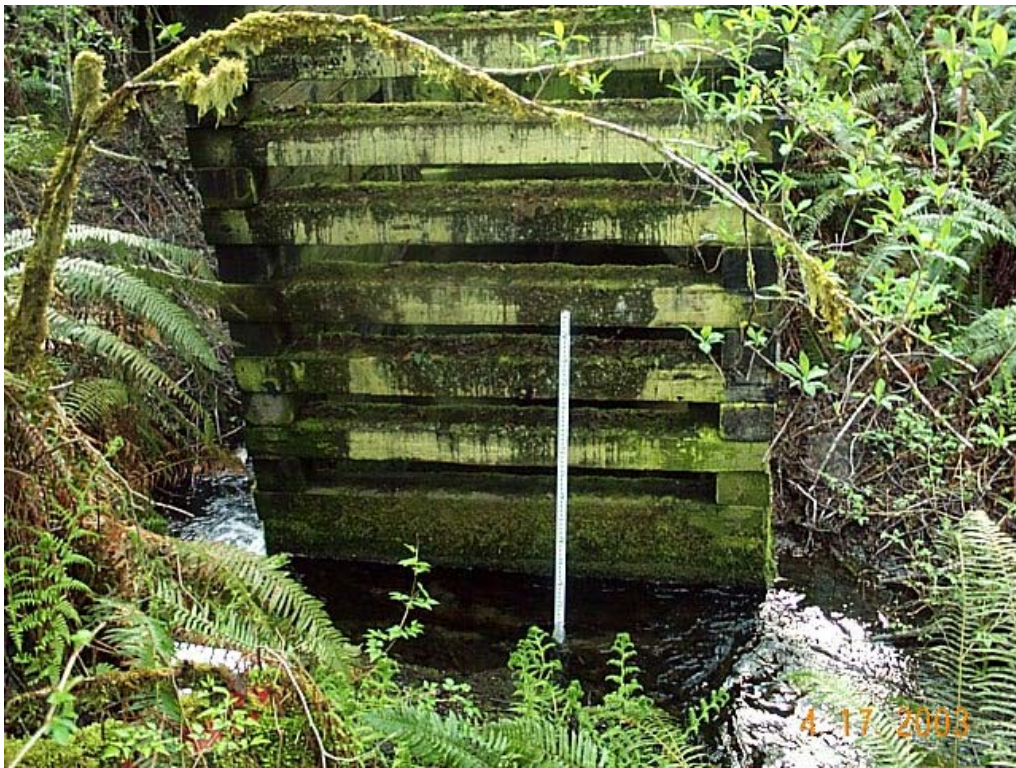
**RR MP 2.19** (Figures 15 and 16)

This RR culvert is located at the headwaters of an unnamed stream (WRIA 14.0047) that drains into Oakland Bay near Shelton (Figure 12; WP 146). The stream channel appears to be perennial at this point in the watershed, originating in a forested wetland on the upstream side of the railroad grade. There is a natural barrier in the lower mainstem of this creek upstream of SR-3. In addition, the culvert under SR-3 appears to be a complete fish-passage barrier. The RR culvert was assessed as a complete barrier based on WDFW Level-A analysis (little natural streambed material inside the culvert, slope >1%, and outlet perched approximately 1 foot). The PI score is 6.43. No fish were observed in the stream during culvert surveys and the channel is listed as a Type 5 by WA-DNR. The stream is classified as potentially fish-bearing based on the channel size and gradient criteria. The RR culvert is a 6-foot diameter (209 ft in length) reinforced concrete pipe (RCP) with an upstream trash rack made from railroad ties. It is recommended that this rack be removed to allow the free flow of water and organic material through the culvert. In addition, the removal will eliminate the potential water quality problem of the creosote railroad ties being in the creek and will improve passage for water, sediment, organic material, and biota through the culvert.

**Figure 15.** Existing trash rack on inlet of railroad culvert MP 2.19.

| <b>Culvert MP</b> | <b>Creek</b> | <b>Barrier Status</b> | <b>PI Score</b> | <b>Corrective Action</b> | <b>Cost Estimate</b> |
|---|---|---|---|---|---|
| 2.19 | Unnamed | Complete | 6.43 | Remove Trash Rack and Replace Culvert | \$\$\$ |

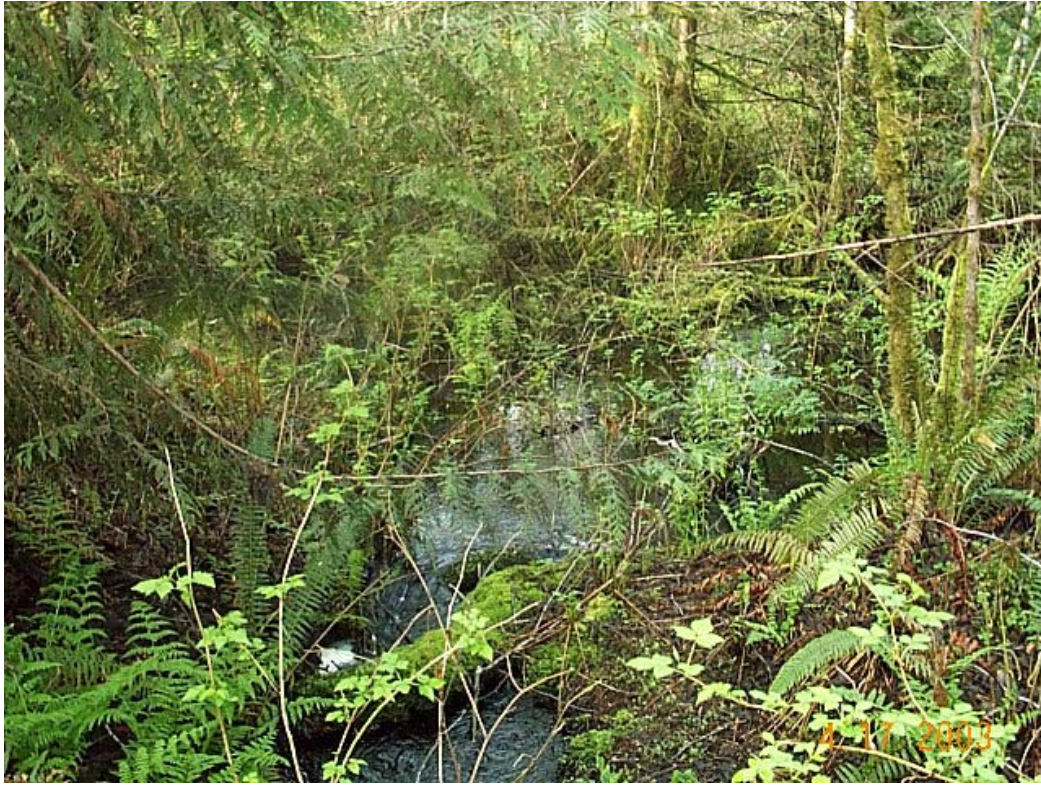
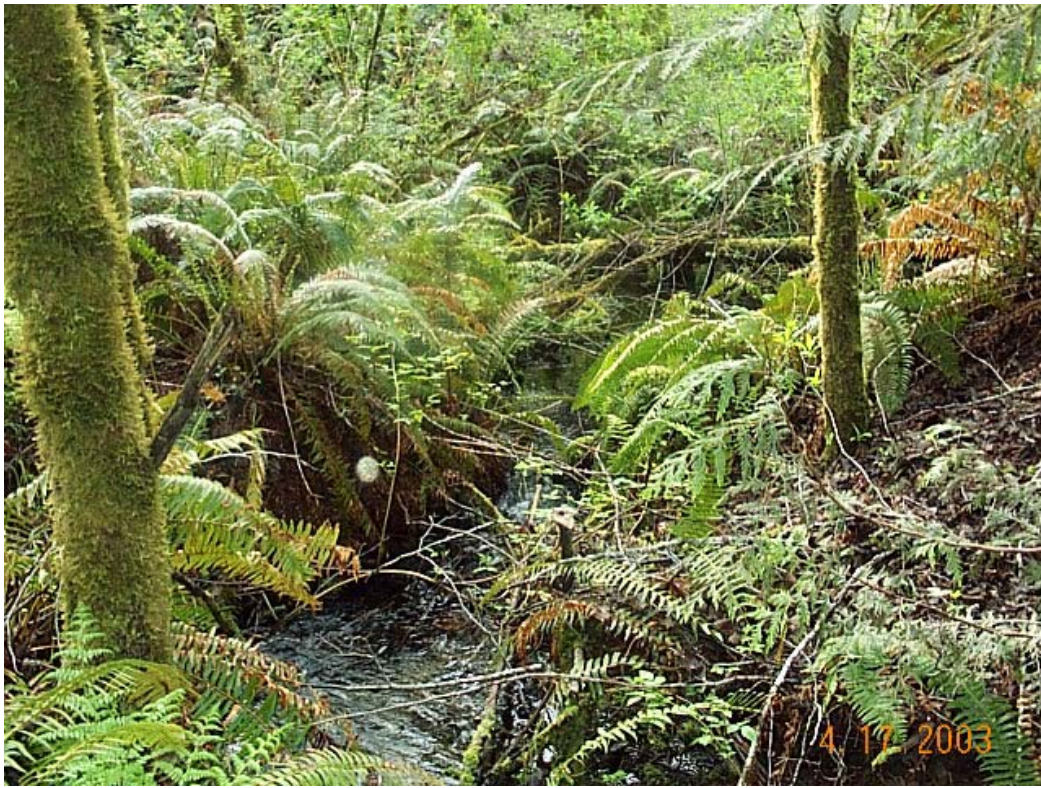
**Figure 16.** Riparian wetland upstream of railroad culvert MP 2.19.

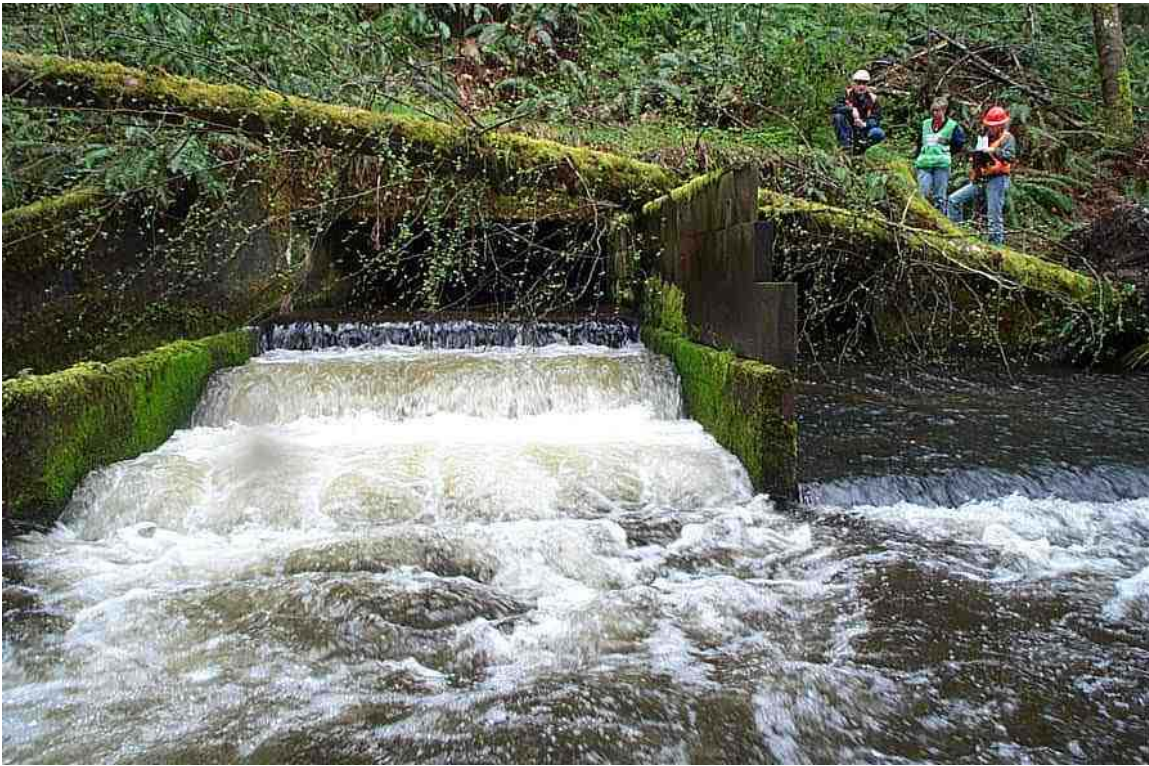
**RR MP 3.79** (Figure 17)

This RR culvert is located on the mainstem of Johns Creek (WRIA 14.0049) northeast of Shelton (Figure 12; WP 162). The culvert is a double-box (8- by 5-ft) concrete culvert. One side is fitted with a fish ladder to allow for adult fish passage upstream. Because of the flat concrete floor of the culvert and the lack of natural streambed material through its length, the culvert is likely a partial barrier to juveniles during high- and low-flow conditions. The fish ladder appears to function adequately for upstream adult passage except for short periods during extreme flow events. The fish ladder meets WDFW criteria for adult fish passage. This culvert is not recommended for replacement at this time, but passage could possibly be enhanced for both adults and juveniles if the culvert could be modified to meet stream simulation guidelines with a more natural streambed (see WDFW 1999).

**Figure 17.** Johns Creek box culvert and fishway, railroad MP 3.79.

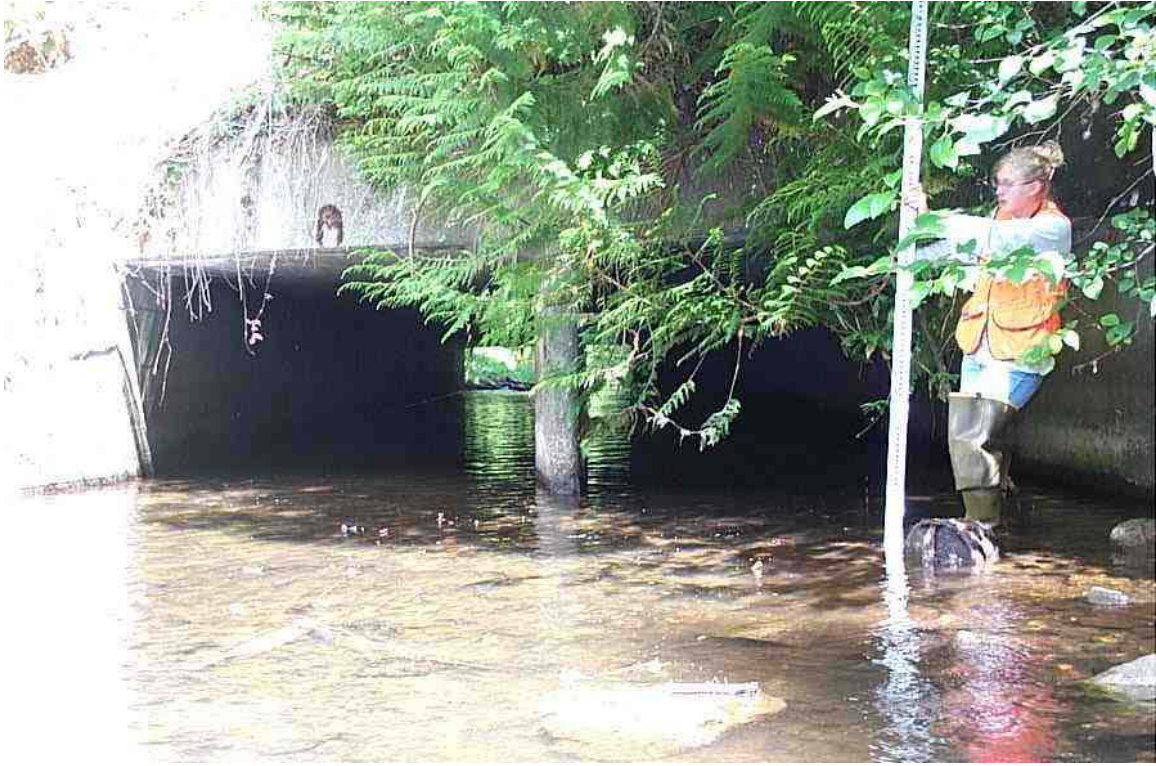
**RR MP 6.60** (Figure 18)

This RR culvert is located in the headwaters of Cranberry Creek (WRIA 14.0051) northeast of Shelton (Figure 12; WP 147). The culvert is a double-box (8- by 5-ft) concrete culvert. The culvert was assessed as passable during LFA surveys (WCC, 2002). No corrective action is needed for this RR culvert.

**Figure 18.** Cranberry Creek box culvert, railroad MP 6.60.

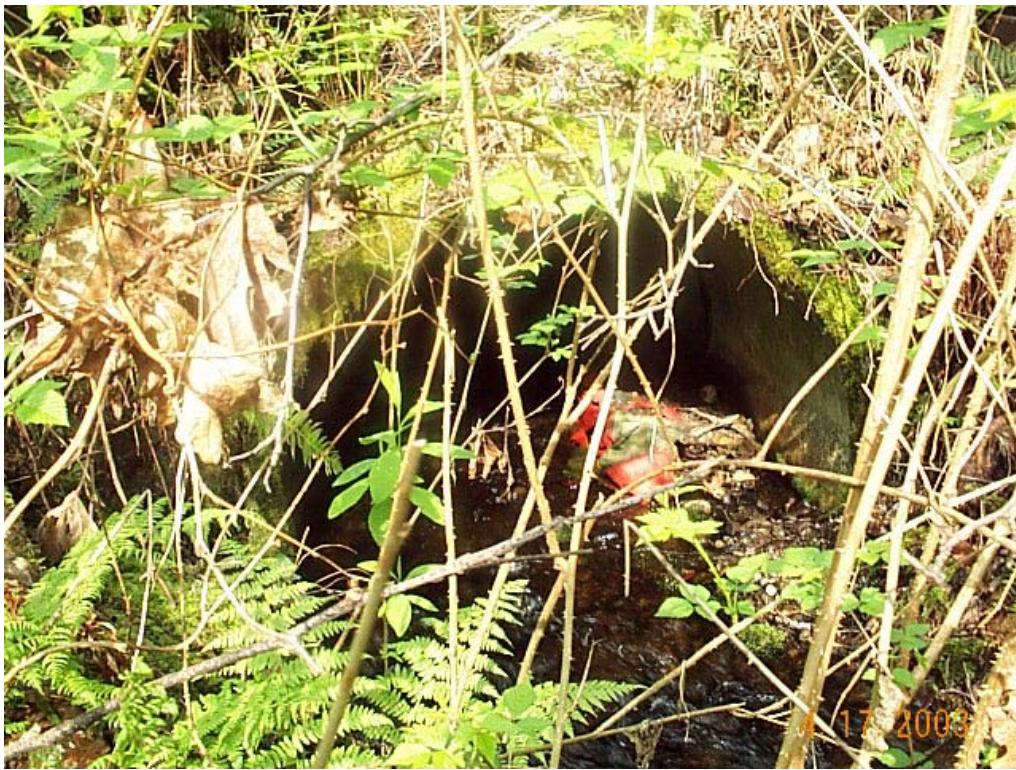
**RR MP 7.52** (Figure 19)

This RR culvert is located on a headwater tributary of Cranberry Creek (WRIA 14.0052) northwest of Shelton (Figure 12; WP 165). The culvert is a 3-ft concrete pipe (125 ft in length). The stream channel appears to be seasonal at this point in the watershed, originating in a forested wetland on the upstream side of the railroad grade. The RR culvert was assessed as passable based on WDFW Level-A analysis (natural streambed material throughout the culvert, slope <1%, and adequate culvert diameter). However, the culvert may be a partial barrier during high and/or low flow periods. Therefore, a habitat assessment was conducted and a PI score of 6.73 was obtained for this culvert. No fish were observed in the stream, and the channel is listed as a Type 5 by WA-DNR. However, based on stream channel size the stream was classified as potentially fish-bearing

**19.** Outlet of railroad culvert MP 7.52.

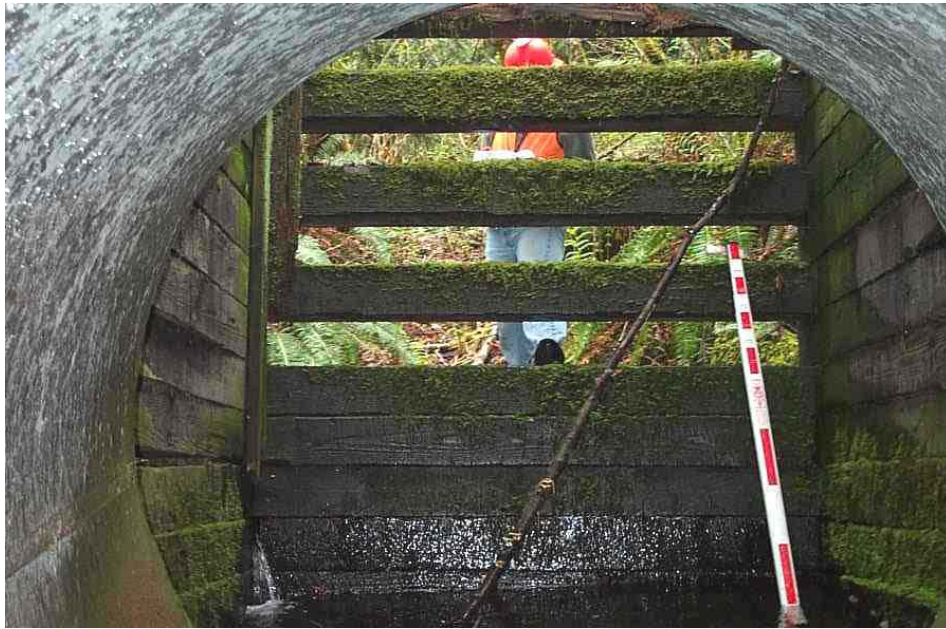
**RR MP 8.90** (Figures 20 and 21)

This RR culvert is located on a headwater tributary of Deer Creek (no assigned WRIA number) northeast of Shelton (Figure 12; WP 149). The culvert is a 6-ft concrete pipe (323 ft in length) with an upstream trash rack made from railroad ties. It is recommended that this railroad-tie trash rack be removed to allow the free flow of biota, water, and organic material through the culvert. In addition, the removal will eliminate the potential water quality problem of the creosote railroad ties being in the creek and will allow for more unrestricted passage for fish, amphibians, and wildlife through the culvert. The RR culvert was assessed as passable based on WDFW Level-A analysis (natural streambed material throughout the culvert, slope <1%, and adequate culvert diameter). However, the culvert may be a partial barrier during high and/or low flow periods. Therefore, a habitat assessment was conducted and a PI score of 7.32 was obtained for this culvert. Habitat assessment surveys downstream of the railroad culvert indicate extensive wetlands and beaver ponds interspersed with stream channels. Passage through this area is likely seasonal and very dependent on flow conditions and beaver activity. Upstream of the culvert, the habitat is dominated by forested wetlands and beaver ponds, which could provide rearing habitat for both cutthroat and coho. Although no fish were observed during culvert surveys, the stream is still classified as potentially fish-bearing based on channel width and existing habitat.

**Figure 20.** Trash rack on inlet of railroad culvert MP 8.90.

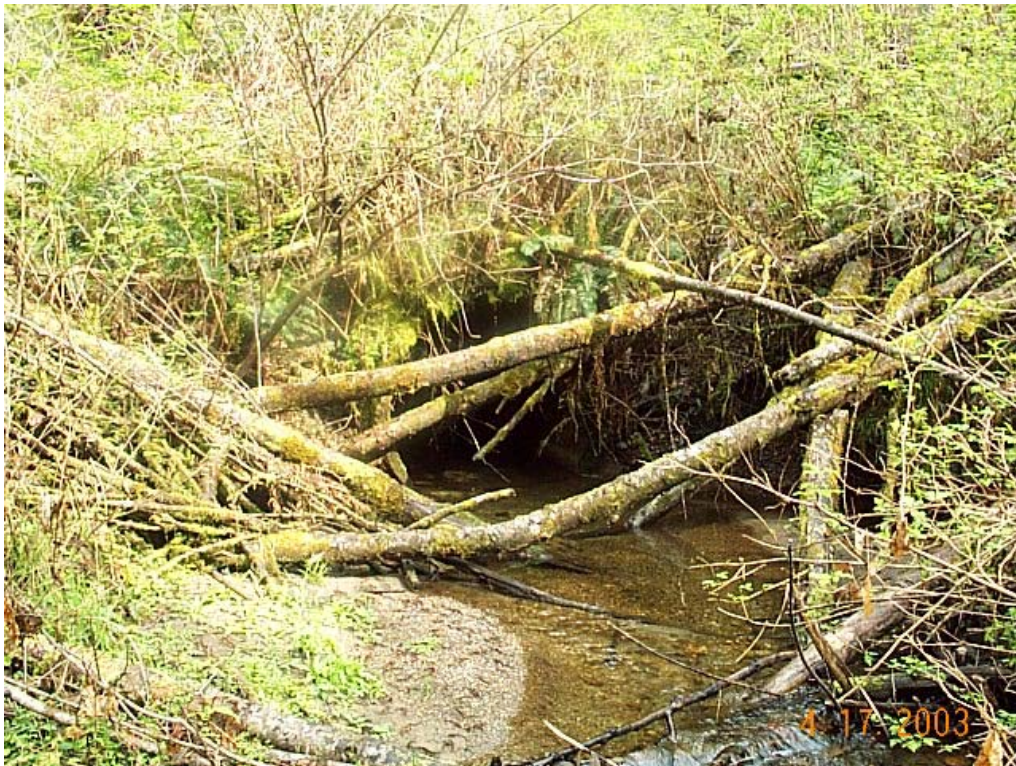
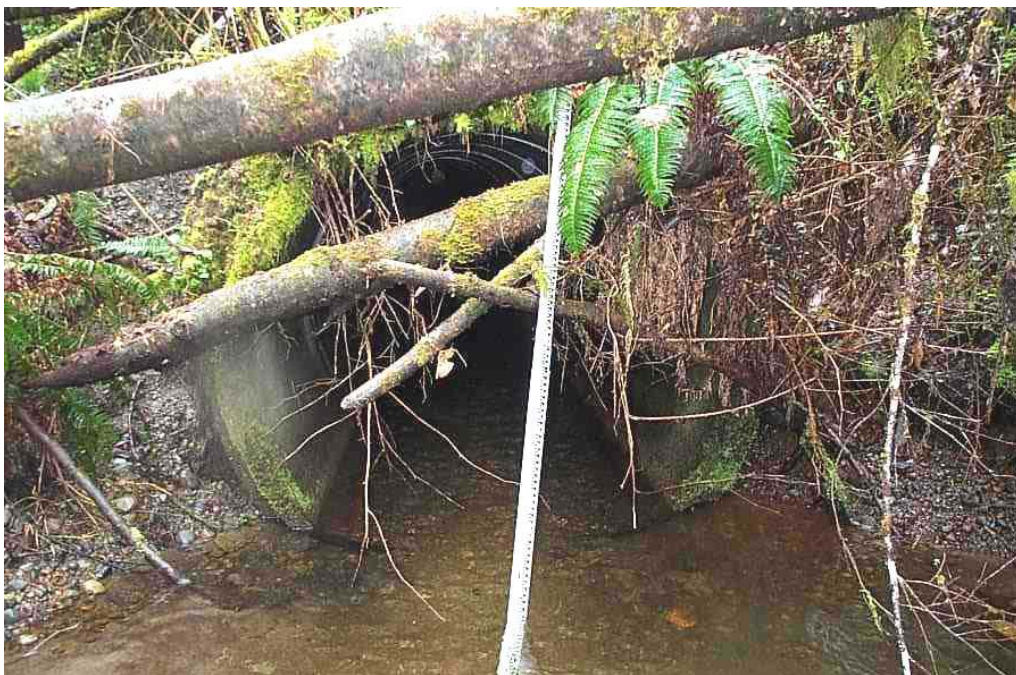
**Figure 21.** Outlet of railroad culvert MP 8.90.

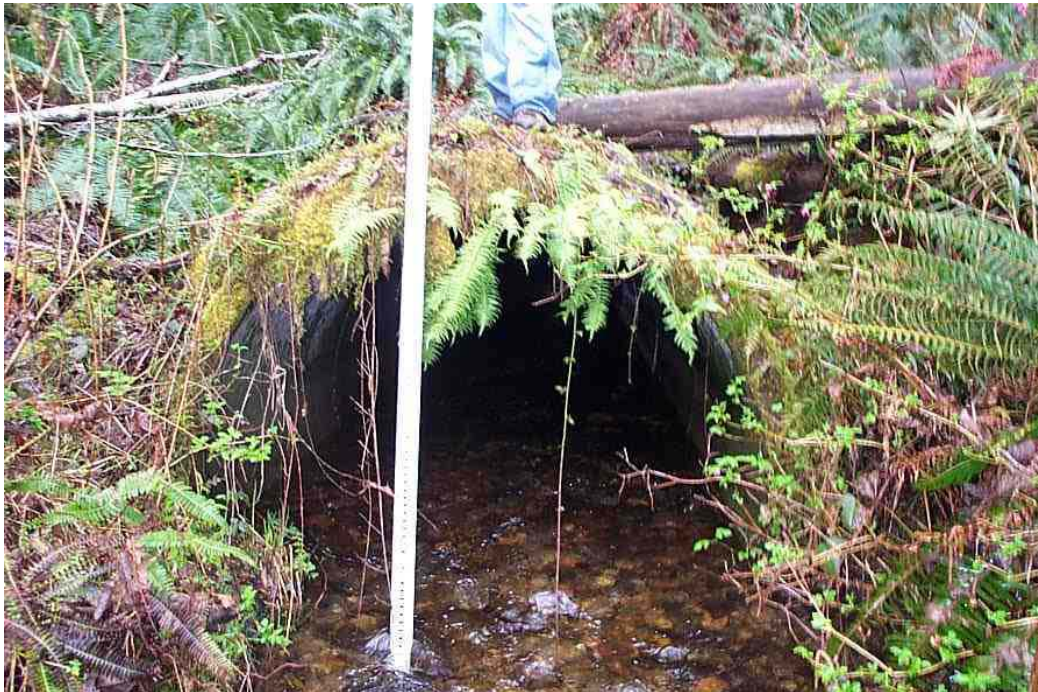
**RR MP 9.28** (Figure 22)

This RR culvert is located on a headwater tributary of Deer Creek (no assigned WRIA number) northeast of Shelton (Figure 12; WP 166). The culvert is a 4-ft concrete pipe (300 ft in length). The stream channel appears to be seasonal at this point in the watershed, originating in a forested wetland on the upstream side of the railroad grade. The RR culvert was assessed as passable based on WDFW Level-A analysis (natural streambed material throughout the culvert, slope <1%, and adequate culvert diameter). However, the culvert may be a partial barrier during high and/or low flow periods. Therefore, a habitat assessment was conducted and a PI score of 7.12 was obtained for this culvert. No fish were observed in the stream during culvert surveys and the channel is listed as a Type 5 by WA-DNR, however the stream was classified as potentially fish-bearing based on channel size.

Figure 22. **Outlet of railroad culvert MP 9.28**

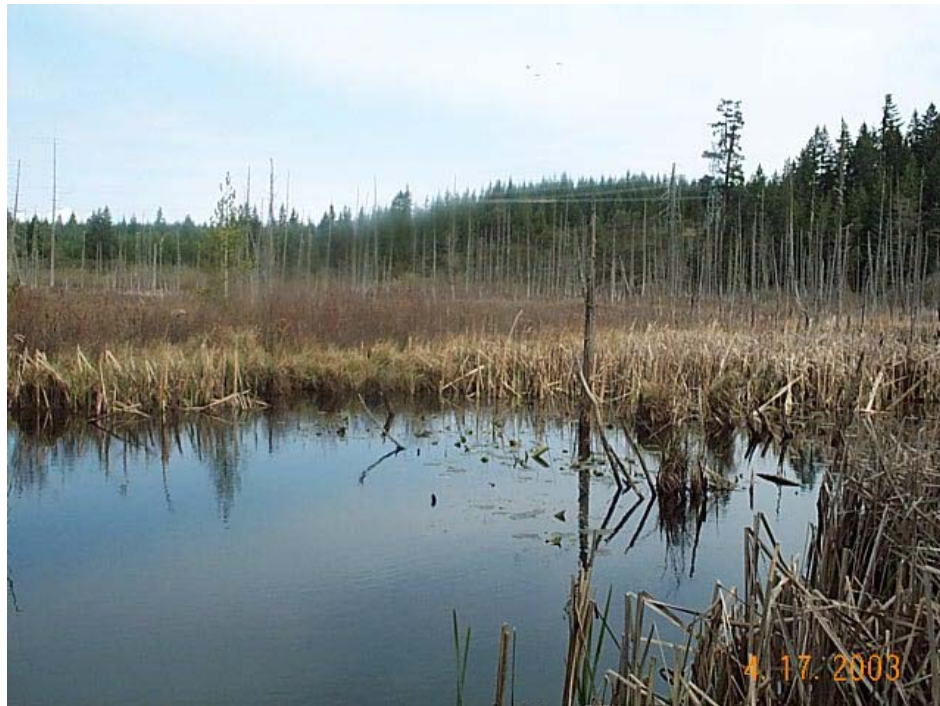
**RR MP 10.50** (Figures 23 and 24)

This RR culvert is located on a headwater tributary of Deer Creek (no assigned WRIA number) northeast of Shelton (Figure 12; WP 167). The culvert crossings consist of twin (3-ft) concrete pipes (100 ft in length) approximately 400 feet apart. The stream channel originates from an extensive beaver pond wetland located on the upstream side of the railroad grade (see Figure 22). Very little water was flowing in the culverts or the downstream channels at the time of the survey, although there was water in the upstream beaver pond wetland. The RR culverts were assessed as passable based on WDFW Level-A analysis (natural streambed material throughout the culvert, slope <1%, and adequate culvert diameter). However, because there are two relatively small culverts located at this crossing and because of the presence of beaver activity, these culverts may be partial barriers during some flow conditions or when beaver activity causes a blockage of one or both culverts. No fish were observed in the stream, however the stream should be considered potentially fish-bearing based on existing habitat conditions and stream channel size. Determination of resident salmonid use of the upstream beaver pond wetland would require additional surveys of the downstream channel and upstream wetlands. Stream habitat assessments were conducted and a PI score of 6.55 was determined. The RR culverts were classified as passable based on WDFW Level-A analysis (natural streambed material throughout the culvert, slope <1%, and adequate culvert diameter). However, the beaver pond location at the inlet of the railroad culverts is problematic from both a passage and maintenance perspective. It is recommended that a “beaver deceiver” device be constructed at the culvert inlets to prevent beaver activity from reducing culvert capacity and restricting passage. These installations are designed to allow unrestricted flow through the culverts, as well as fish passage, while preventing the beaver from damming the culvert inlets. These devices do require special operational and maintenance efforts to ensure fish passage.

Figure 23. Beaver pond at inlet of railroad culvert MP 10.50.

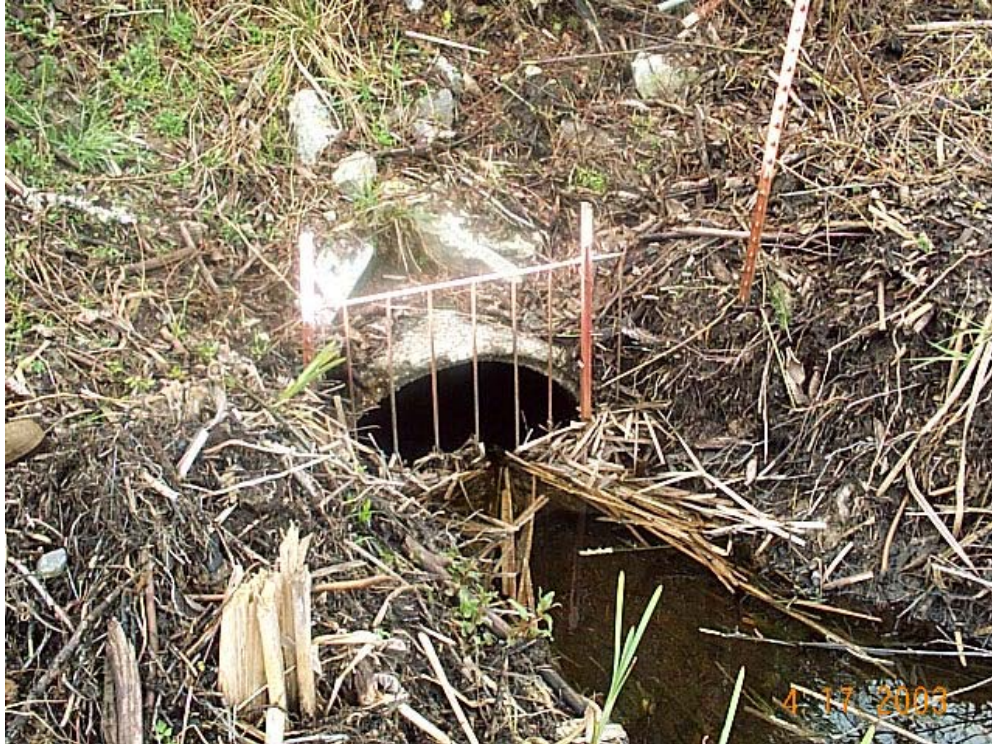
**Figure 24.** Inlet of railroad culvert MP 10.50.

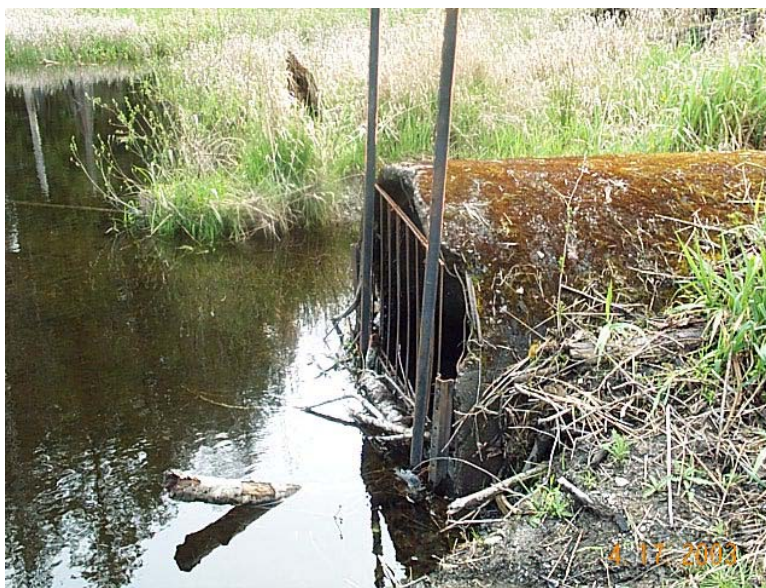
**RR MP 12.01** (Figures 235, 26, and 27 through 22)

This RR culvert is located on a headwater tributary of Deer Creek (WRIA 14.0060) northeast of Shelton (Figure 13; WP 160). The culvert is a 5-ft concrete pipe (258 ft in length). The stream channel appears to be perennial at this point in the watershed, originating in a beaver pond wetland on the upstream side of the railroad grade. Very little water was flowing in the culvert or the downstream channel at the time of the survey, although there was water in the upstream beaver pond wetland. No fish were observed in the stream. There may be salmonid use of the upstream beaver pond wetland, but this study was not able to make that determination. Therefore, the stream was classified as potentially fish-bearing. There are also wetlands, beaver ponds, and signs of beaver activity downstream of the railroad culvert. The stream system can be described as a series of interconnected headwater wetlands at this point in the watershed. The RR culvert was assessed as passable based on WDFW Level-A analysis (natural streambed material throughout the culvert, slope <1%, and adequate culvert diameter). Although passable, the existing beaver activity may lead to periodic culvert blockages during some flow conditions. Therefore, a habitat assessment was conducted and a PI score of 7.45 was determined. The beaver pond location at the inlet and outlet of the RR culvert is problematic from both a passage and maintenance perspective. It is recommended that a “beaver deceiver” device be constructed at the culvert inlet to prevent beaver activity from reducing culvert capacity and restricting passage. These installations are designed to allow unrestricted flow through the culvert, as well as fish passage, while preventing the beaver from damming the culvert inlet. The culvert outlet should also be cleared of debris and monitored for debris accumulation in the future. An additional beaver deterrent device may be required on the outlet as well. These devices do require special operational and maintenance efforts to ensure fish passage.

**Figure 25.** Existing inlet of railroad culvert MP 12.01.

| <b>Culvert MP</b> | <b>Creek</b> | <b>Barrier Status</b> | <b>PI Score</b> | <b>Corrective Action</b> | <b>Cost Estimate</b> |
|---|---|---|---|---|---|
| 12.01 | Deer | Passable | 7.45 | Replace Trash Rack with Beaver Deceiver and Monitor Passage | \$ |

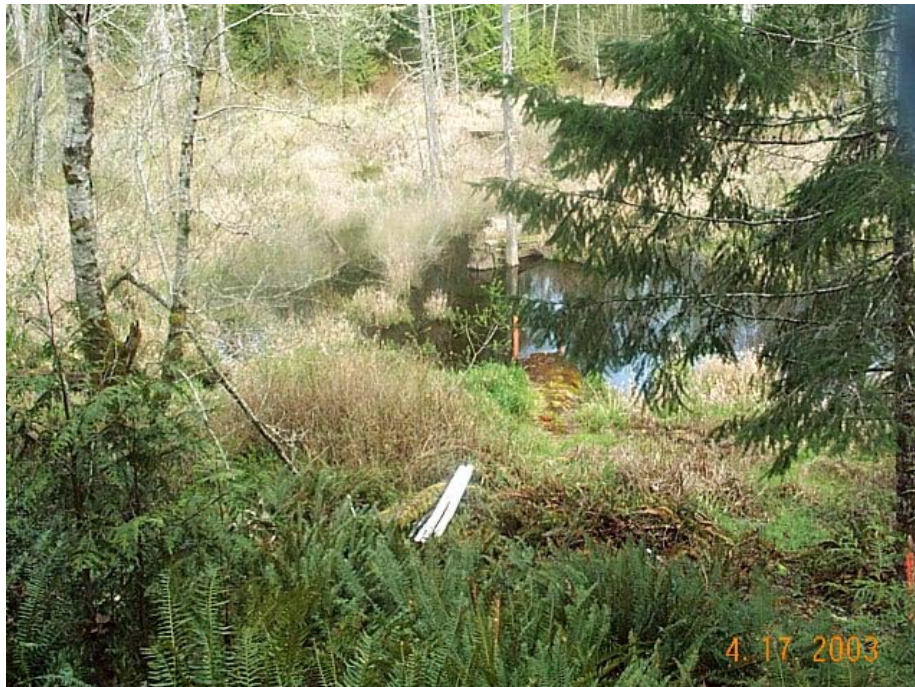
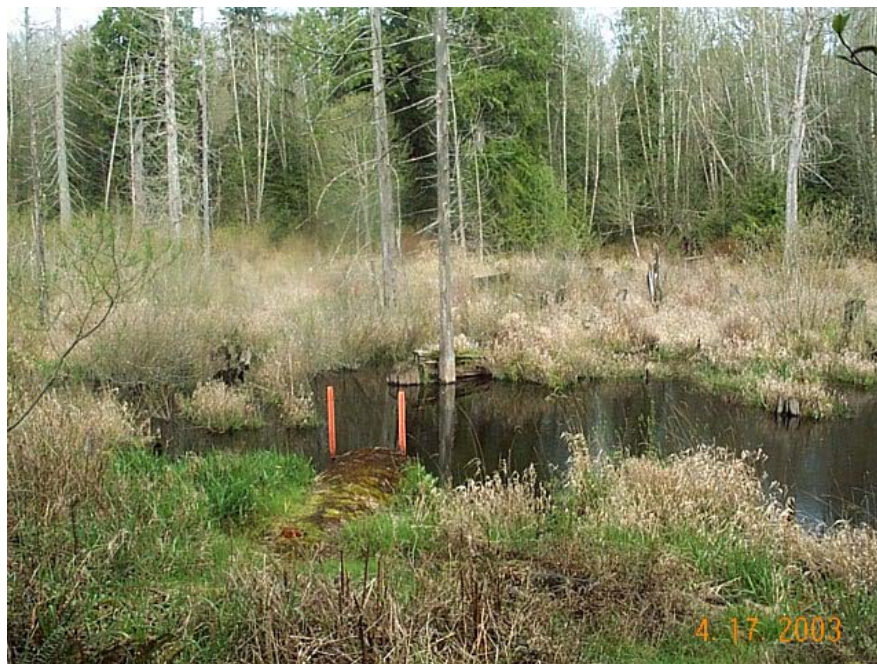
**Figure 26.** Beaver pond wetland at inlet of railroad culvert MP 12.01.

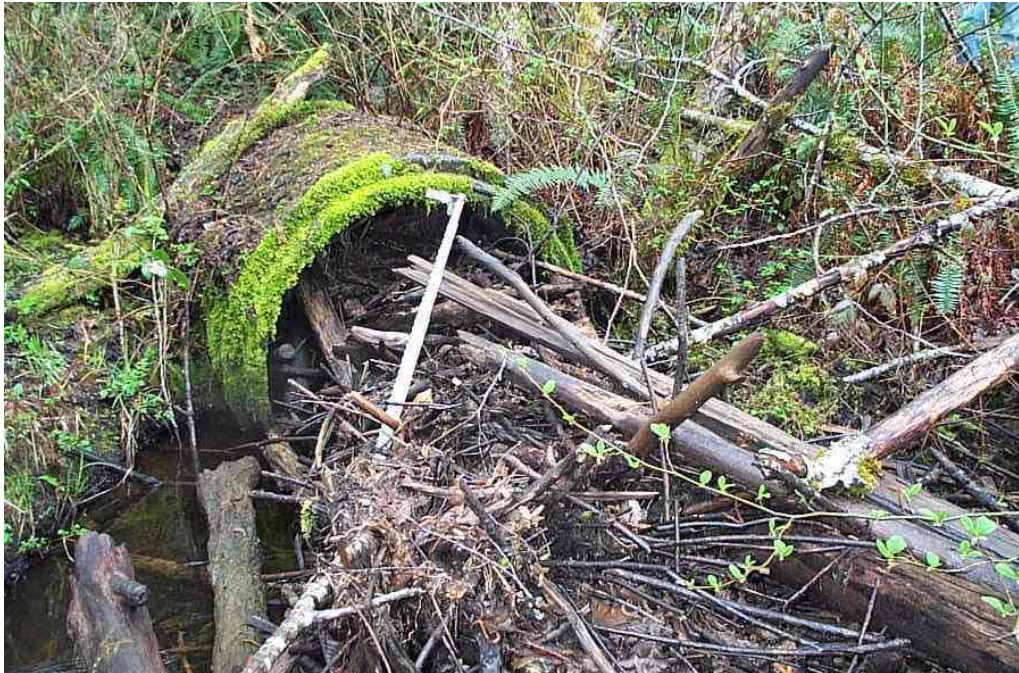
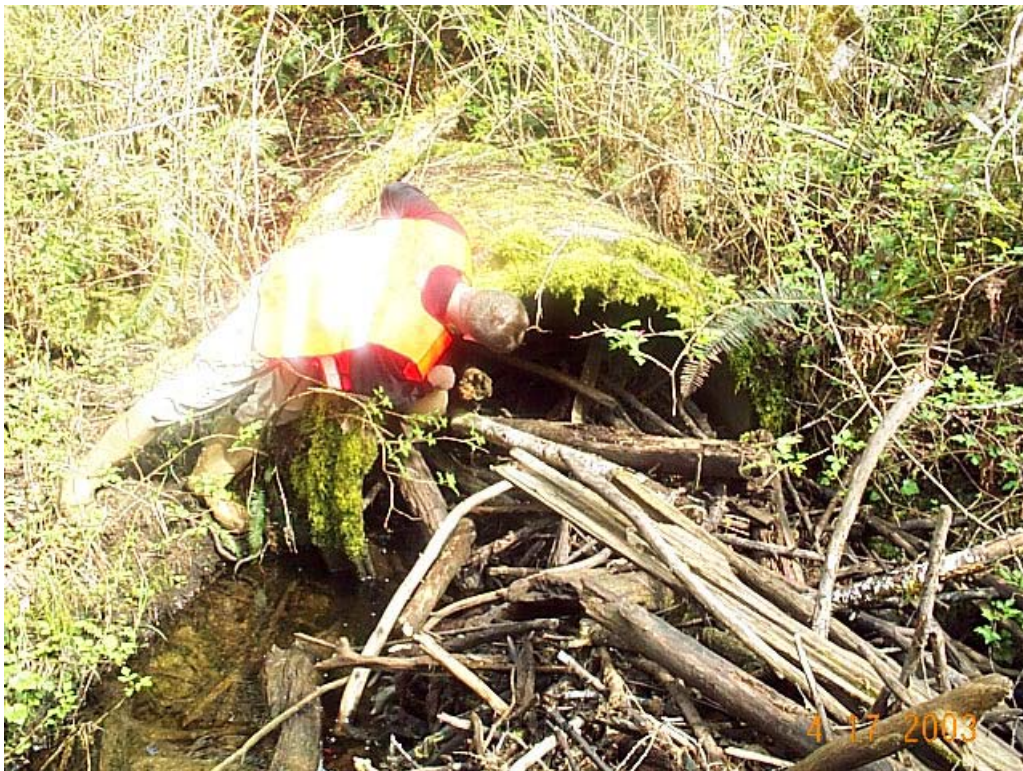
**Figure 27.** Outlet of railroad culvert MP 12.01.

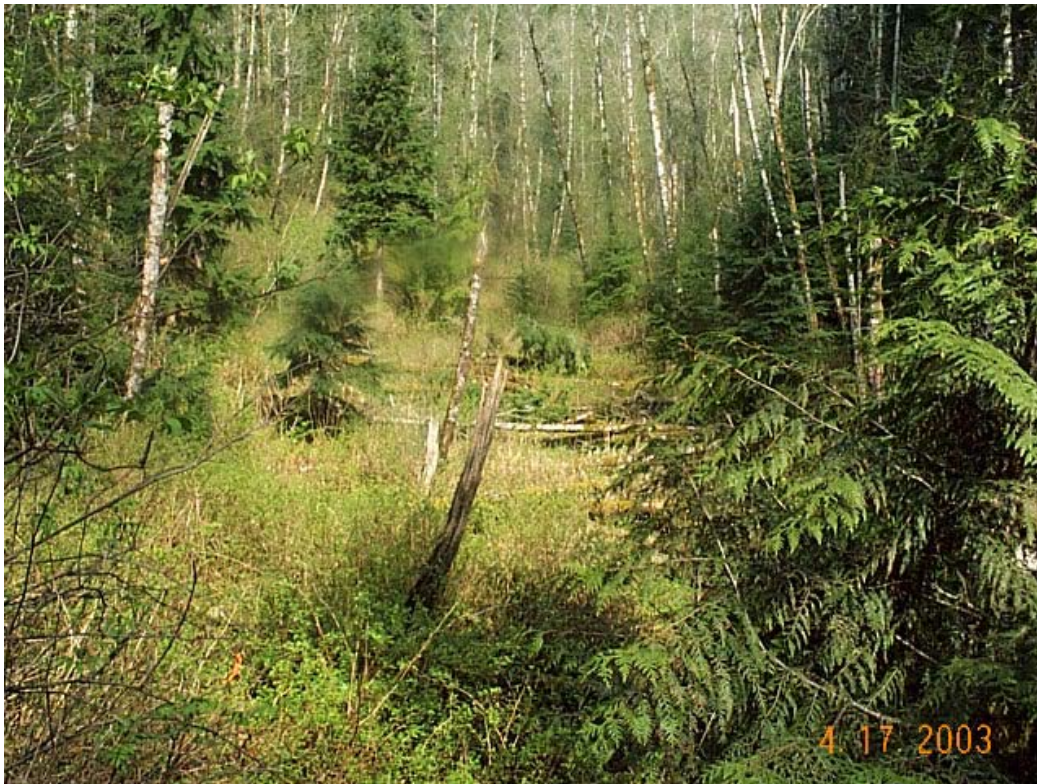
**RR MP 12.73** (Figures 28 and 29)

This culvert is located on a headwater tributary of Deer Creek (WRIA 14.0061) northeast of Shelton (Figure 13; WP 150). The culvert is a 4-ft concrete pipe (113 ft in length). The stream channel appears to be perennial at this point in the watershed, originating in a forested wetland on the upstream side of the railroad grade. The RR culvert was assessed as a complete barrier based on WDFW Level-A analysis (little natural streambed material inside the culvert, slope >1%, and outlet perched approximately 1 foot). The PI score is 8.59. No fish were observed in the stream during culvert surveys and the channel is listed as a Type 5 by WA-DNR, however, the stream is classified as potentially fish-bearing based on the channel size and gradient criteria. Determination of resident or anadromous salmonid use would require additional surveys of the downstream channels and upstream wetlands.

**Figure 28.** Upstream wetland at railroad culvert MP 12.73.

| <b>Culvert MP</b> | <b>Creek</b> | <b>Barrier Status</b> | <b>PI Score</b> | <b>Corrective Action</b> | <b>Cost Estimate</b> |
|---|---|---|---|---|---|
| 12.73 | Deer | Complete | 8.59 | Replace | \$\$\$\$ |

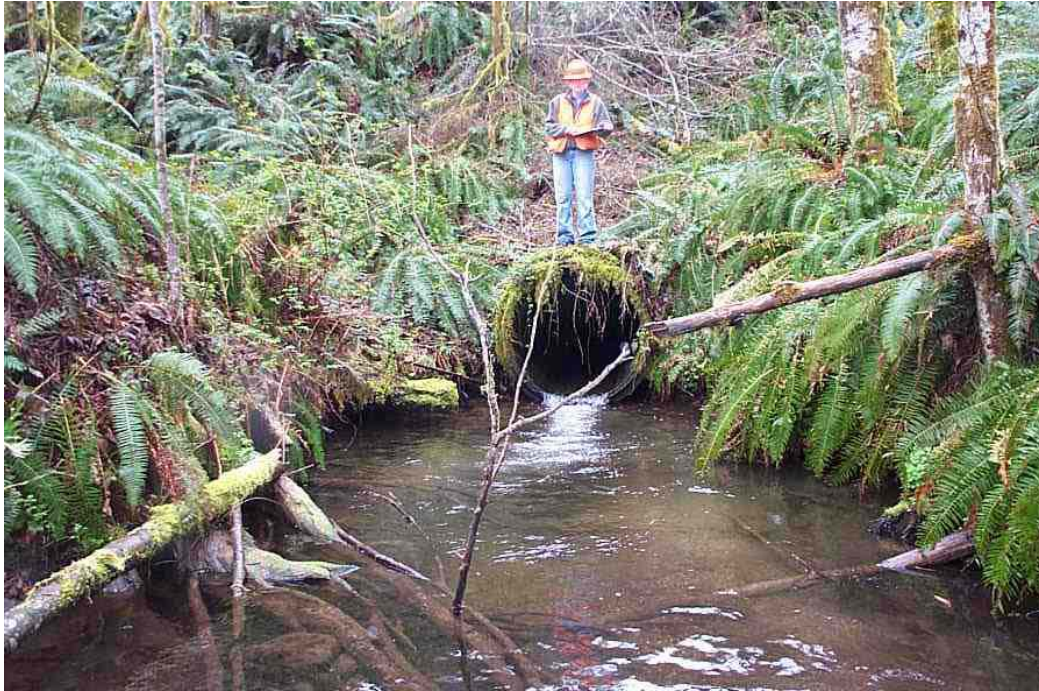
**Figure 29.** Outlet of railroad culvert MP 12.73.

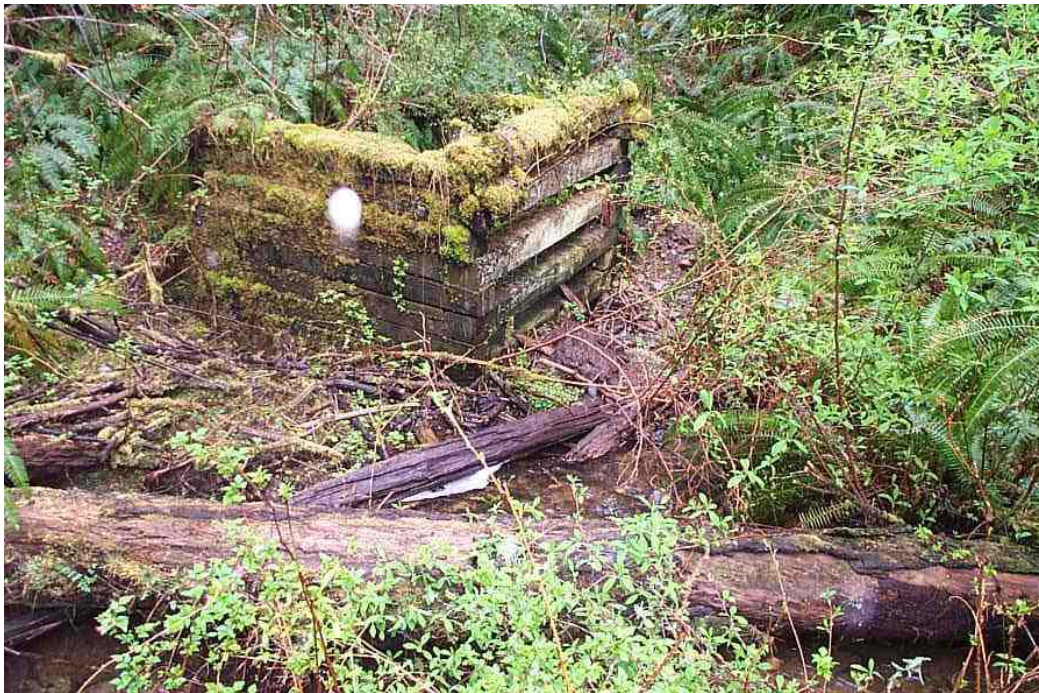
**RR MP 13.10** (Figures 30, 31, and 32)

This RR culvert is located on a headwater tributary of Deer Creek (WRIA 14.0065) northeast of Shelton (Figure 13; WP 151). The culvert is a 6-ft concrete pipe (134 ft in length). The stream channel appears to be perennial at this point in the watershed, originating in a forested wetland and an abandoned beaver pond on the upstream side of the railroad grade. The RR culvert was assessed as passable based on WDFW Level-A analysis (natural streambed material throughout the culvert, slope <1%, and adequate culvert diameter). The culvert has an upstream trash rack made from railroad ties. It is recommended that this railroad-tie trash rack be removed to allow the free flow of water and organic material through the culvert. Removal of these ties will also eliminate the potential water quality problem of the creosote railroad ties being in the creek, and will further allow more unrestricted passage of fish, amphibians, and wildlife through the culvert. Although no fish were observed in this channel during culvert surveys, the creek is still considered to be potentially fish-bearing. Therefore, a habitat assessment was conducted and a PI score of 8.16 was determined.

**Figure 30.** Trash rack at inlet of railroad culvert MP 13.10.

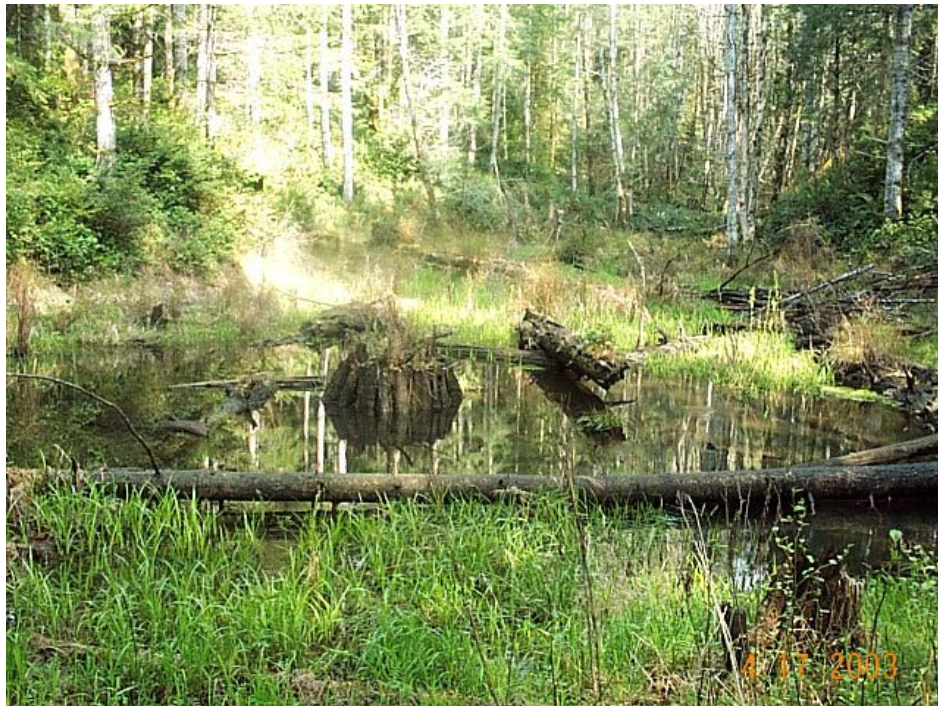
**Figure 31.** Upstream abandoned beaver pond at railroad culvert MP 13.10.

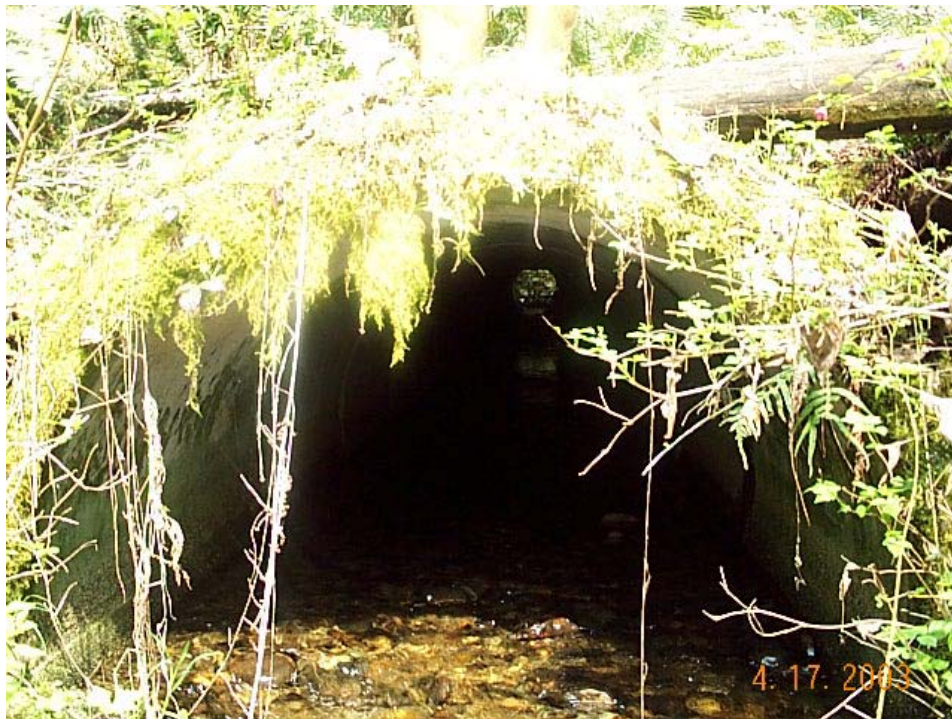
**Figure 32.** Outlet of railroad culvert MP 13.10.

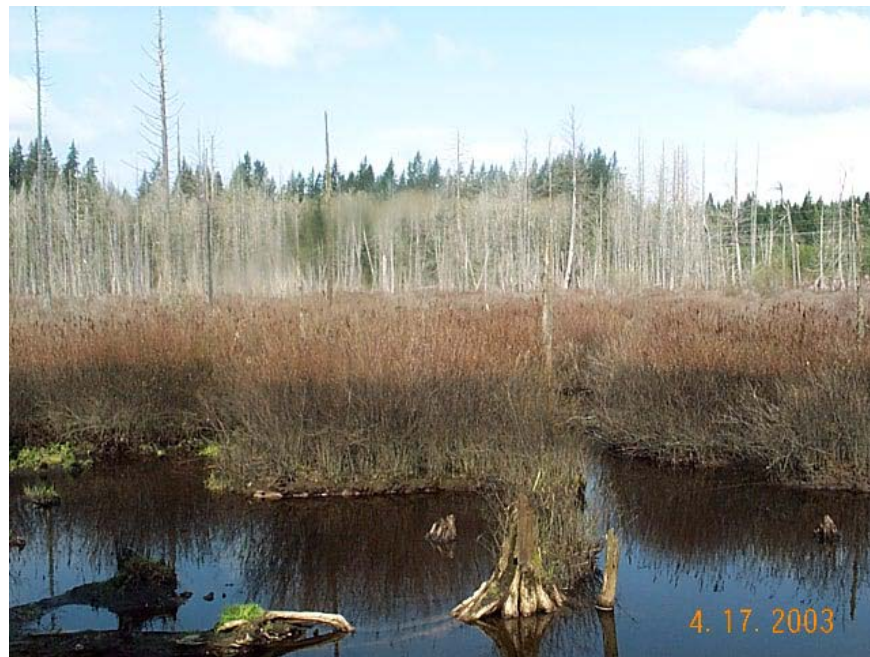
**RR MP 14.89** (Figures 33 and 34)

This RR culvert is located on a headwater tributary of Deer Creek (WRIA 14.0066) northeast of Shelton (Figure 13; WP 152). The culvert is a 4-ft concrete pipe (100 ft in length). The stream channel appears to be perennial at this point in the watershed, originating in a beaver pond wetland on the upstream side of the railroad grade. There is also a beaver pond wetland located on the downstream end of the culvert. The RR culvert was assessed as passable based on WDFW Level-A analysis (natural streambed material throughout the culvert, slope <1%, and adequate culvert diameter). However, the beaver pond location at the inlet of the railroad culvert is problematic from both a passage and maintenance perspective. It is recommended that a “beaver deceiver” device be constructed at the culvert inlet to prevent beaver activity from reducing culvert capacity and restricting passage. These installations are designed to allow unrestricted flow through the culvert, as well as fish passage, while preventing the beaver from damming the culvert inlet. These devices do require special operational and maintenance efforts to ensure fish passage.

**Figure 33.** Beaver pond wetland at inlet of railroad culvert MP 14.89.

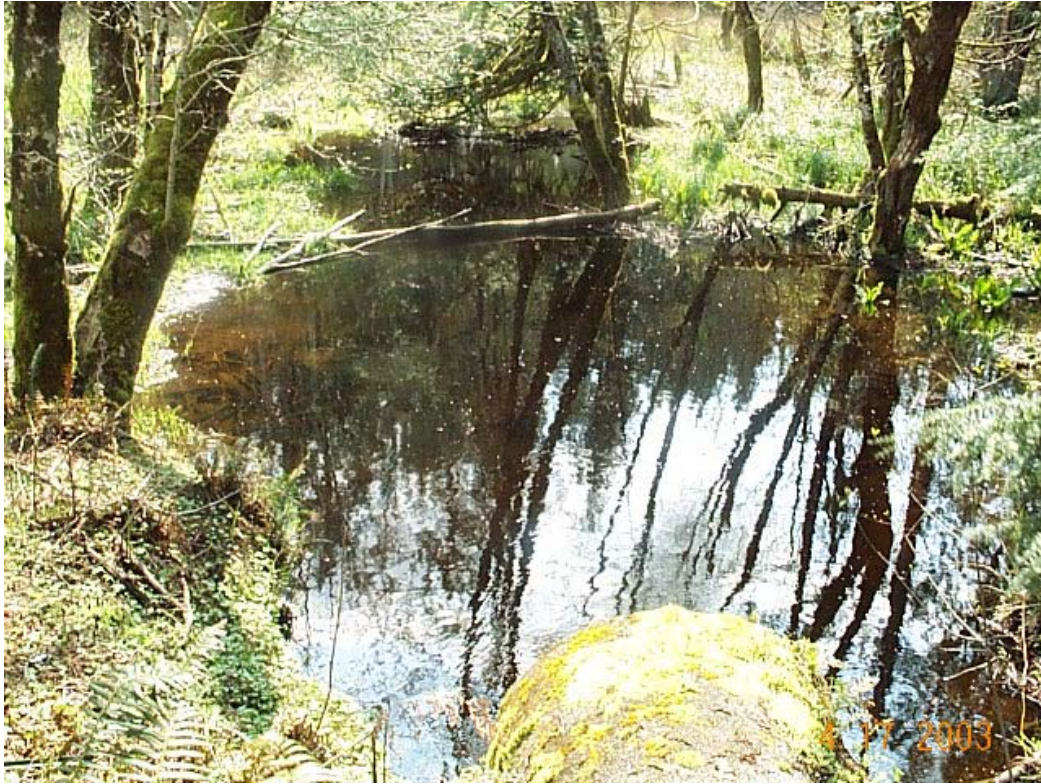
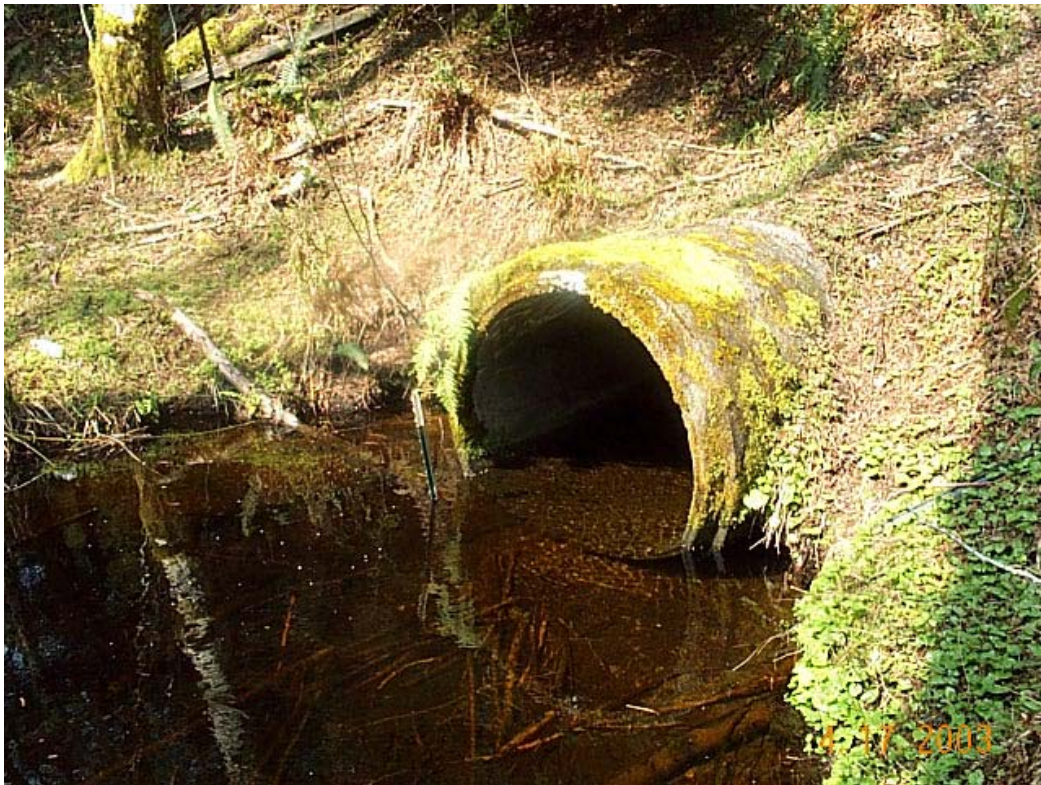
**Figure 34.** Beaver pond wetland at outlet of railroad culvert MP 14.89.
