# An Analysis of Stream Culvert Fish Passage on the Navy Railroad Line between Bremerton and Shelton, Washington

Battelle Marine Sciences Laboratory  
Sequim, Washington

December 2004

Prepared for:  
Puget Sound Naval Shipyard and Intermediate Maintenance Facility

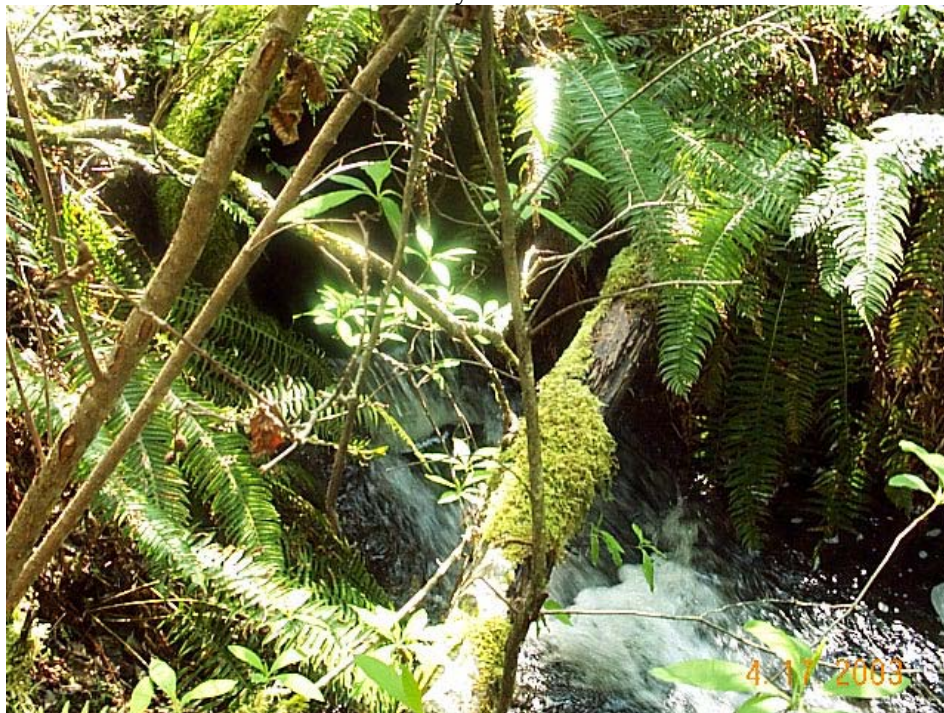
**RR MP 21.67** (Figures 35 and 36)

This RR culvert is located in the headwaters of Lake Devereaux Creek (WRIA 14.0125) between Allyn and Belfair (Figure 13; WP 159). The culvert is a 3-ft concrete pipe (132 ft in length). The culvert is classified as a fish passage barrier based on WDFW Level-B analysis. The culvert is undersized and there is a small (~6 ft) waterfall located just downstream of the culvert outlet. This barrier may have formed as a result of excessive flows through this culvert or may have been natural, however, its location at the culvert outlet exacerbates the fish passage problem at this culvert. The culvert has a PI score of 7.34 based on habitat assessment surveys. Lake Devereaux and the outlet wetlands provide good rearing habitat upstream of the culvert, although the creek is seasonal and very dependent on flows from the lake. There is adequate spawning and rearing habitat located downstream; however, there are at least two other barrier culverts downstream of the railroad culvert. The most significant of these barriers is at the mouth of the creek (SR-104), which should be replaced by the Washington State Department of Transportation (WSDOT) so as to allow full access to the stream system for native salmonids.

**Figure 35.** Outlet of railroad culvert MP 21.67.

| <b>Culvert MP</b> | <b>Creek</b> | <b>Barrier Status</b> | <b>PI Score</b> | <b>Corrective Action</b> | <b>Cost Estimate</b> |
|---|---|---|---|---|---|
| 21.67* | Lake Devereaux | Complete | 7.34 | Replace | \$\$\$ |

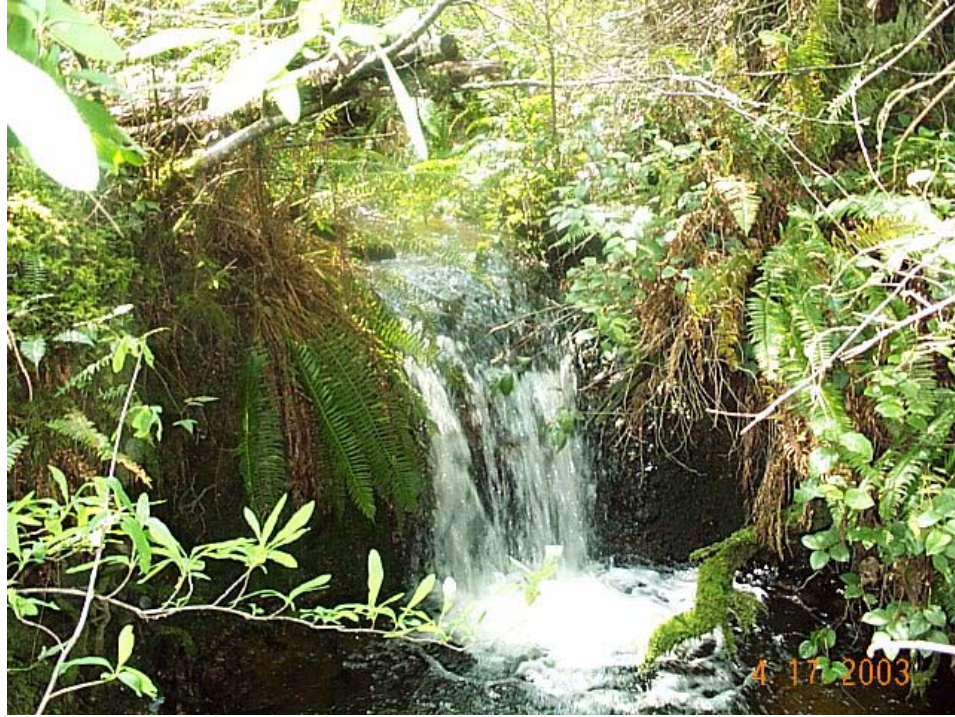
**Figure 36.** Falls just downstream of outlet of railroad culvert MP 21.67.

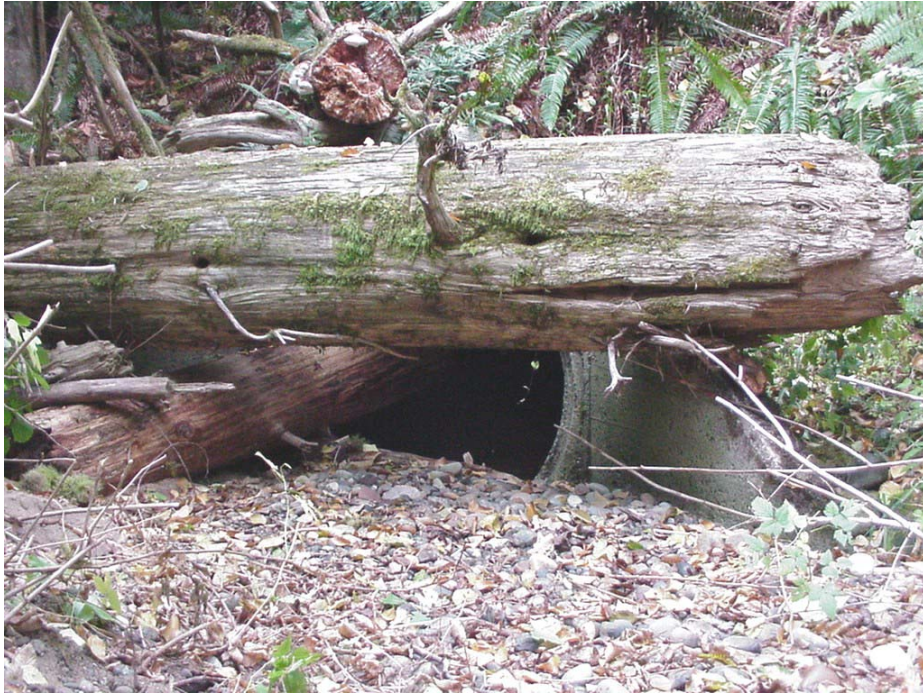
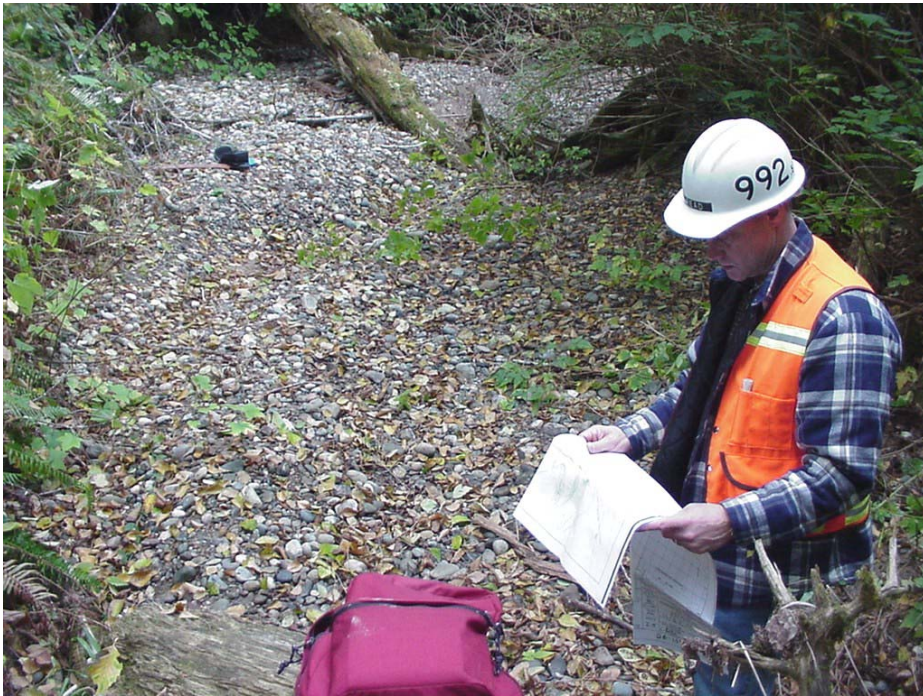
**RR MP 28.24** (Figures 37, 38, and 39)

This RR culvert is located on the “Airport” tributary of the Union River (WRIA 15.0512) between Belfair and Gorst (Figure 14; WP 153). The culvert is a 4-ft concrete pipe (278 ft in length). The stream was classified as fish-bearing by LFA (WCC, 2001). The culvert is classified as a complete barrier based on WDFW Level-B analysis (the culvert is undersized for the stream channel, the culvert gradient is  $> 1\%$ , no natural streambed material exists in the culvert, and the culvert outlet is perched 3 feet above the streambed). These findings are from a report by WDFW personnel who conducted culvert assessment and instream habitat assessment surveys in 2001. The culvert has a PI score of 15.32 (WDFW, 2001). In addition to being a passage barrier, recent inspections by Navy railroad engineers found that there are structural defects in the culvert, such that the culvert will need to be replaced in the next 5 to 10 years. This culvert replacement has been placed on the long-range maintenance schedule for the Navy railroad. Because of the size of the stream, the depth of railroad-grade fill, and length of this culvert, it is likely that a new culvert would have to be “bored and jacked” in place to correct this fish-passage barrier.

Stormwater runoff from the Bremerton Airport (City of Bremerton and Kitsap County jurisdiction) has also resulted in significant stormwater flow increases in the upstream channel, as well as streambank erosion and streambed scour. The result has been significant degradation in spawning and rearing habitat upstream of the railroad culvert and an exacerbation of the flow-capacity problems of the original culvert design (WDFW, 2001). The correction of this stormwater runoff problem should be integrated with any long-term plan for culvert replacement. In addition, rehabilitation of damaged or lost habitat between the railroad grade and the airport will also be required. Although this stream is classified as perennial by WDFW, flow is very seasonal and is dependent on the headwater wetlands located on airport property for flow. There are water quality concerns with these wetlands, as they receive runoff from the airport runway and hanger areas. Coordination between WDFW, City of Bremerton, Kitsap County, HCSEG, and the Navy will be required to correct this fish passage barrier, as well as the stormwater problems and instream habitat rehabilitation needs.

**Figure 37.** Inlet of railroad culvert MP 28.24.

| <b>Culvert MP</b> | <b>Creek</b> | <b>Barrier Status</b> | <b>PI Score</b> | <b>Corrective Action</b> | <b>Cost Estimate</b> |
|---|---|---|---|---|---|
| 28.24 | Union | Complete | 15.32 | Replace | \$\$\$\$\$ |

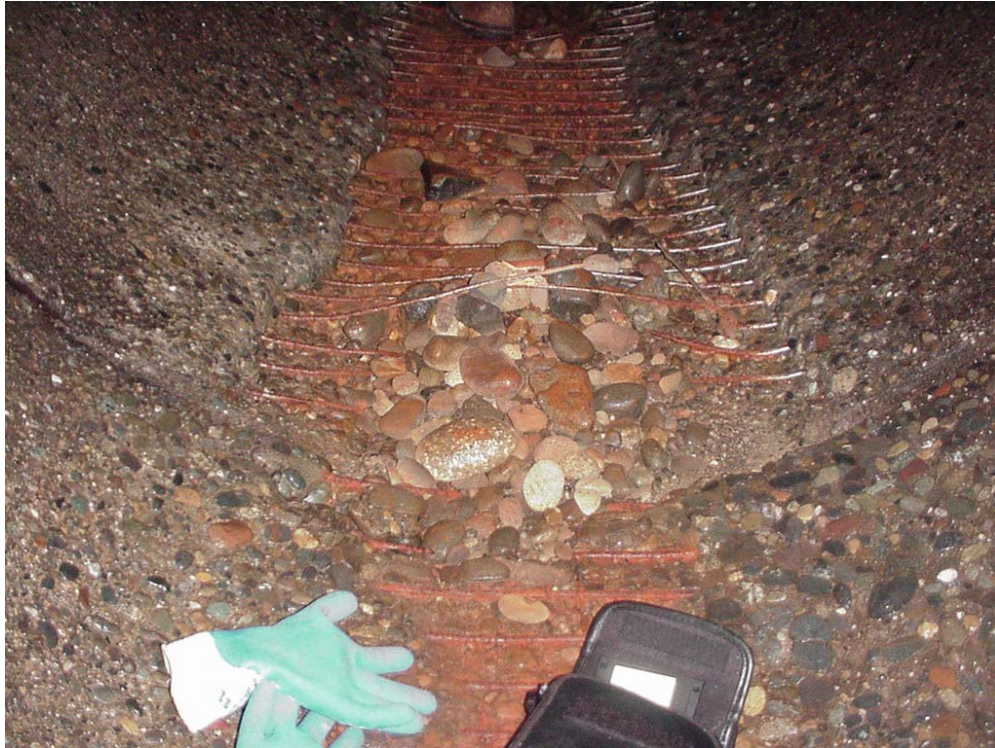
**Figure 38.** Interior structural damage to railroad culvert MP 28.24.

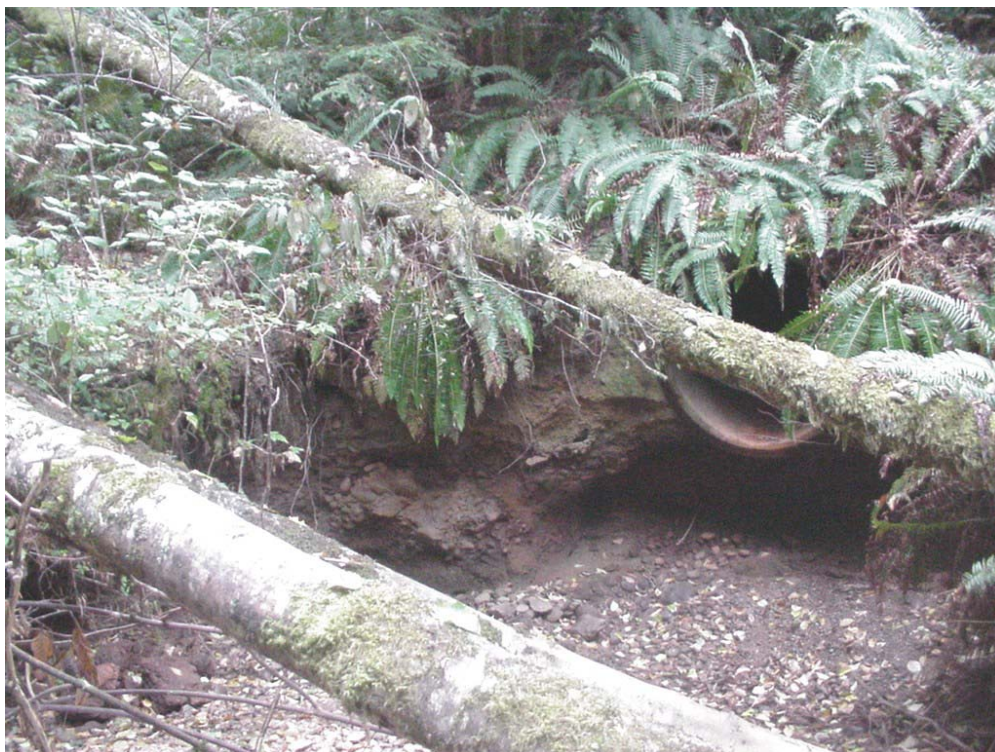
**Figure 39.** Outlet of railroad culvert MP 28.24.

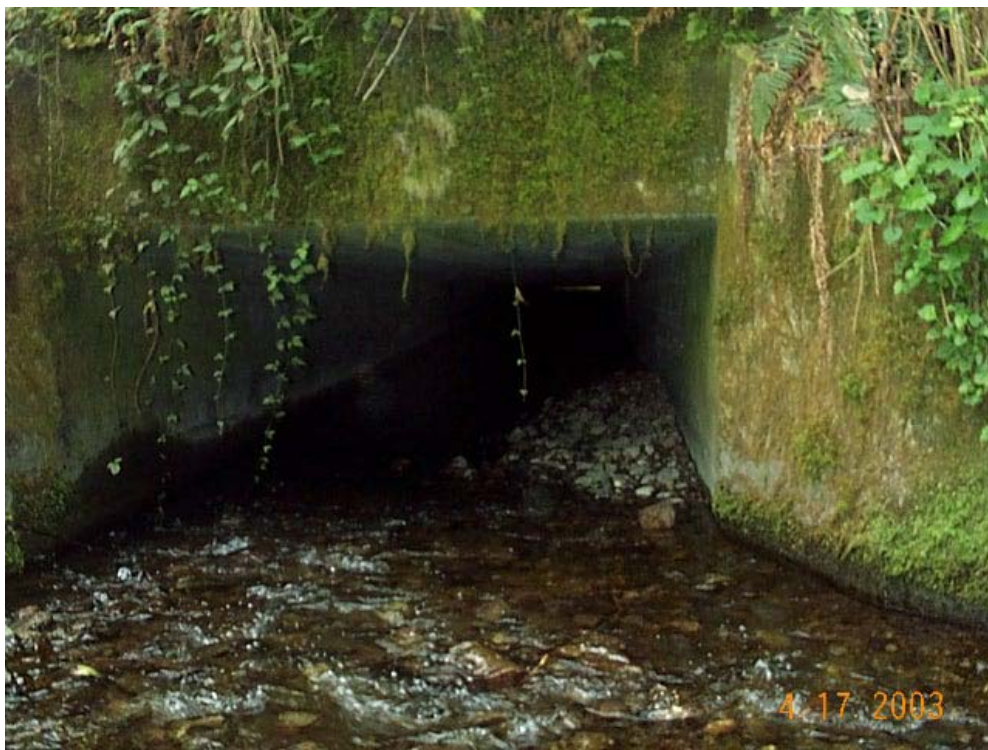
This RR culvert is located on a tributary of Gorst Creek (WRIA 15.0223) northwest of Gorst (Figure 14; WP 161). The culvert is an 8- by 5-ft concrete box culvert (180 ft in length) that has been classified as passable by WDFW Level-A analysis. There is adequate flow capacity in the culvert as sized, the culvert gradient is <1%, and natural streambed material exists throughout. However, there is a debris jam located just downstream of the culvert that may be causing a partial barrier at the culvert inlet during high flow conditions. The Suquamish Tribe and WDFW habitat biologists have recommended that this debris jam be relocated downstream (WDFW Hydraulic Permit required) and the creek monitored. One section of the culvert roof may also be cracked. Although not believed to be a structural or passage problem, railroad engineers should investigate it. These corrective actions have been scheduled. There is ample, good quality spawning and rearing habitat upstream and downstream of the culvert. Juvenile salmonids were observed upstream and downstream of the culvert during stream surveys. In addition, the Suquamish Tribe spawning surveys have noted that this is a very productive tributary in the Gorst Creek system.

**Figure 40.** Inlet of railroad culvert MP 31.55.

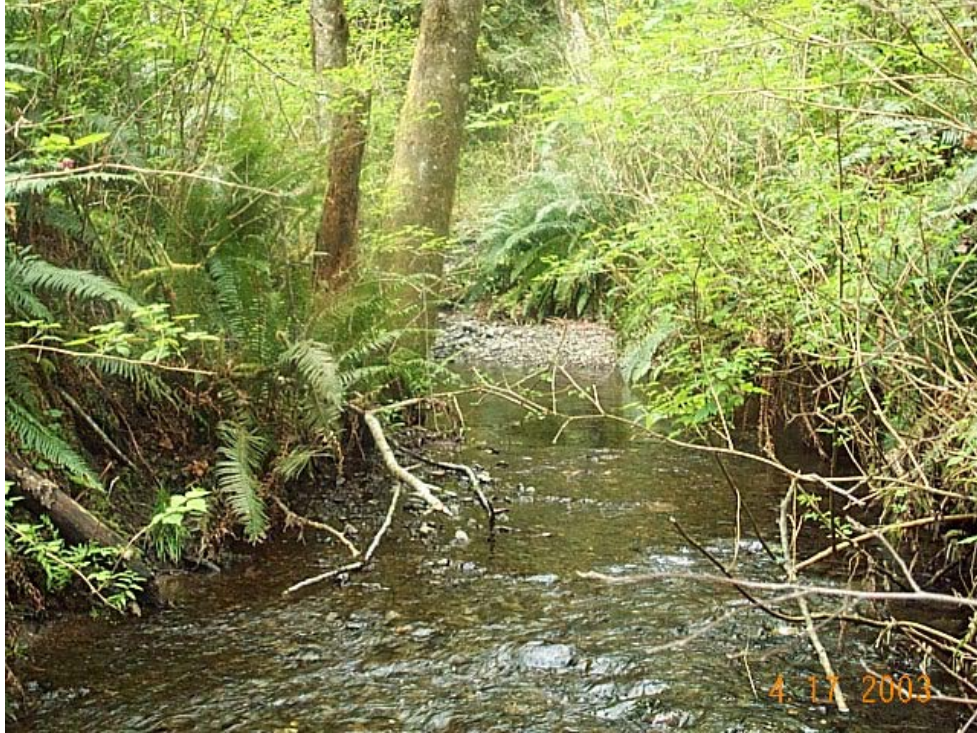
**Figure 41.** Instream habitat upstream of railroad culvert MP 31.55.

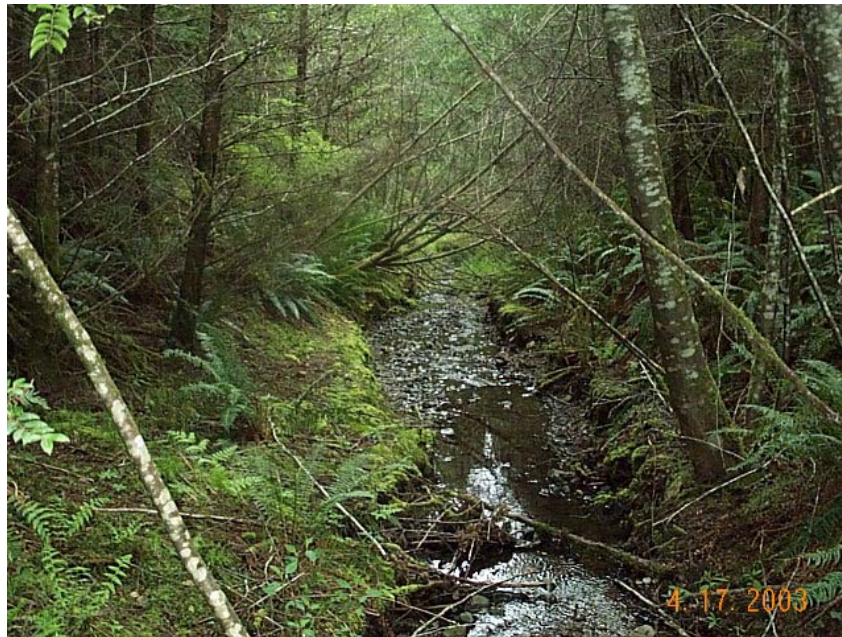
**RR MP 32.09** (Figures 42, 43, and 44)

This RR culvert is located at the headwaters of an un-named tributary of Gorst Creek, northwest of Gorst (Figure 14; WP 156). The culvert is a 30-in. concrete pipe (213 ft in length). The stream channel is seasonal at this point in the watershed, originating in a steep (>20% slope) forested area on the upstream side of the railroad grade. No water was flowing in the culvert or the downstream channel at the time of the survey, although there was flow upstream of the culvert, so the creek is likely hyporheic for much of the year throughout sections of this tributary. The culvert was assessed as a fish-passage barrier based on WDFW Level-B analysis. An instream habitat assessment was conducted and a PI score of 2.17 was determined. Upstream habitat is limited mainly by the steep gradient. No fish were observed in the stream, however limited resident salmonid use may be possible just upstream of the culvert based on channel size and habitat conditions. In addition, limited juvenile rearing habitat also exists. Therefore, the stream is classified as potentially fish-bearing. There were several potential barriers noted downstream of the culvert (beaver dams and logging road culverts on City of Bremerton property). These culverts should be evaluated and PI scores derived for each.

**Figure 42.** Instream habitat downstream of railroad culvert MP 32.09.

| <b>Culvert MP</b> | <b>Creek</b> | <b>Barrier Status</b> | <b>PI Score</b> | <b>Corrective Action</b> | <b>Cost Estimate</b> |
|---|---|---|---|---|---|
| 32.09 | Gorst | Complete | N/A | Replace | \$\$\$\$\$ |

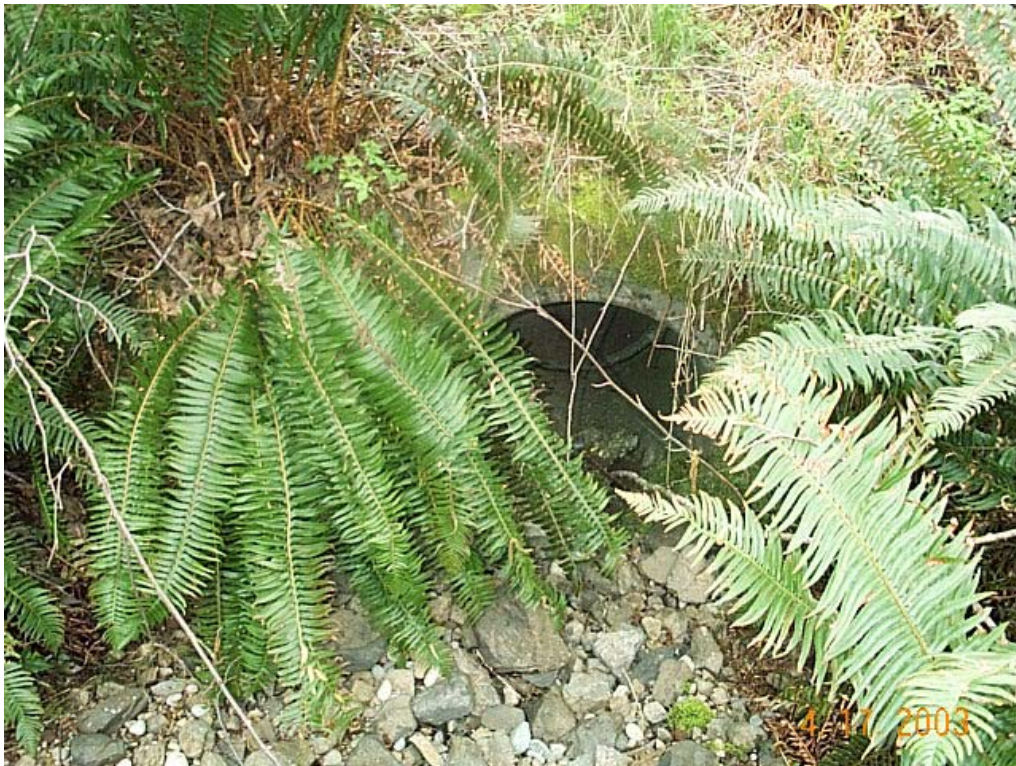
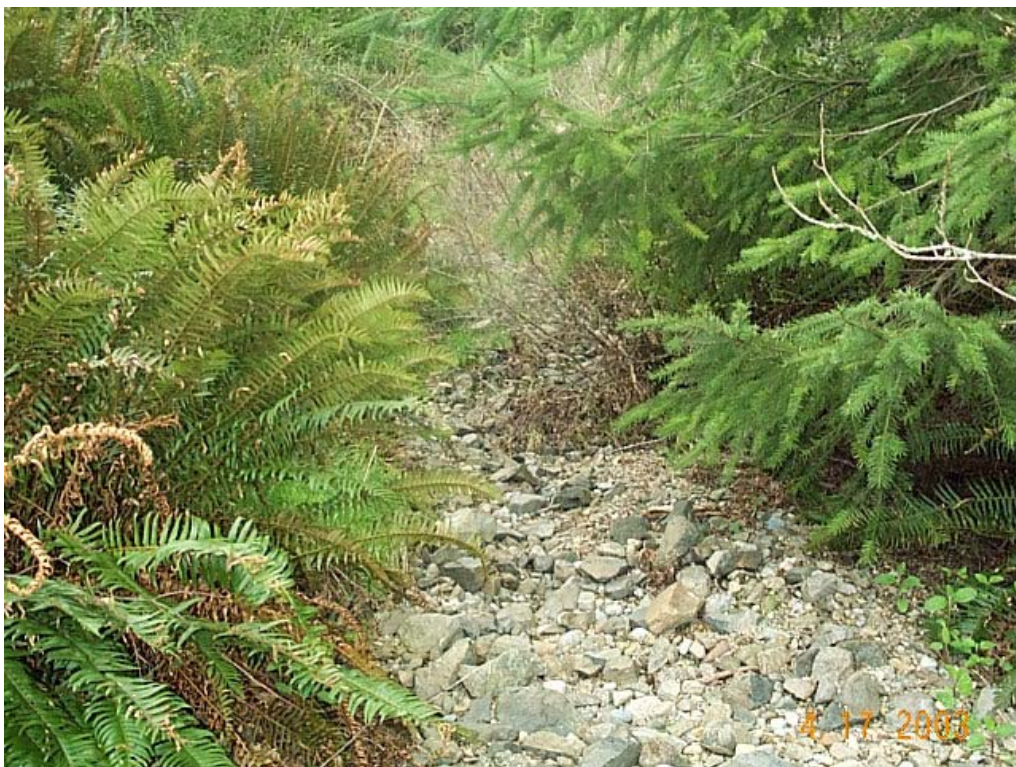
**Figure 43.** Outlet of railroad culvert MP 32.09.

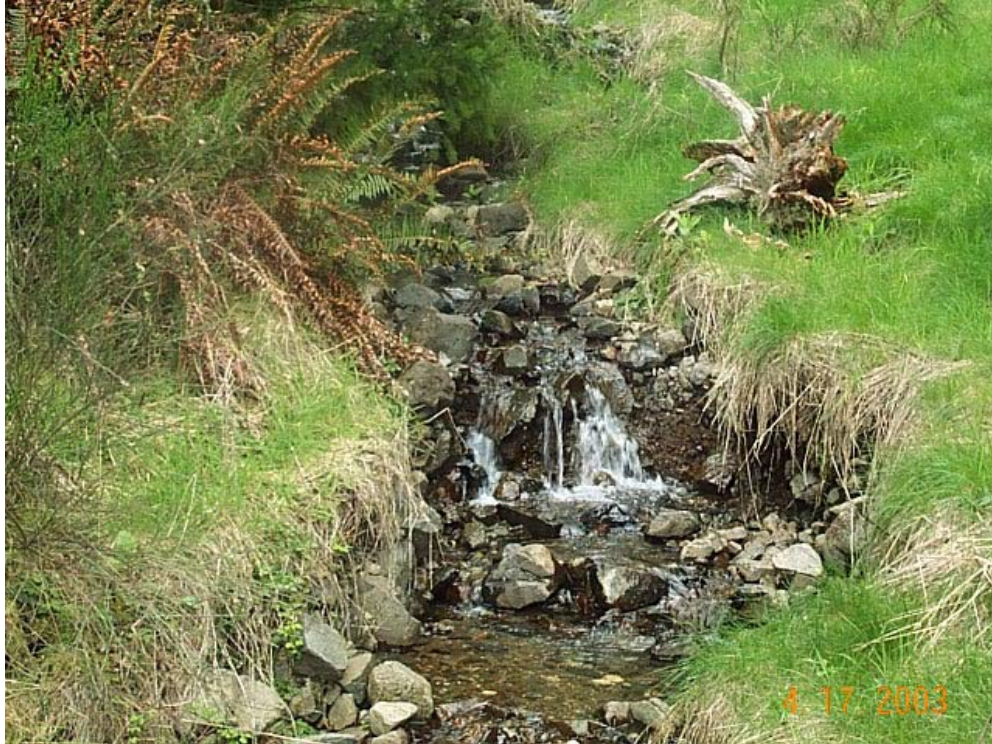
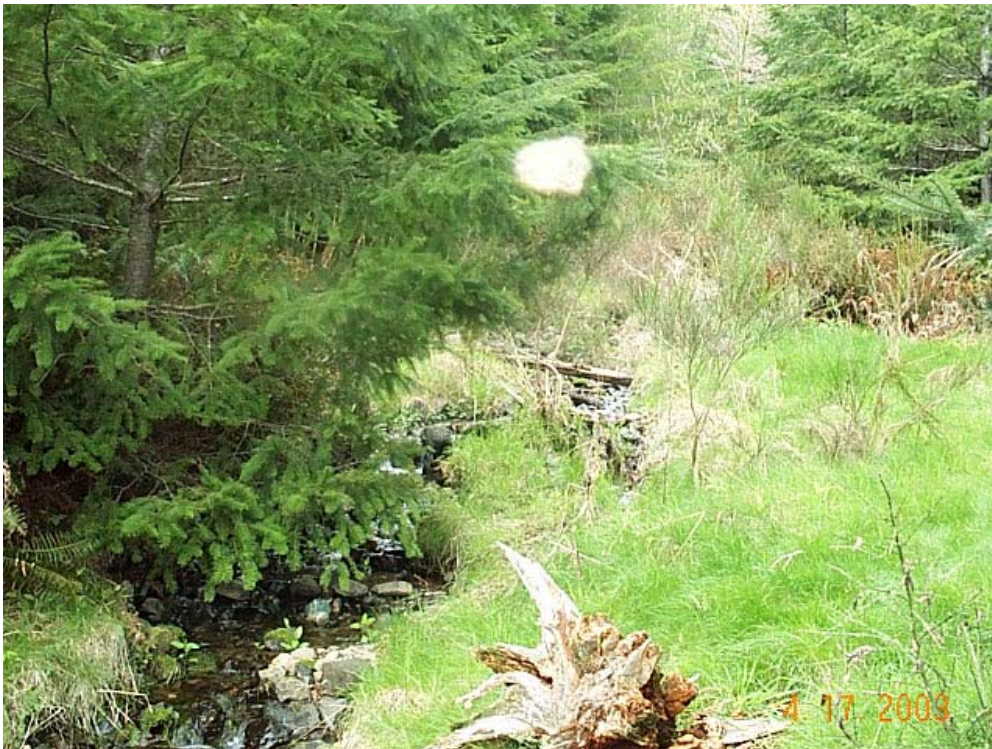
**Figure 44.** Instream habitat just upstream of railroad culvert MP 32.09.

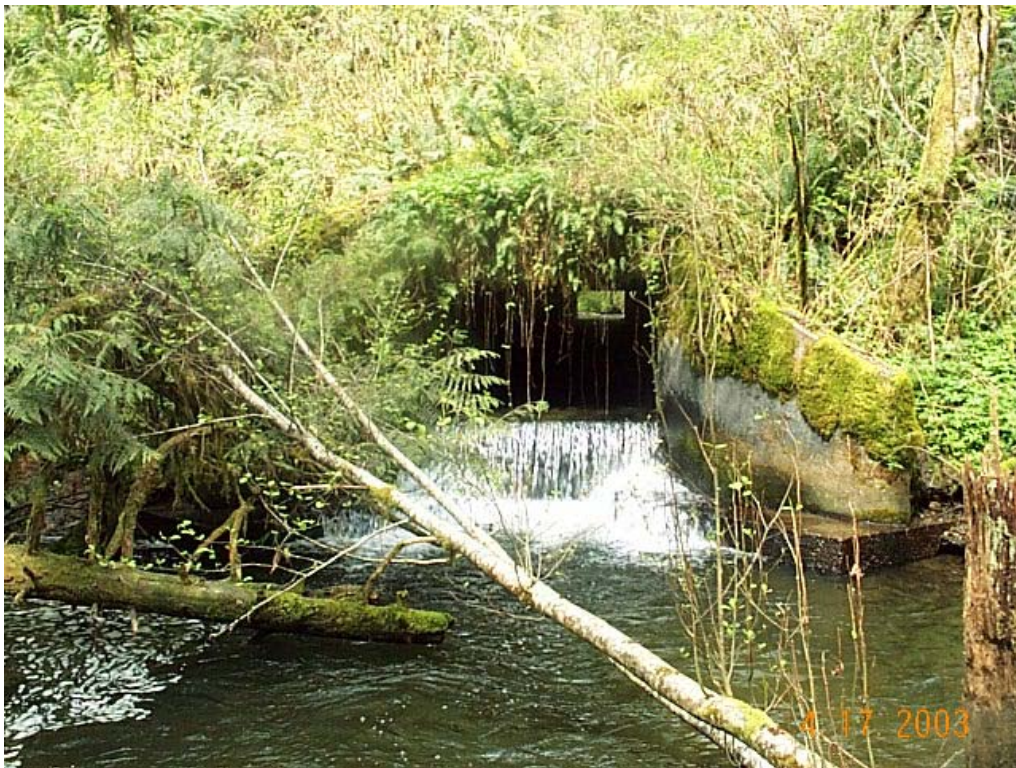
**RR MP 0.71** (Figure 45)

This RR culvert is located on the Heins Creek tributary of Gorst Creek (WRIA 15.0221) northwest of Gorst (Figure 14; WP 157). The culvert is an 8- by 5-ft concrete box culvert (159 ft in length) that has been classified as a barrier by WDFW Level-B analysis (survey conducted by WDFW in 2002). Juvenile and adult salmonids have been observed upstream and downstream of the culvert; so it is likely passable during certain flow conditions. There is ample, good quality spawning and rearing habitat upstream and downstream of the culvert. The culvert has a PI score of 9.79 (based on WDFW surveys conducted in 2002). There is also a downstream (partial) barrier on the City of Bremerton access road that should be corrected by the City in coordination with work on the RR culvert. Current plans call for the replacement of this downstream barrier during summer 2005. An engineered fishway was installed on the railroad culvert during the summer of 2004.

**Figure 45.** Heins Creek (railroad MP 0.71) culvert outlet.

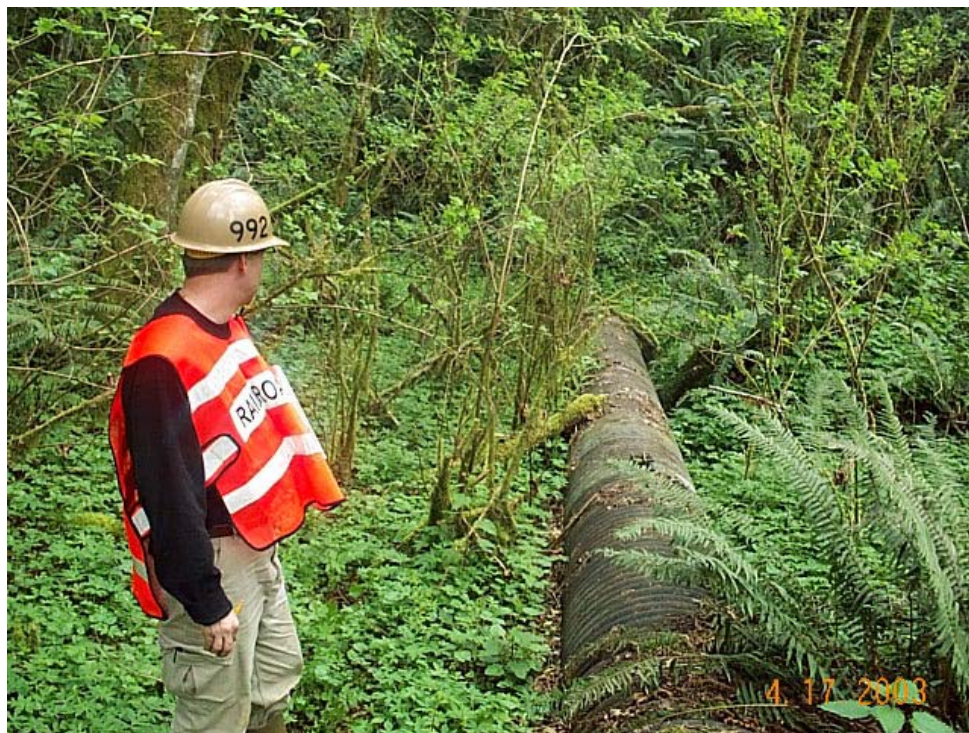
**RR MP 1.04** (Figures 46, 47, 48, 49, and 50)

rugated-metal piping attached to each end (267 ft in length). The reason for this unusual configuration is unknown, but it has resulted in a complete barrier to fish passage. There is also a downstream (partial) barrier at the City of Bremerton access road that should be corrected by the City as soon as possible. This undersized, downstream culvert is a 2-ft concrete box, with no natural streambed material in the culvert. This culvert is likely a barrier to juveniles during all flows and possibly adults under low or high flow conditions. The railroad culvert was found to be a complete barrier to fish passage based on the standard WDFW culvert survey (Level-B analysis). There is ample, good quality spawning and rearing habitat upstream of the railroad culvert. The railroad culvert has a PI score of 10.17. This culvert should be replaced with a bottomless arched culvert or a box-culvert bridge. As with Heins creek, the downstream (partial) barrier should also be replaced by the City of Bremerton in coordination with any scheduled railroad culvert corrective action.

**Figure 46.** Upstream extension on Jarstad Creek (railroad MP 1.04) culvert.

| <b>Culvert MP</b> | <b>Creek</b> | <b>Barrier Status</b> | <b>PI Score</b> | <b>Corrective Action</b> | <b>Cost Estimate</b> |
|---|---|---|---|---|---|
| 1.04 | Jarstad | Complete | 10.17 | Replace | \$\$\$ |

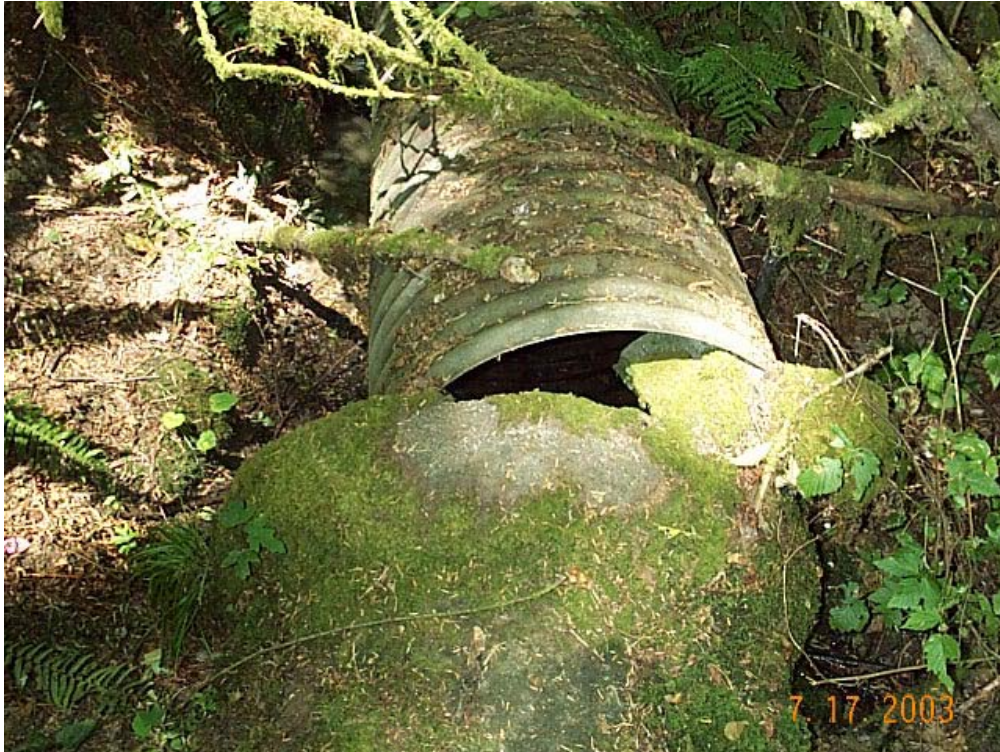
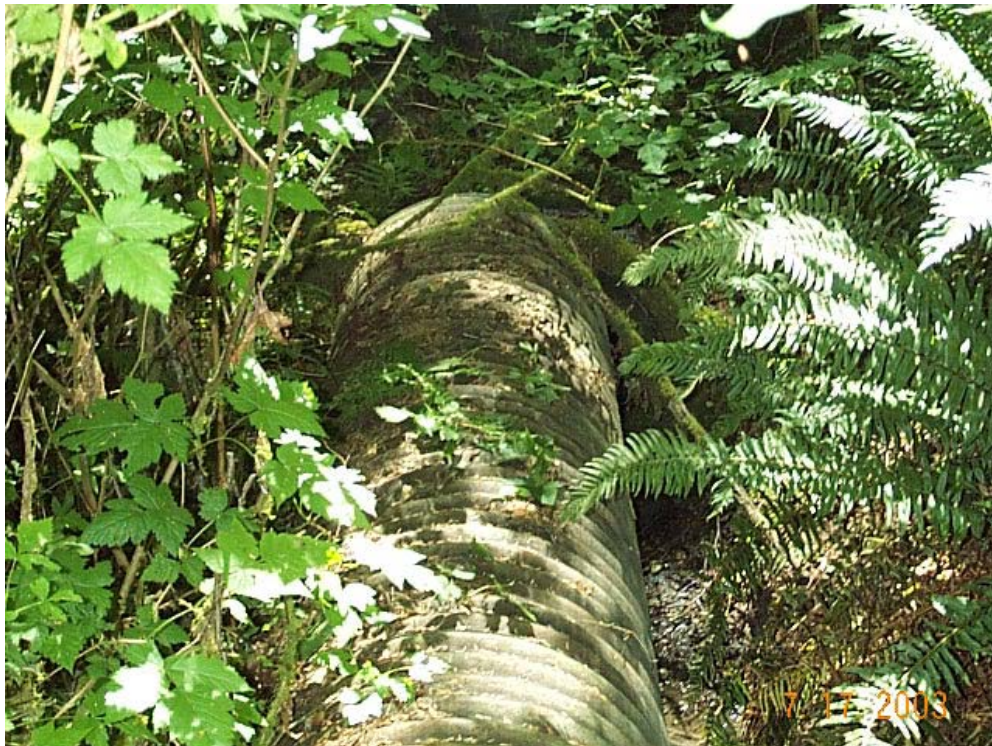
**Figure 47.** Upstream extension on Jarstad Creek (railroad MP 1.04) culvert.

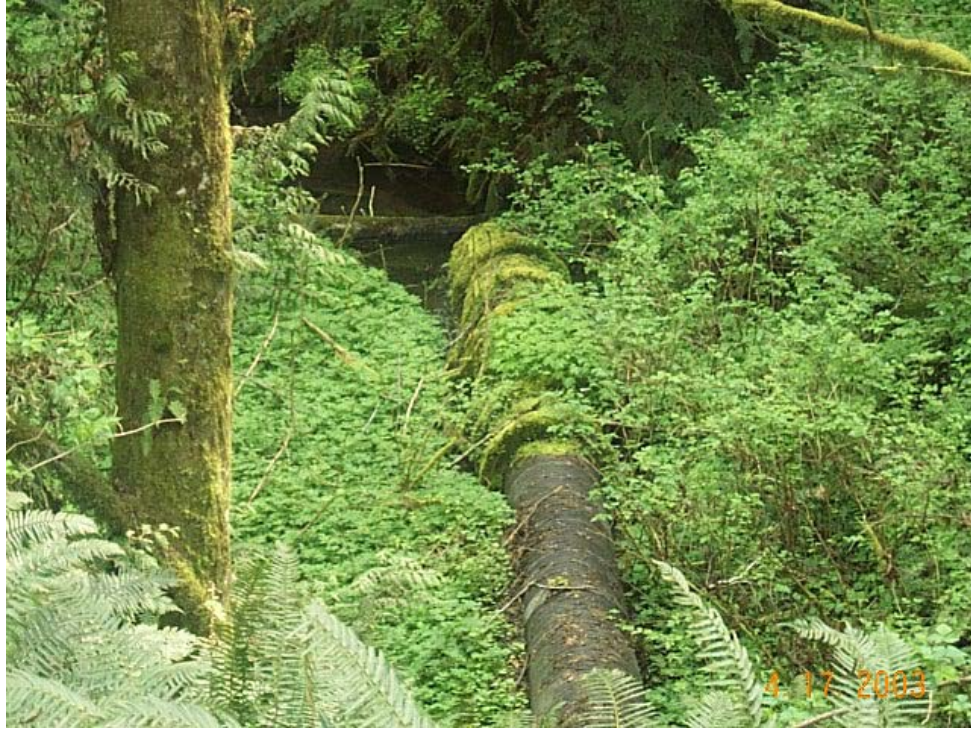
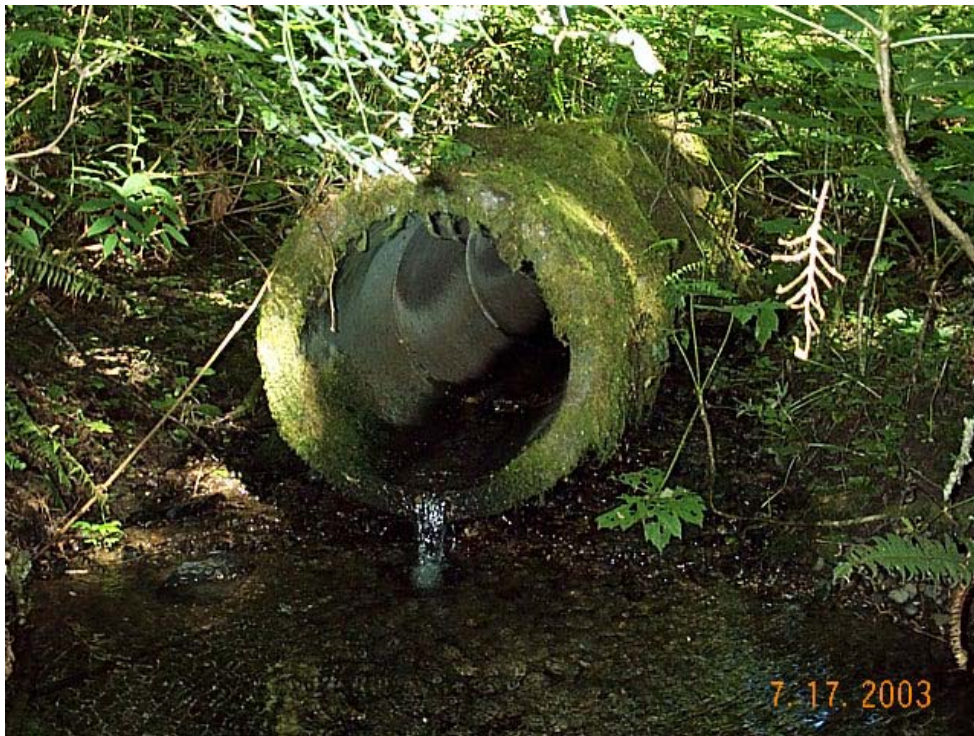
**Figure 48.** Outlet of Jarstad Creek (railroad MP 1.04) culvert.

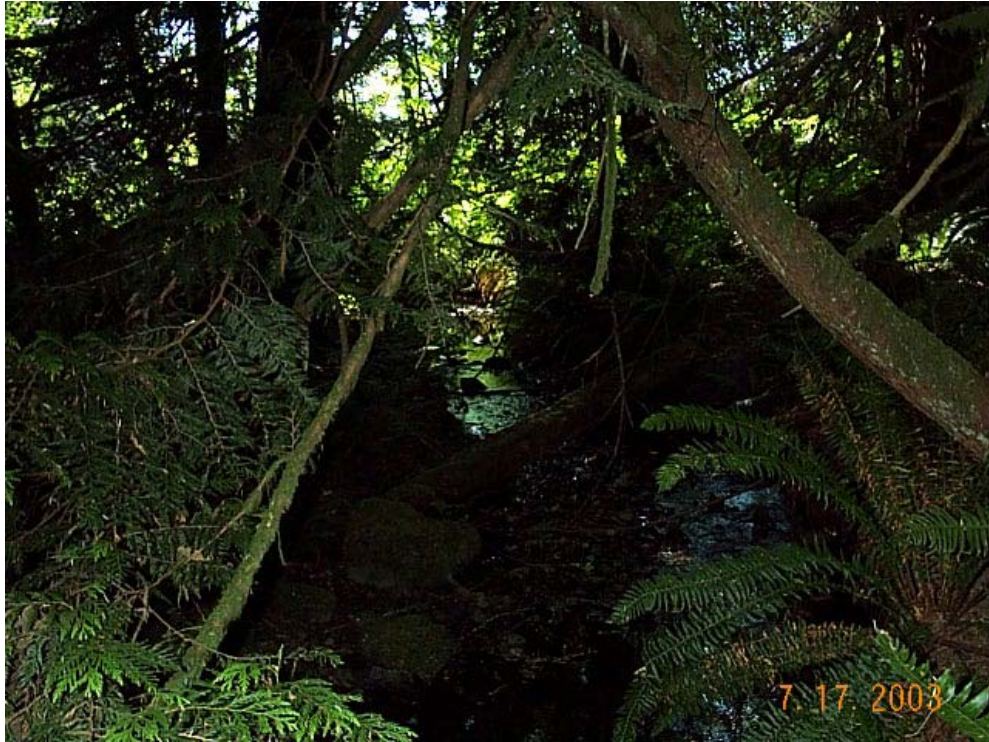
**Figure 49.** Instream habitat downstream of Jarstad Creek (railroad MP 1.04) culvert.

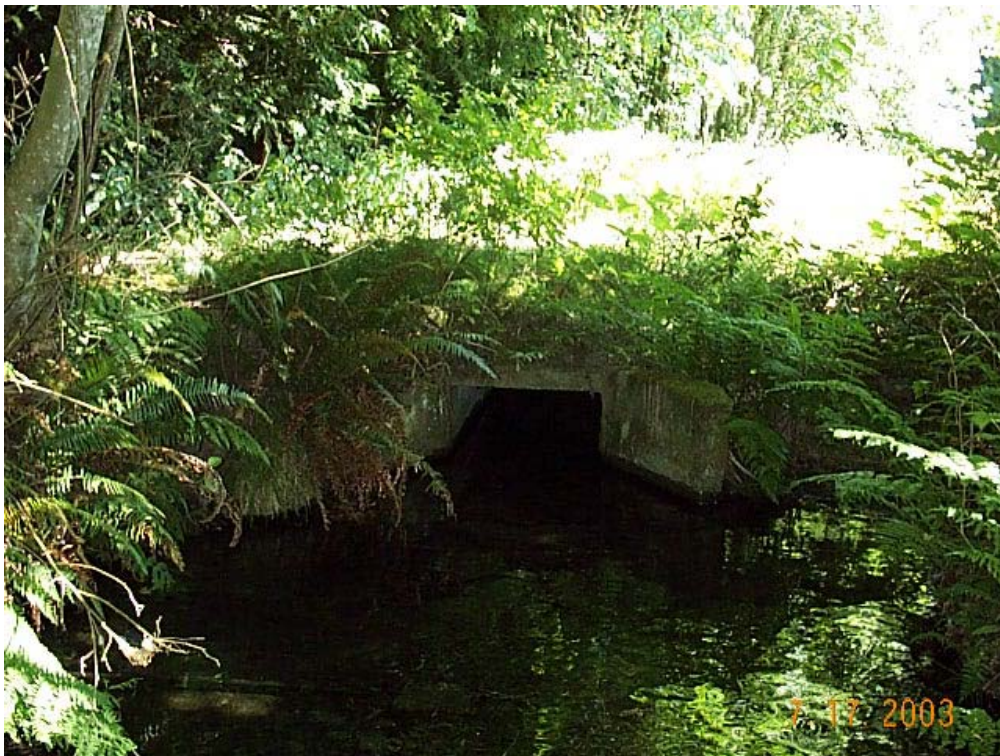
**Figure 50.** Bremerton culvert downstream of Jarstad Creek (railroad MP 1.04) culvert.
