## Sediment Profile Imaging Report

# Demonstration of *in-situ* Treatment of Contaminated Sediments with Reactive Amendments: Baseline Survey

**March, 2013**

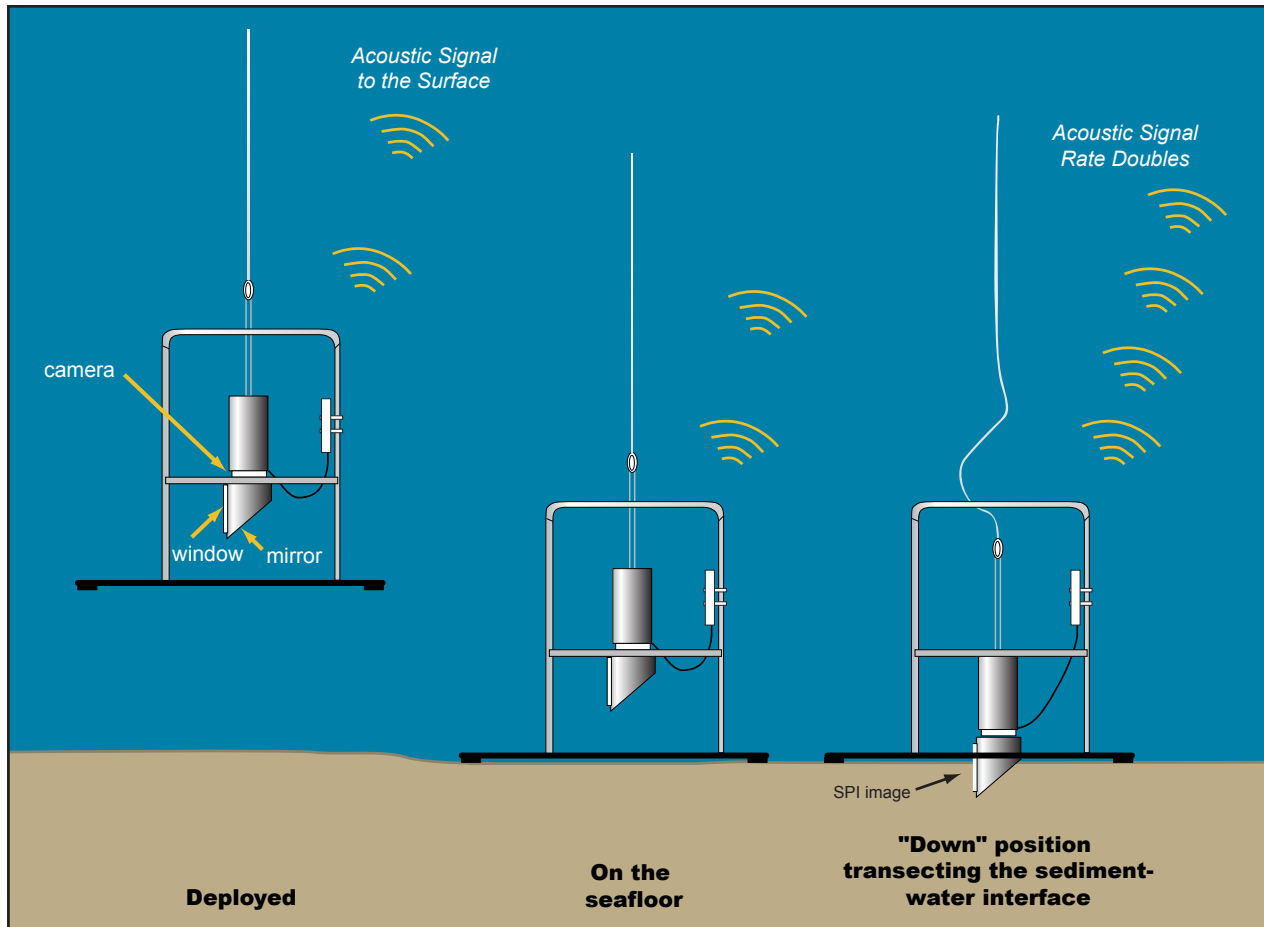
Figure 2: Deployment and operation of the SPI camera system. The central cradle of the camera is held in the “up” position by tension on the winch wire as it is being lowered to the seafloor (left); once the frame base hits the bottom (center), the prism is then free to penetrate the bottom (right) and take the photograph.

SPI was developed almost four decades ago as a rapid reconnaissance tool for characterizing physical, chemical, and biological seafloor processes and has been used in numerous seafloor surveys throughout North America, Asia, Europe, and Africa (Rhoads and Germano 1982, 1986, 1990; Revelas et al. 1987; Diaz and Schaffner, 1988; Valente et al. 1992; Germano et al. 2011). The sediment profile camera works like an inverted periscope. A Nikon D7000 16.2-megapixel SLR camera with two 8-gigabyte secure digital (SD) cards is mounted horizontally inside a watertight housing on top of a wedge-shaped prism. The prism has a Plexiglas<sup>®</sup> faceplate at the front with a mirror placed at a 45° angle at the back. The camera lens looks down at the mirror, which is reflecting the image from the faceplate. The prism has an internal strobe mounted inside at the back of the wedge to provide illumination for the image; this chamber is filled with distilled water, so the camera always has an optically clear path. This wedge assembly is mounted on a moveable carriage within a stainless steel frame. The frame is lowered to the seafloor on a winch wire, and the tension on the wire keeps the prism in its “up” position. When the frame comes to rest on the seafloor, the winch wire goes slack (see Figure 2) and the camera prism descends into the sediment at a slow, controlled rate by the dampening action of a hydraulic piston so as not to disturb the sediment-water interface. On the way down, it trips a trigger that activates a time-delay circuit of variable length (operator-selected) to allow the camera to penetrate the seafloor before any image is taken. The knife-sharp edge of the prism transects the sediment, and the prism penetrates the bottom. The strobe is discharged after an appropriate time delay to obtain a cross-sectional image of the upper 20 cm of the sediment column. The resulting images give the viewer the same perspective as looking through the side of an aquarium half-filled with sediment. After the first image is obtained at the first location, the camera is then raised up about 2 to 3 meters off the bottom to allow the strobe to recharge; a wiper blade mounted on the frame removes any mud adhering to the faceplate. The strobe recharges within 5 seconds, and the camera is ready to be lowered again for a replicate image.

Surveys can be accomplished rapidly by “pogo-sticking” the camera across an area of seafloor while recording positional fixes on the surface vessel.

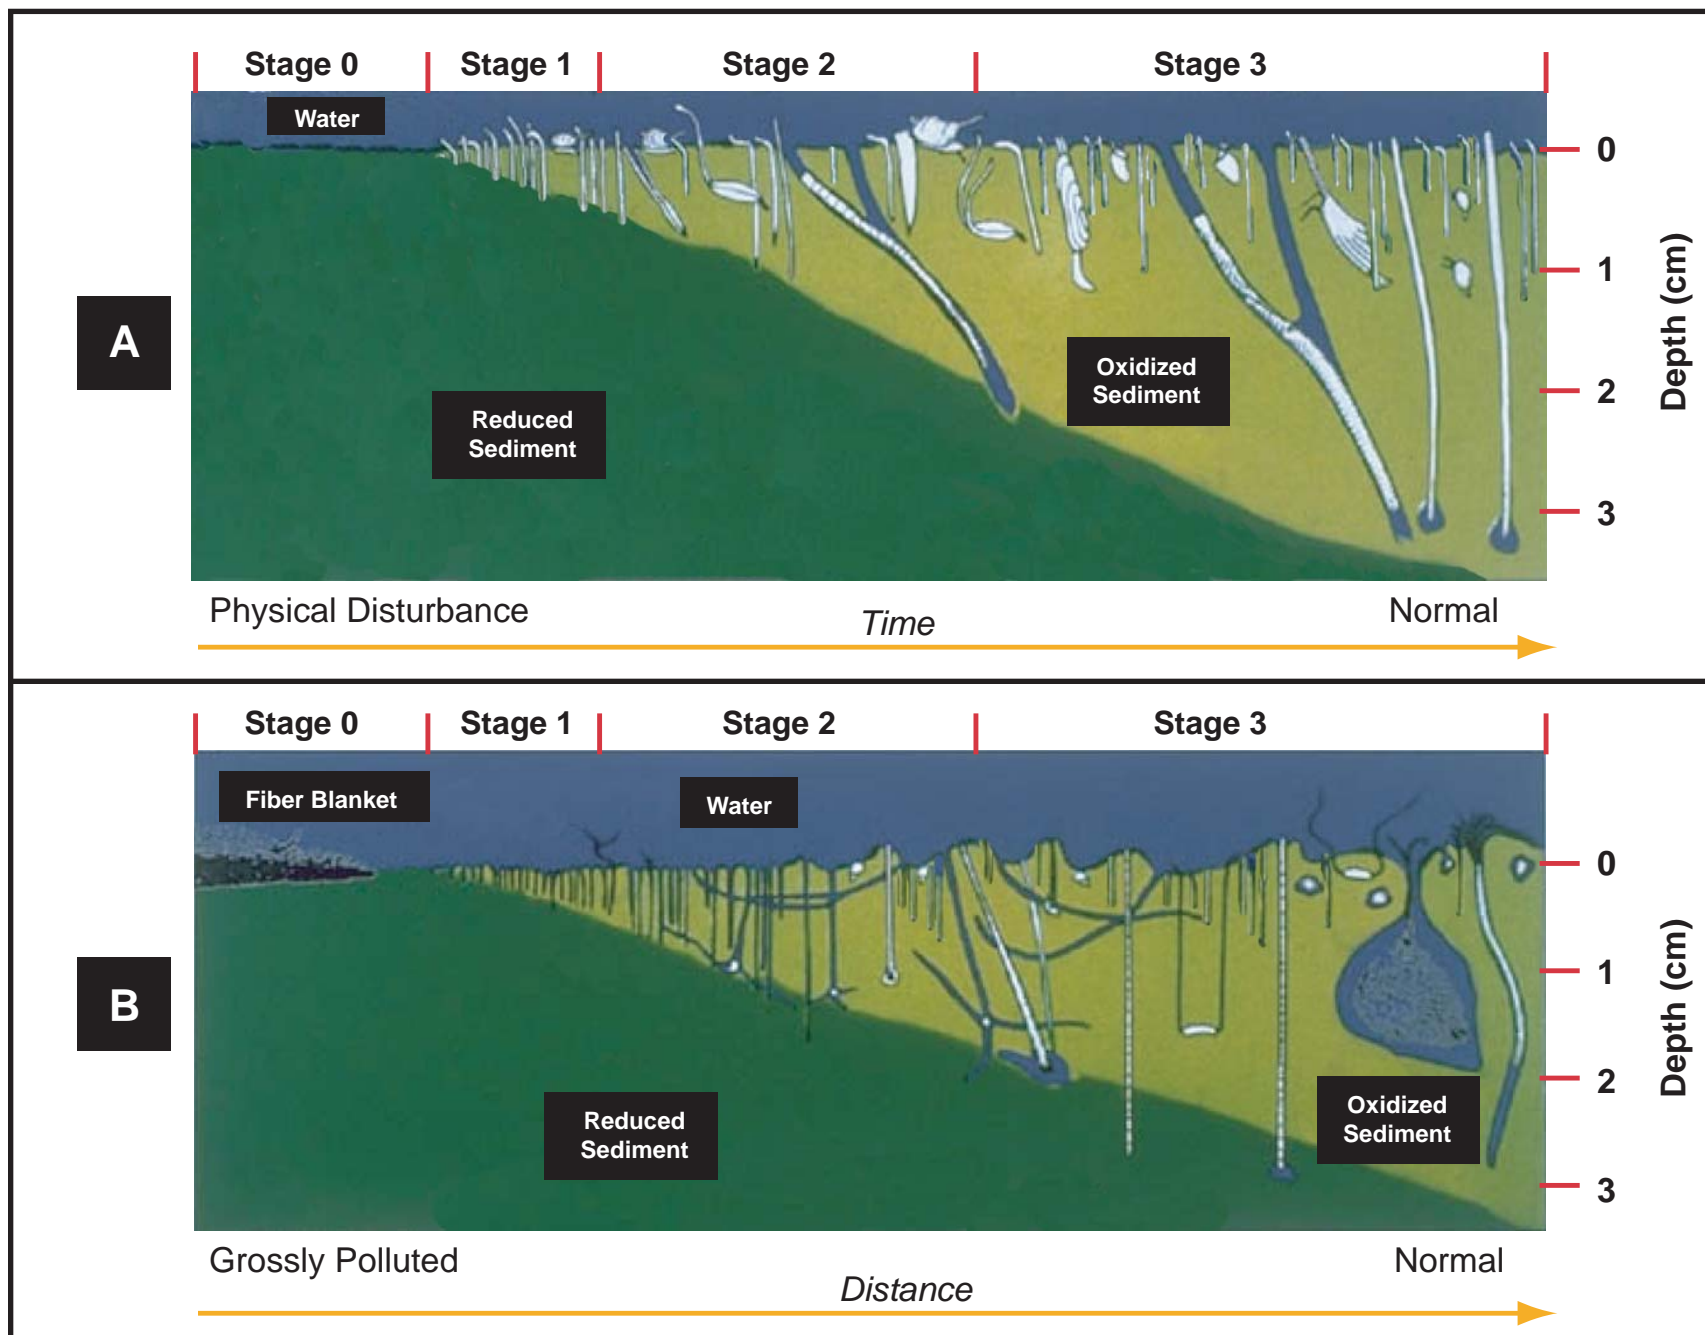
Figure 4: The stages of infaunal succession as a response of soft-bottom benthic communities to physical disturbance (top panel) or organic enrichment (bottom panel). From Rhoads and Germano, 1982.

This continuum of change in animal communities after a disturbance (primary succession) has been divided subjectively into four stages: Stage 0, indicative of a sediment column that is largely devoid of macrofauna, occurs immediately following a physical disturbance or in close proximity to an organic enrichment source; Stage 1 is the initial community of tiny, densely populated polychaete assemblages; Stage 2 is the start of the transition to head-down deposit feeders; and Stage 3 is the mature, equilibrium community of deep-dwelling, head-down deposit feeders (Figure 4).

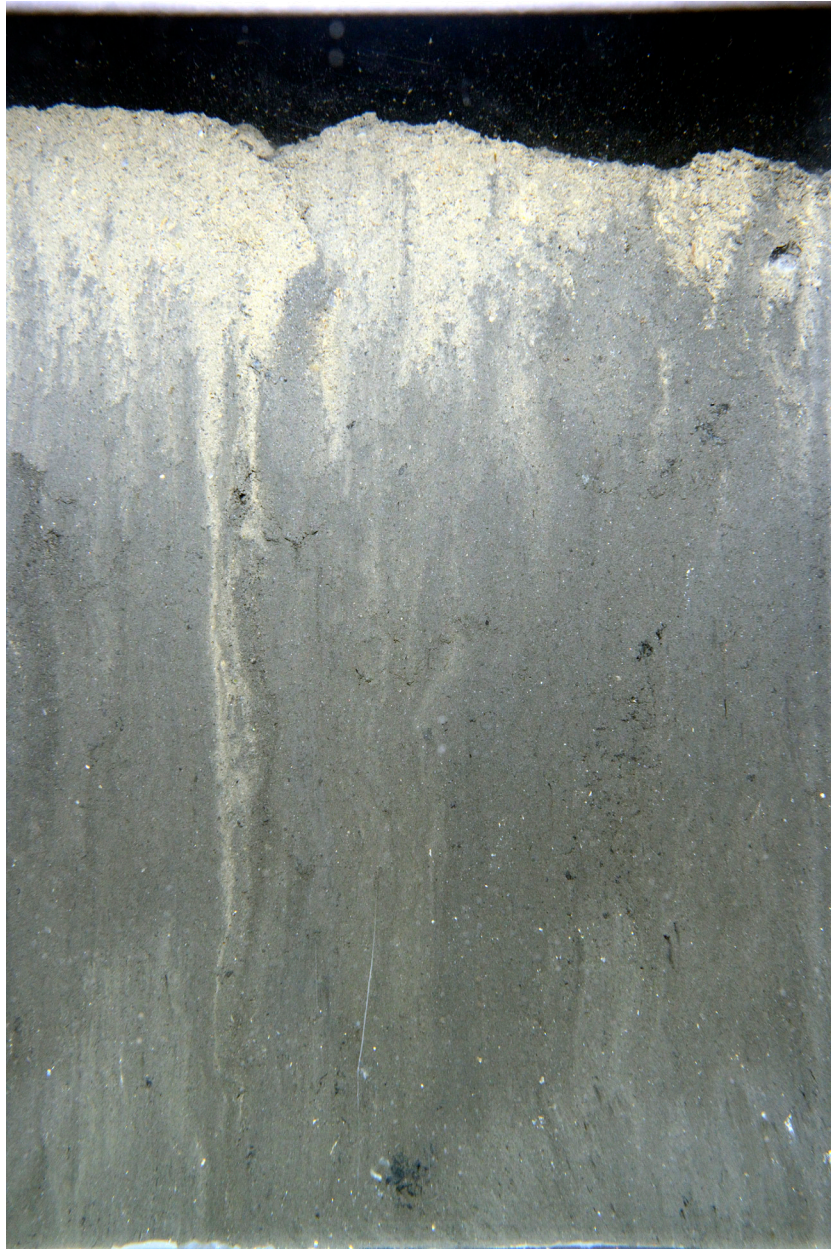
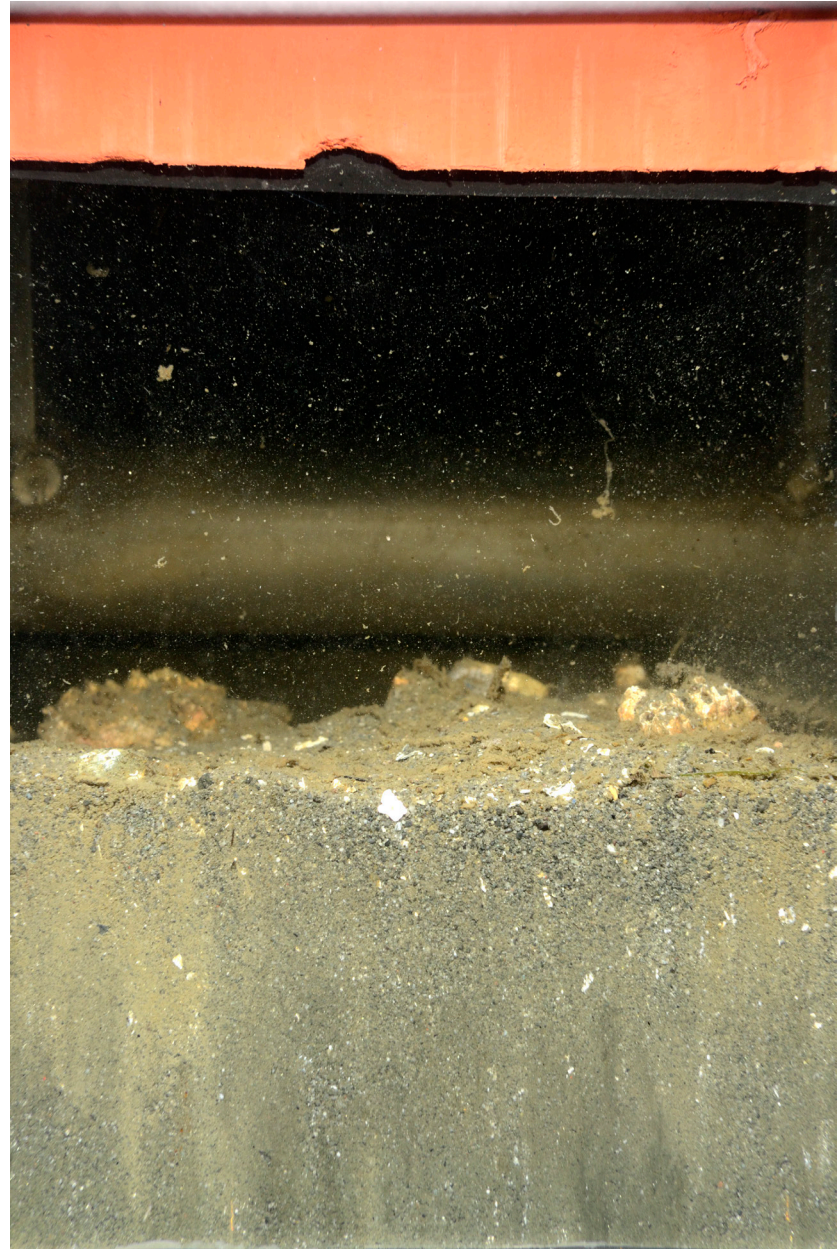
Figure 5: Camera prism penetration was notably deeper in the finer-grained stations such as at Station 1-5 (left) as compared with stations at the southern end of the grid that had a higher sand fraction as seen in this profile image from Station 7-3 (right). Scale: width of each image = 14.5 cm. Note: Orange band on top of right image is from the rubber faceplate wiper on the SPI system.

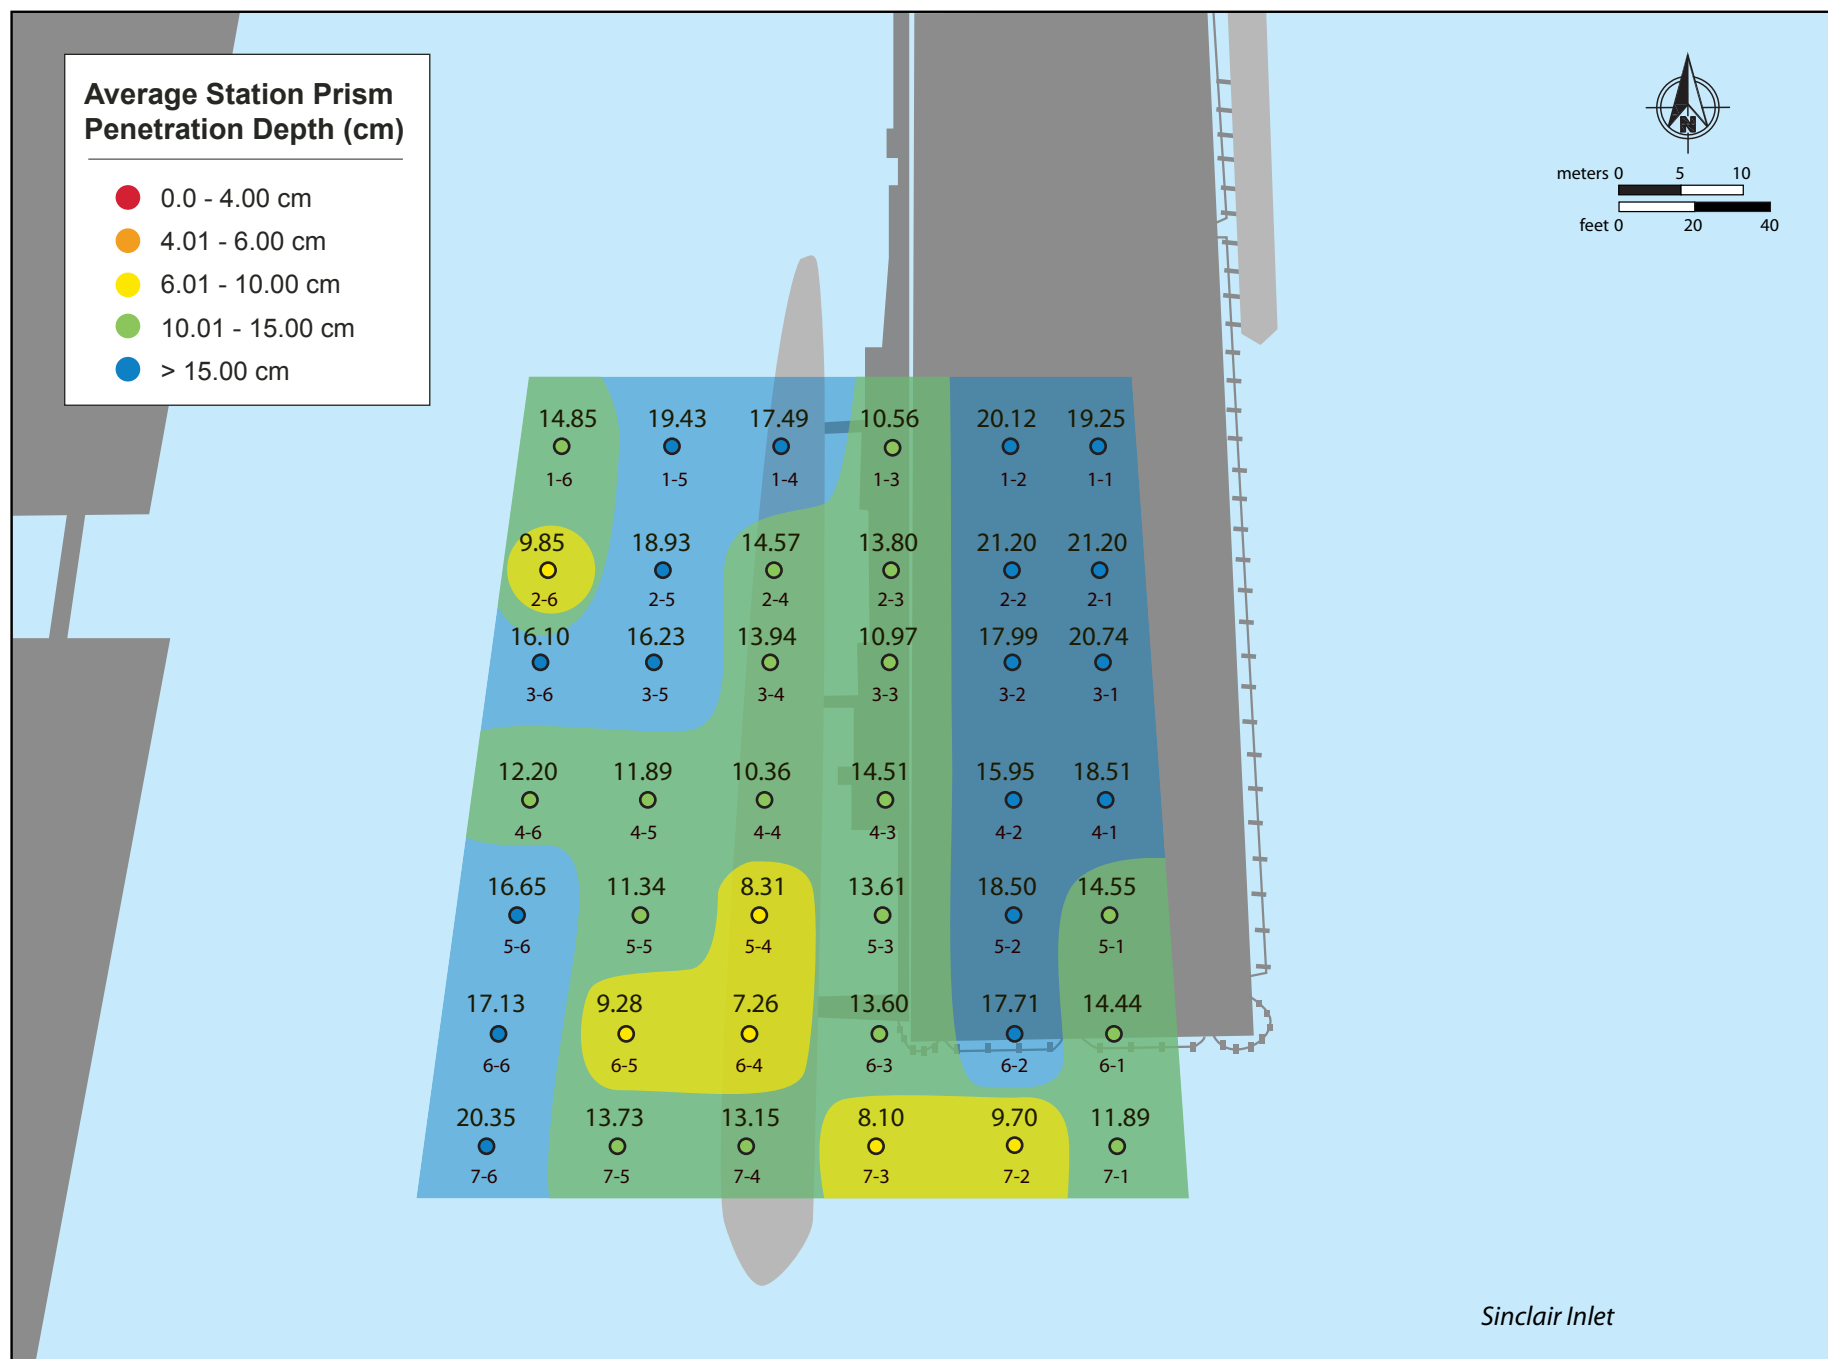
Figure 6: Spatial distribution of mean prism penetration depth (cm) at Pier 7 at the PSNS & IMF Bremerton site in August, 2012.

Sediments throughout the site ranged from silt-clays with minor fractions of very fine to fine sand in the rows that ran under the pier, to silty sands as one progressed beyond the pier into Transect #7 (Figure 5). The mean prism penetration depth in the study area ranged from 7.3 to 21.2 cm, with an overall site average of 14.8 cm; the spatial distribution of mean penetration depth at all stations sampled is shown in Figure 6.

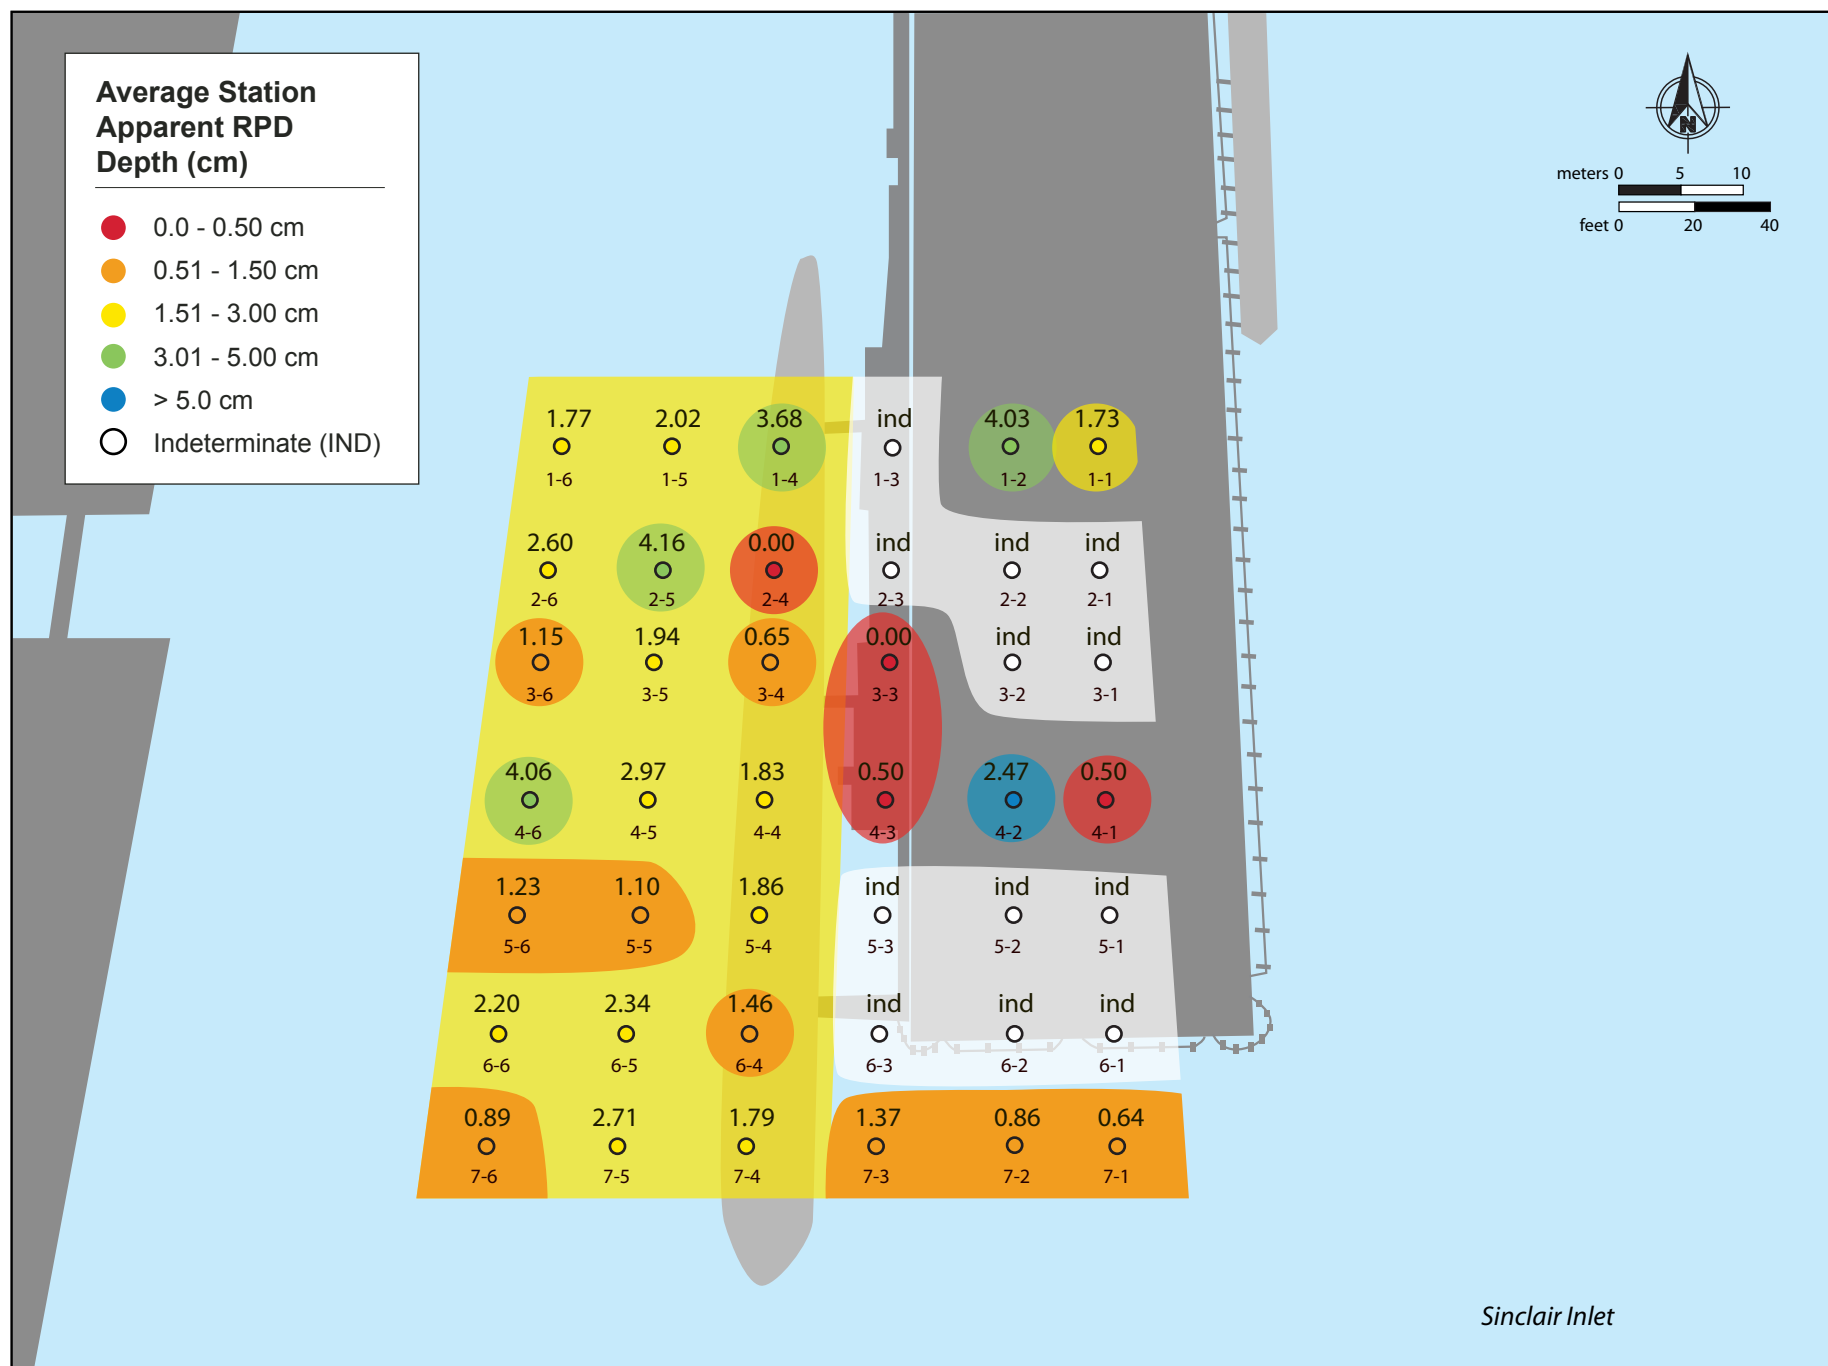
Figure 7: Spatial distribution of apparent RPD depth (cm) at Pier 7 at the PSNS & IMF Bremerton site in August, 2012.

The distribution of mean apparent RPD depths is shown in Figure 7; mean aRPD depths could not be measured at 12 of the stations sampled by divers because of sampling artifacts that caused distortions to the sediment profile and eliminated the possibility of any accurate measurements. While two of the stations had such high sediment-oxygen demand that no detectable aRPD was present (Stations 2-4 and 3-3; see Figure 8), the remaining stations had values ranging from 0.5 to 4.2 cm, with an overall site average of 1.8 cm.

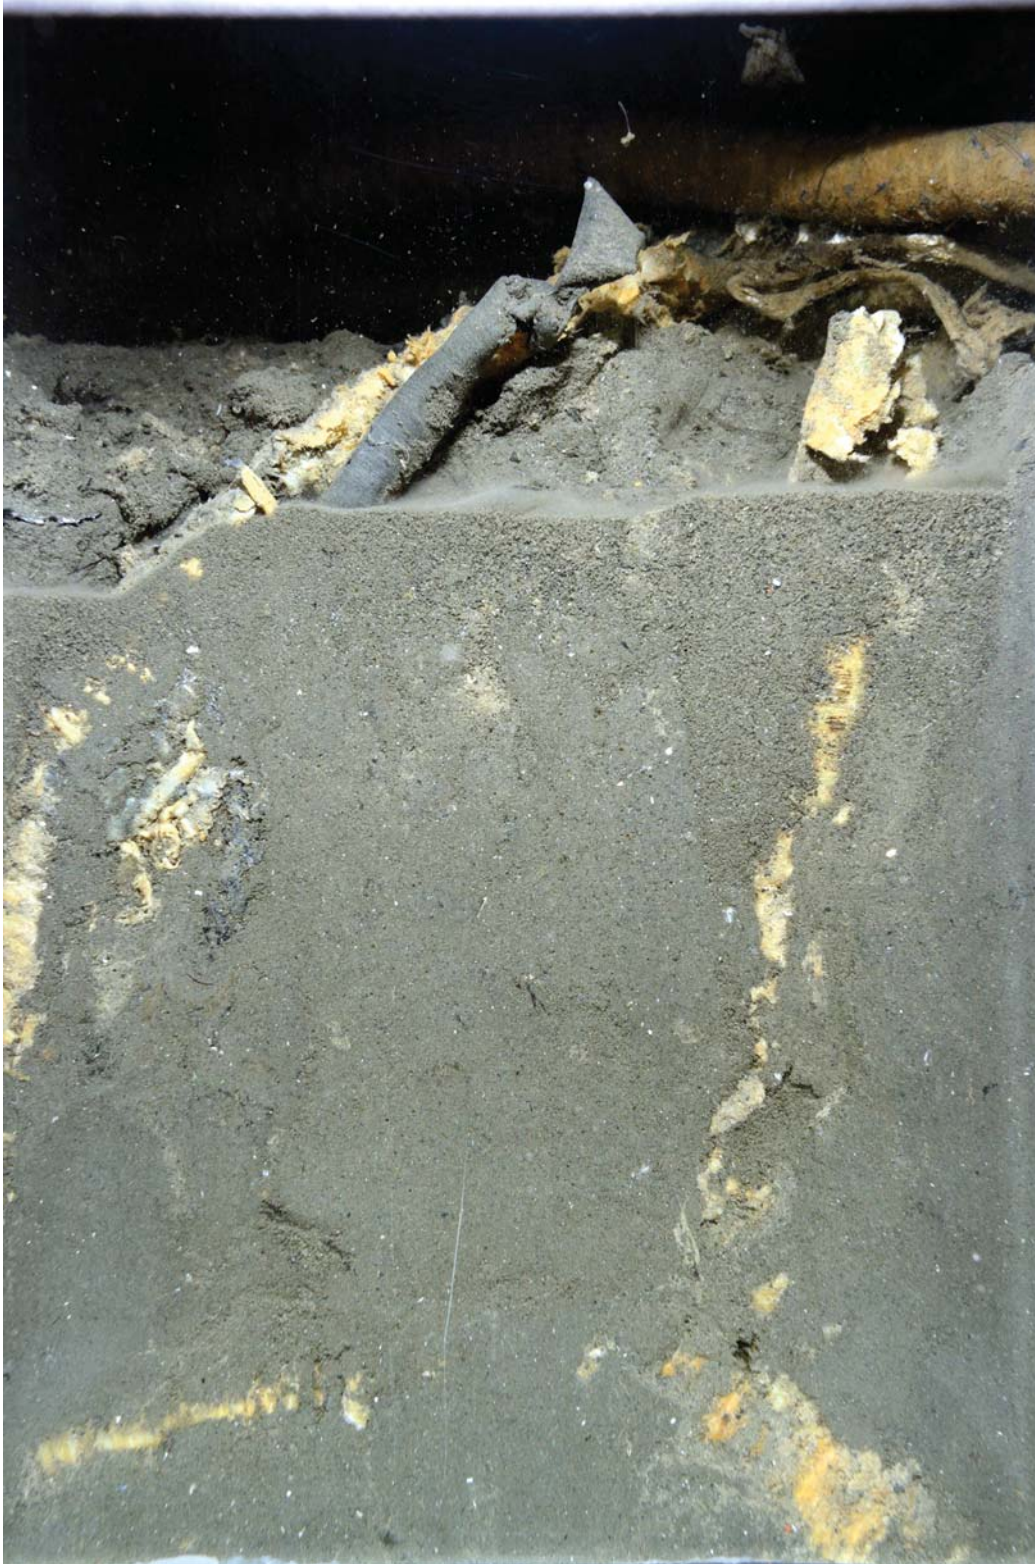
Figure 8: This profile image from Station 2-4 shows sabellid polychaete tubes projecting above a high-organic content sediment with no detectable surface oxidized layer. Scale: width of profile image = 14.5 cm.

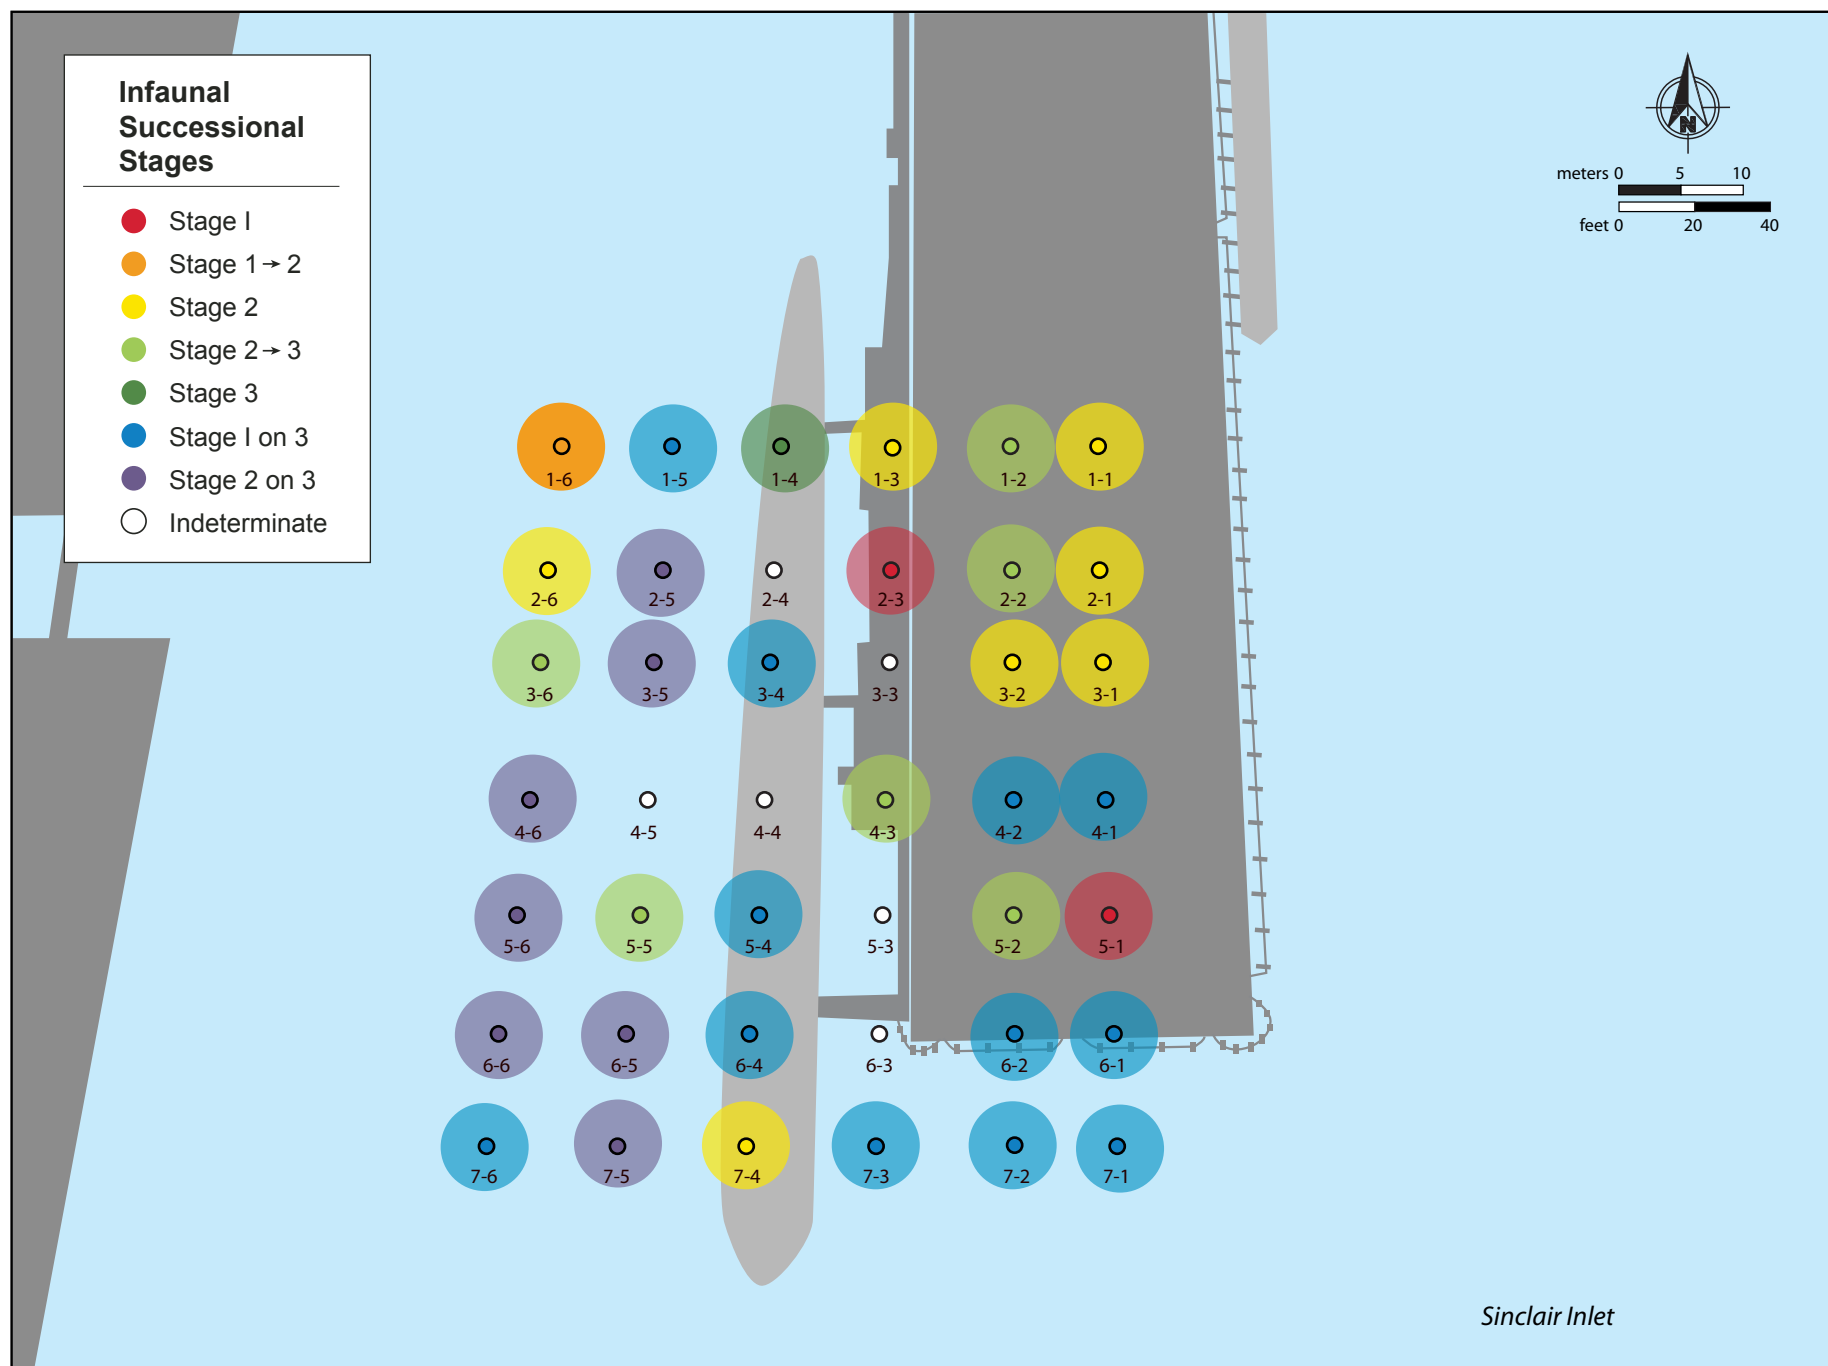
Figure 9: Spatial distribution of infaunal successional stage at the locations sampled around Pier 7 at the PSNS & IMF Bremerton site in August, 2012.

The mapped distribution of infaunal successional stages is shown in Figure 9; while many of the stations had a surface armoring of shell-hash along with shell fragments mixed throughout the sediment column, presence of Stage 3 taxa (infaunal deposit feeders) was evident at 26 of the 42 stations. All of the stations outboard of the pier, e.g. 1-4, 2-4, 3-4, 4-4, etc., had dense assemblages of tubes from large sabellid polychaetes (Figure 10) that had evidently colonized the area from being removed from the bottom of ship hulls and established themselves in the sediments in the berthing areas; no sabellids were found in any of the images taken underneath the pier.

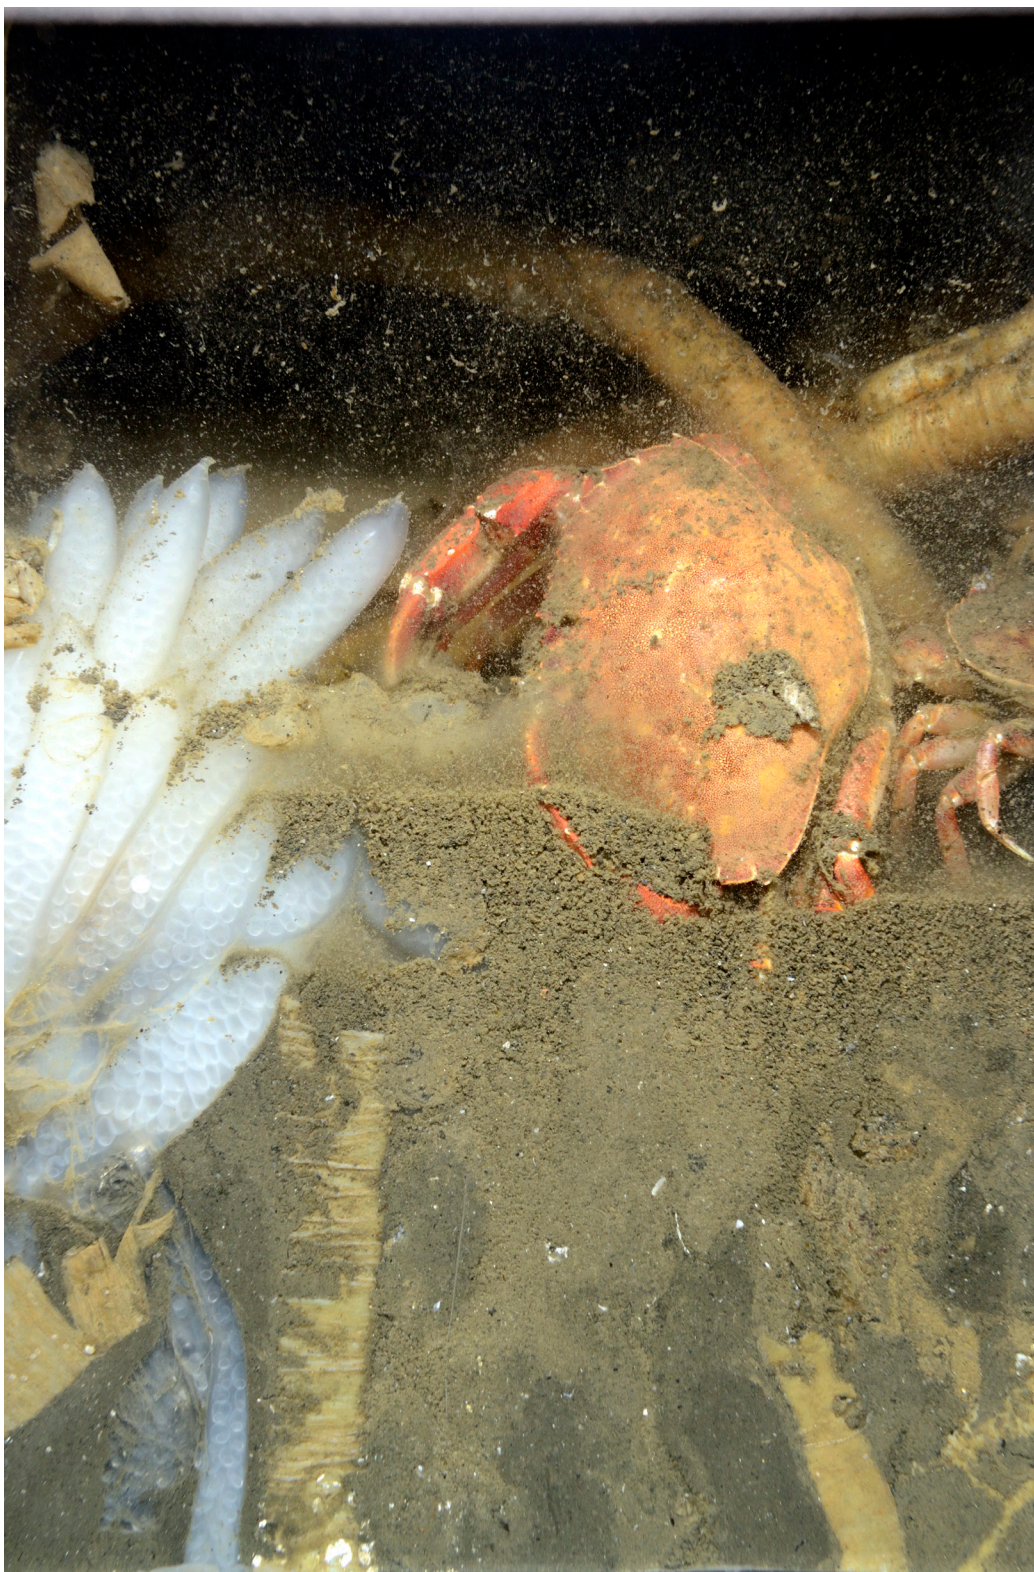
Figure 10: This profile image from Station 4-4 is an excellent example of the size and density of the tubes from sabellid polychaetes that were quite common at locations to the west of the pier. Squid eggs (white casings) and graceful crabs are also clearly visible. Scale: width of profile image = 14.5 cm.

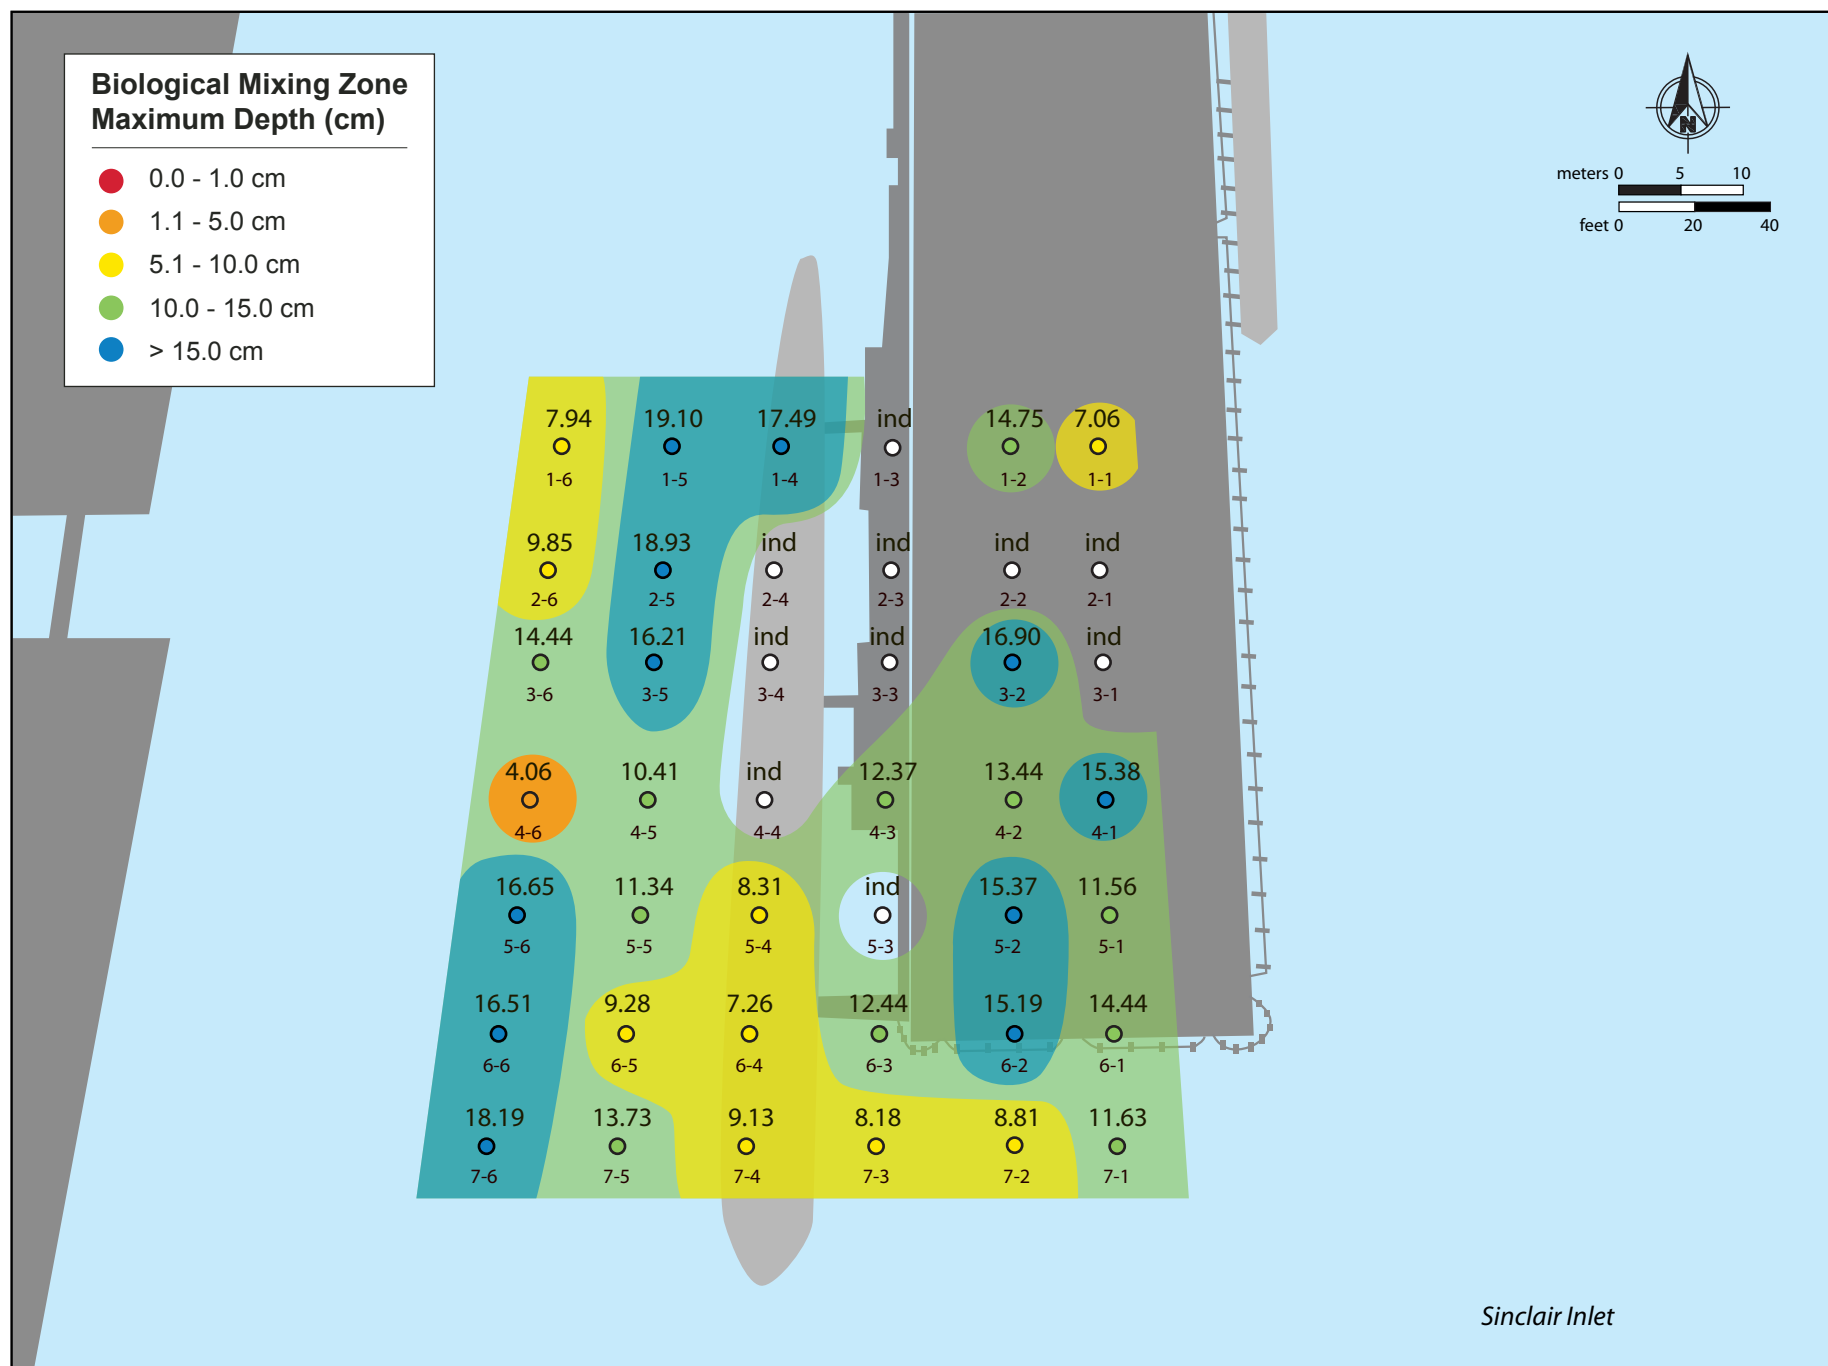
Figure 11: Spatial distribution of maximum biological mixing depth (cm) at Pier 7 at the PSNS & IMF Bremerton site in August, 2012.

The spatial distribution of the maximum depth to which any biological activity was seen in the study area is shown in Figure 11. Evidence of infaunal burrowing was seen even in some of the images where the cross-sectional features of the profile were disturbed by diver sampling; maximum depth of biogenic activity ranged from 4.1 to 19.1 cm, with an overall site average of 12.7 cm for the maximum biological mixing depth.

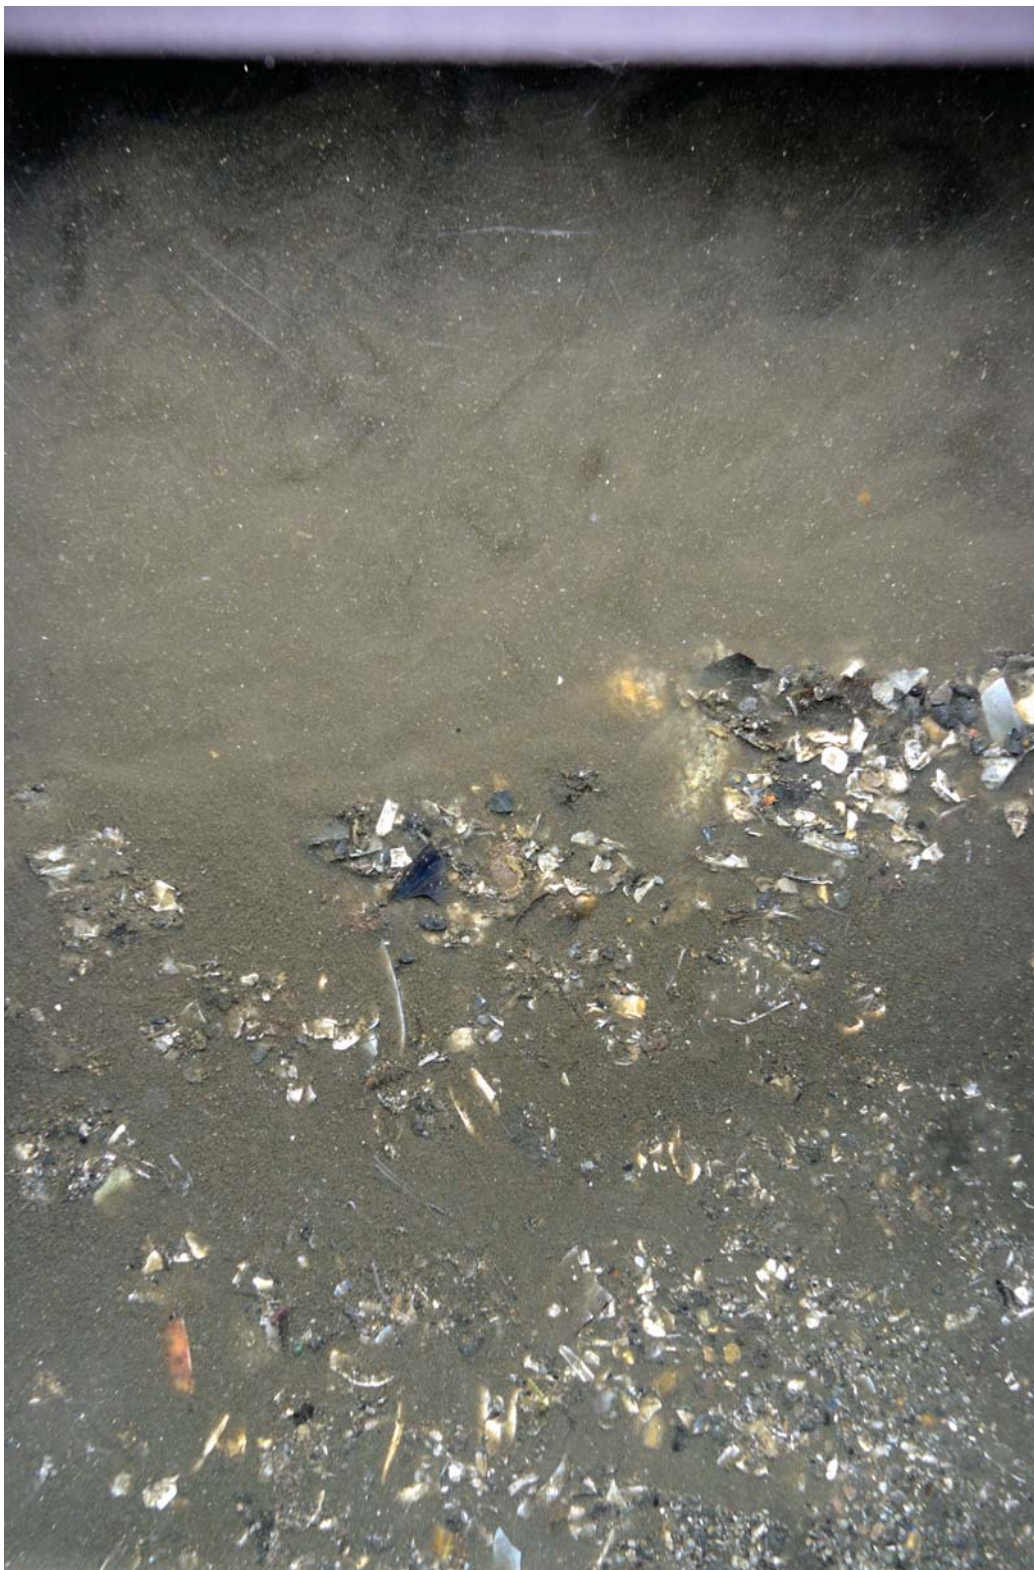
Figure 12: This profile image from Station 1-3 is typical of many of the images collected by divers and shows the lack of preservation of any subsurface features due to the prism being wiggled to insert it in the sediment. Scale: width of image = 14.5 cm.

While it was difficult to get accurate measurements of subsurface features from the images collected by divers (Figure 12) from locations under the pier, the widespread presence of infaunal deposit feeders throughout the site (Figure 9) should insure that adequate biogenic mixing of the amendment will occur after placement. It may prove difficult to accurately assess mixing of the amended cap material at the stations from under the pier that will be sampled by divers, but hopefully they will be able to improve their "prism insertion" techniques in future survey with more practice. We do not anticipate any issues with measuring the presence and depth to which the cap is mixed at those stations sampled from the boat with the support frame.
