Sediment Profile Imaging Report

Demonstration of *in-situ* Treatment of Contaminated Sediments with Reactive Amendments: Post-Cap Survey #1

March, 2013

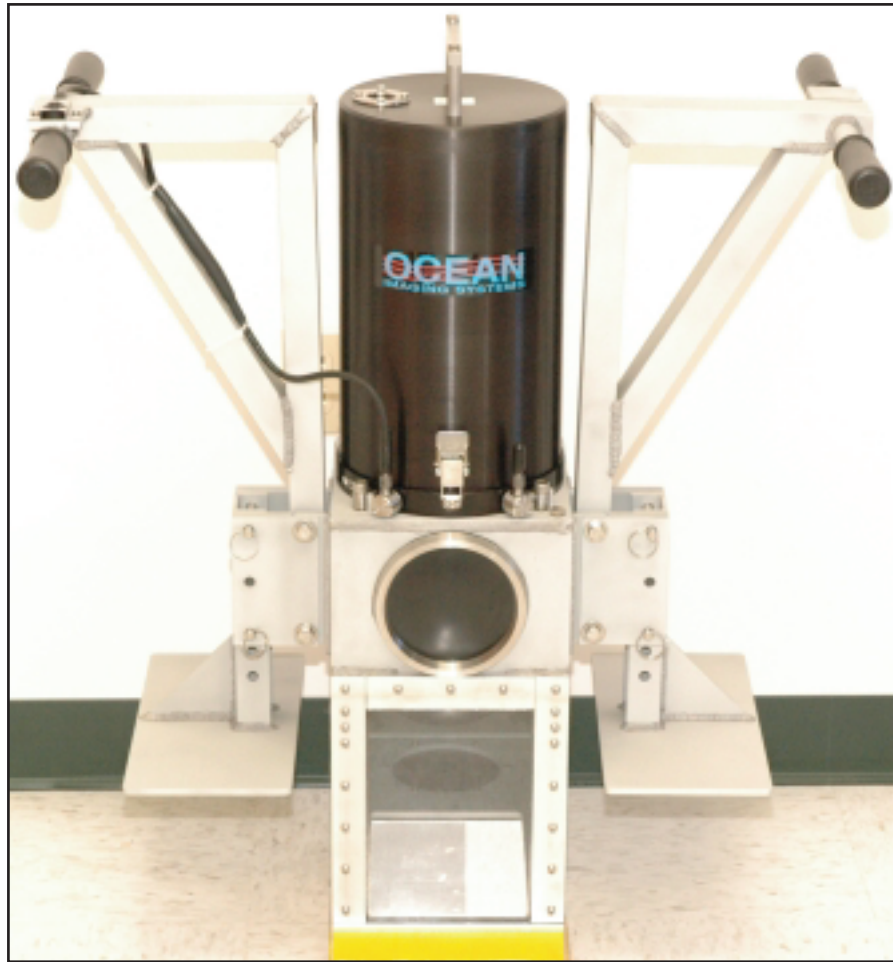
Figure 3: The hand-held SPI system used by divers for all stations that were located underneath Pier 7 at PSNS & IMF, Bremerton site.

The hand-held SPI system (Figure 3) works on the same design, except that there is no time delay once the watertight switch is activated by the diver after the prism is inserted into the sediment. There is no wiper blade on the hand-held system, so the diver needs to clean the faceplate of the camera prism manually with a scrub brush after each image is taken.

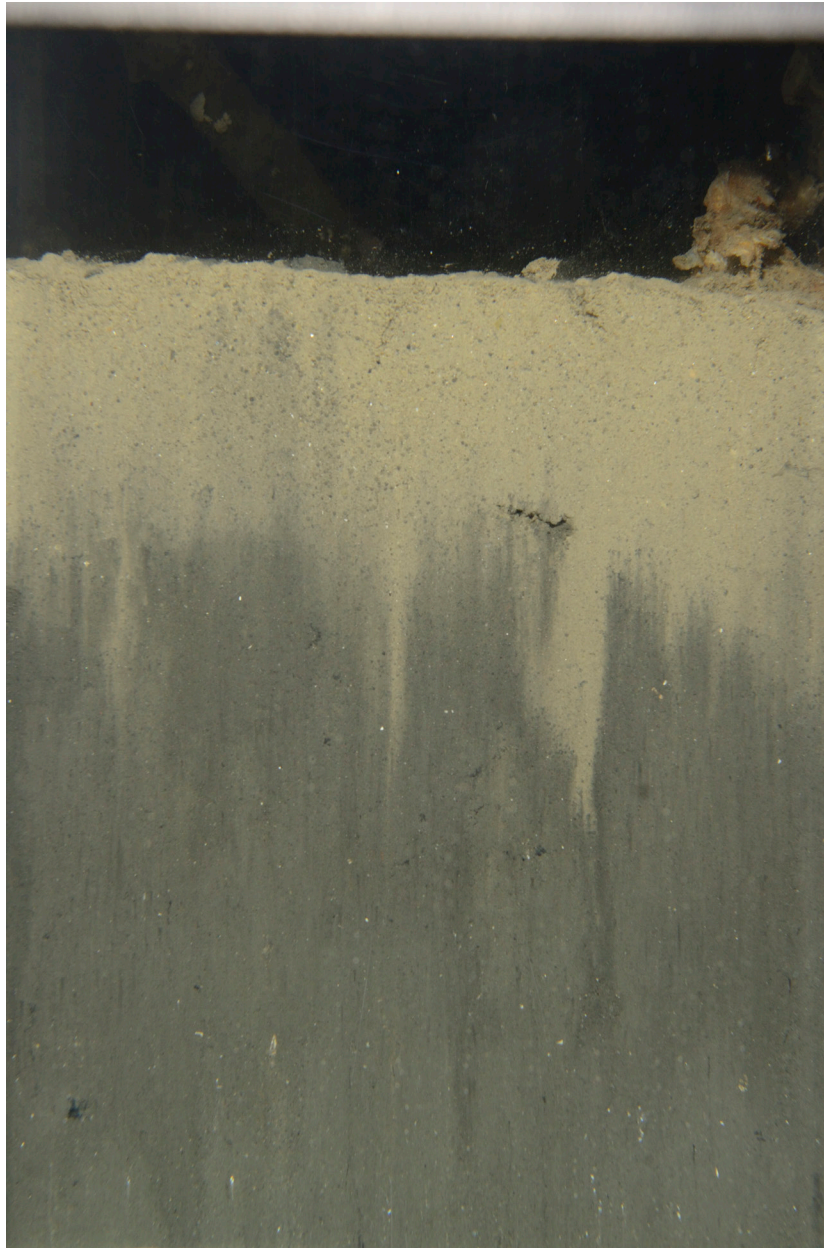
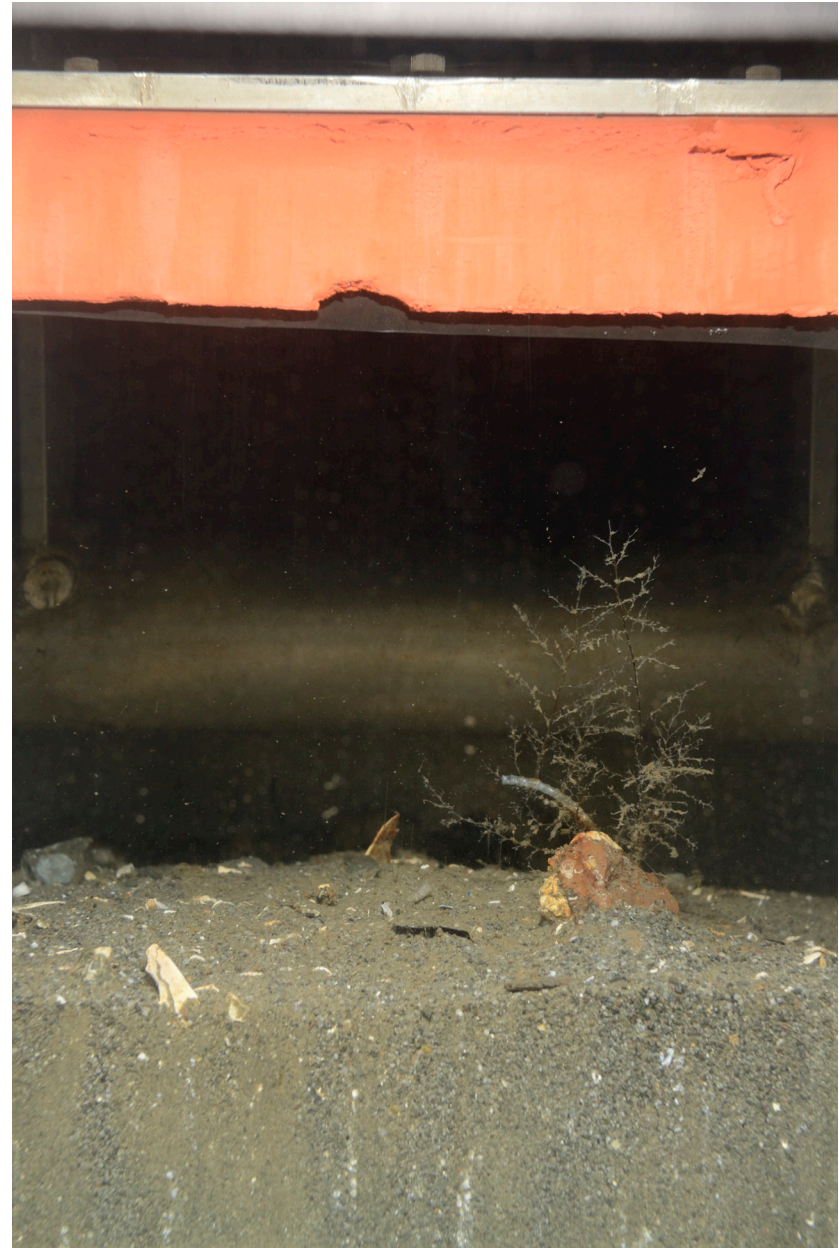
Figure 5: The lower fraction of sand in the natural silt-clay sediments at stations toward the north of the grid allowed for greater prism penetration as seen in this profile image from Station 1-5 (left) as compared with some of the stations south of the pier with a greater fraction of fine to medium sand as seen in this image from Station 7-3 (right). Scale: width of each image = 14.5 cm. Note: Orange band at top of right image is the rubber faceplate-wiper on SPI system.

Sediments throughout the site ranged from silt-clays with minor fractions of very fine to fine sand in the rows that ran under the pier, to silty sands as one progressed beyond the pier into Transect #7 (Figure 5). The addition of the AquaGate amendment material to the sediment surface also provided some surface armoring at select stations which impeded camera prism penetration compared to baseline conditions (Figure 6). The mean prism penetration depth in the study area ranged from 4.1 to 20.7 cm, with an overall site average of 14.6 cm; the spatial distribution of mean penetration depth at all stations sampled is shown in Figure 7.

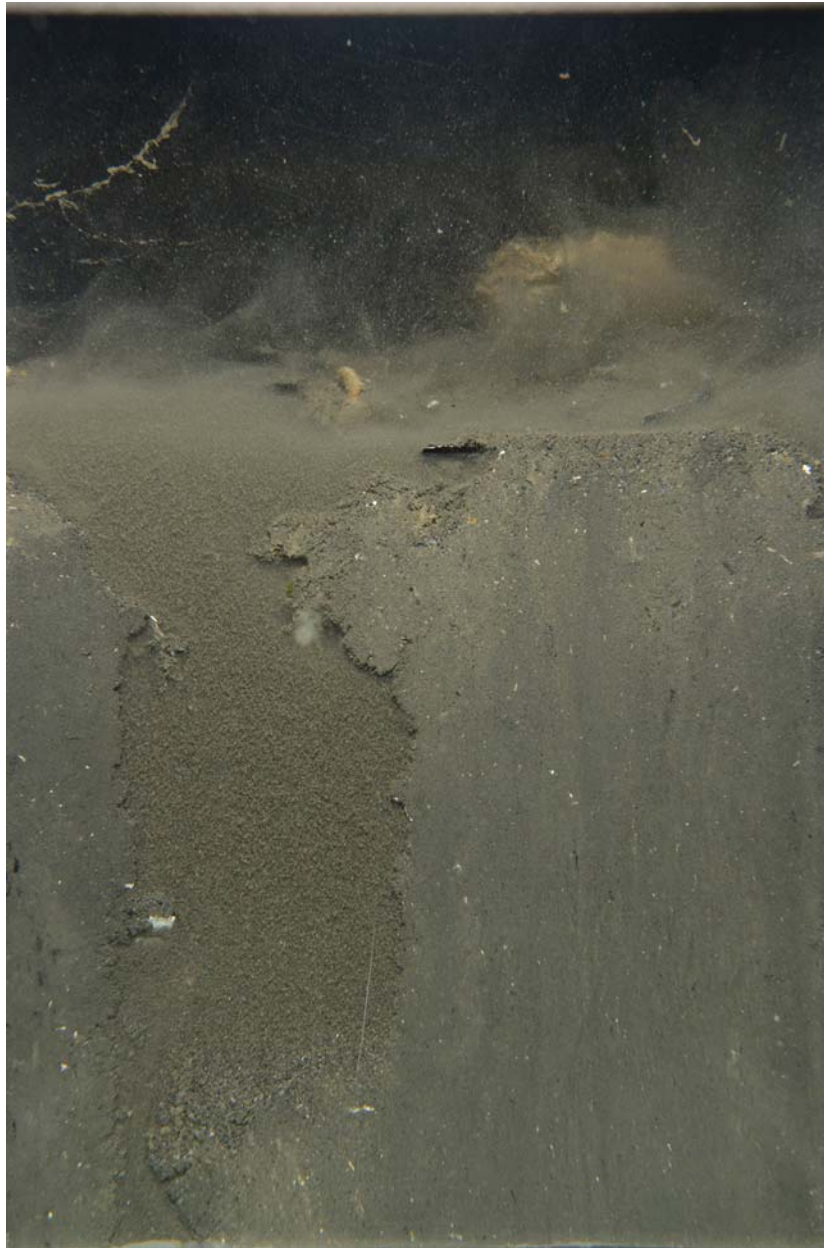
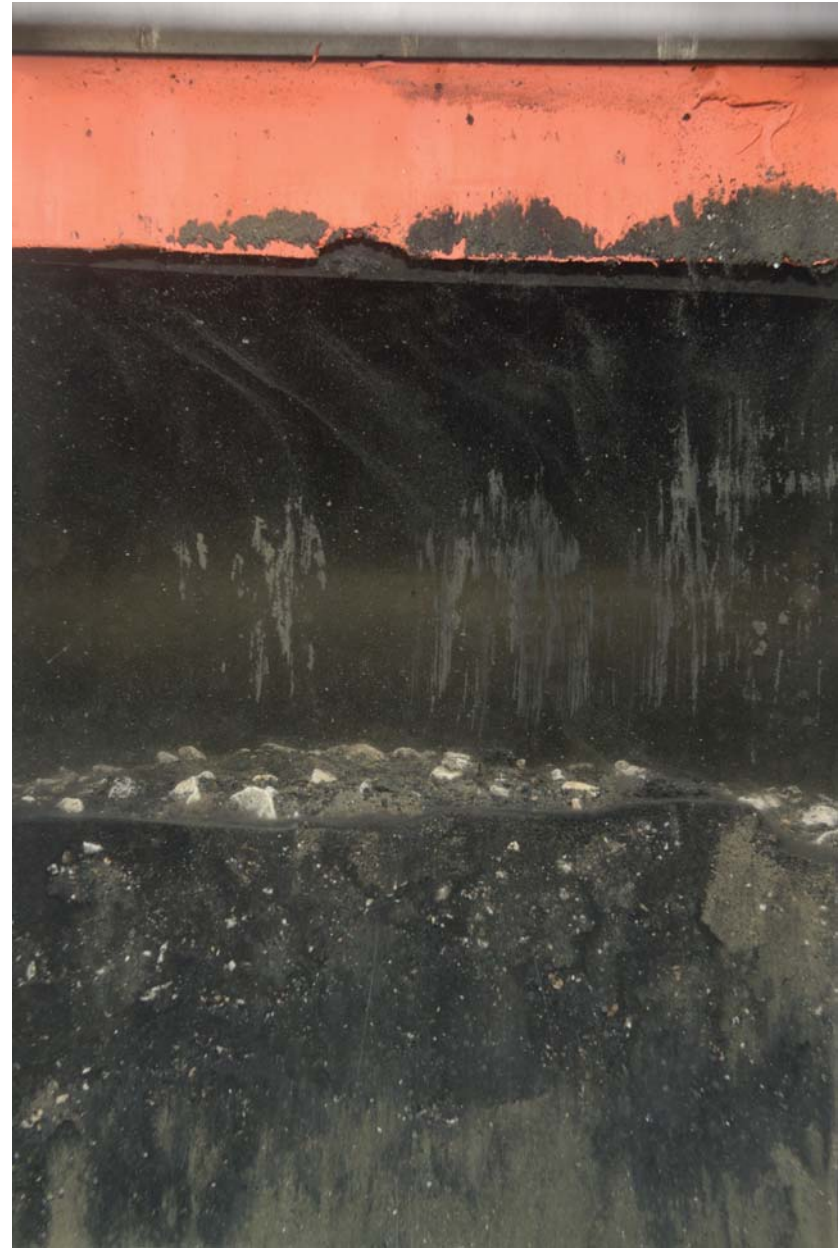
Figure 6: These profile images from Station 3-4 taken before (left) and after (right) cap placement show the effects of cap placement on camera prism penetration depth. Scale: width of each image = 14.5 cm.

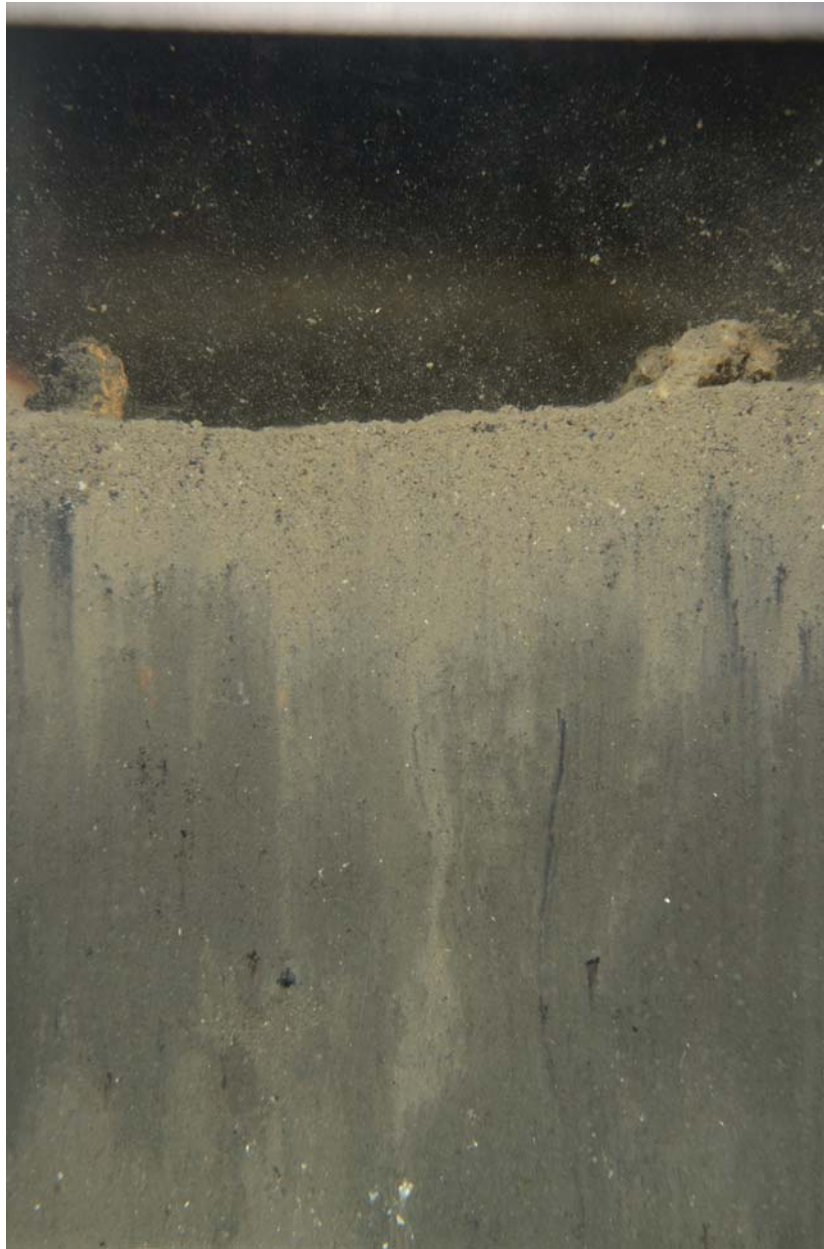
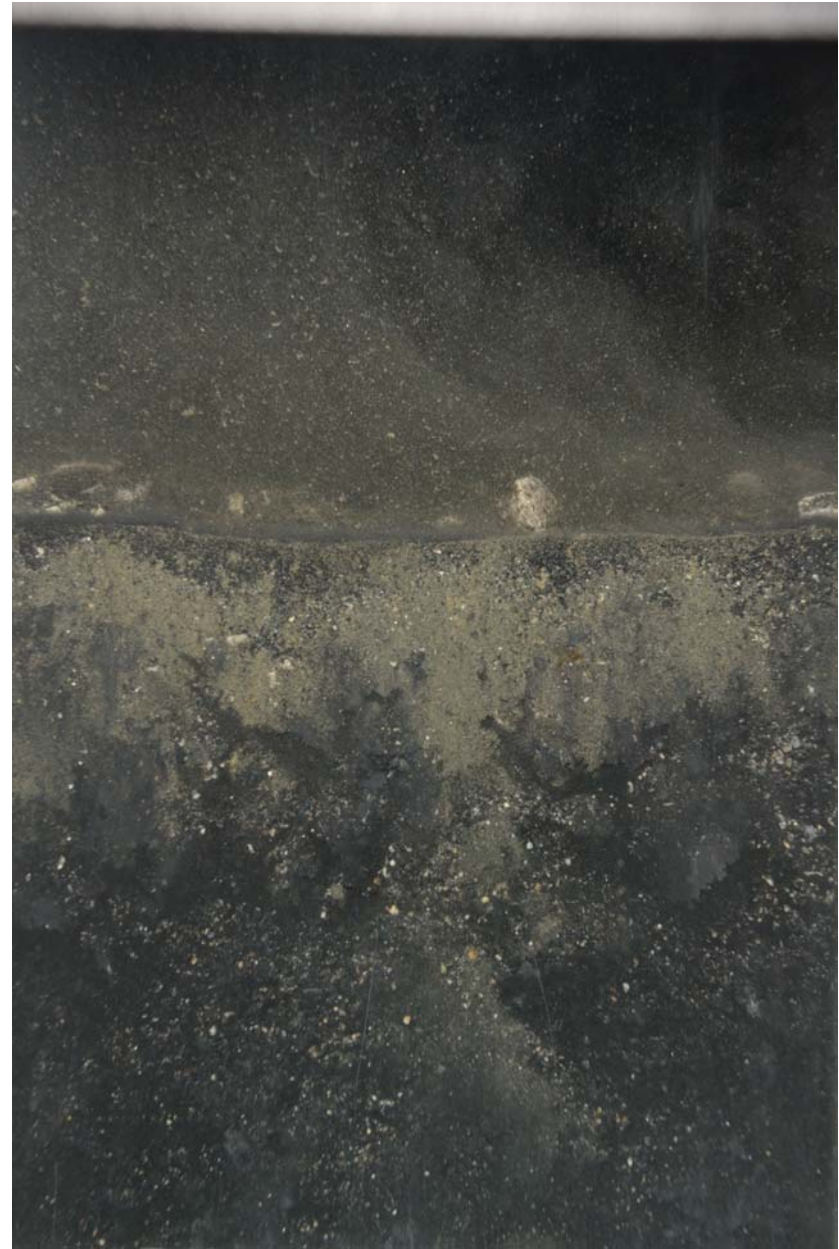
Figure 8: These profile images from Stations 2-5 (left) and 4-4 (right) show the difference between locations with just traces of AquaGate particles (left) versus those with a thicker deposit (right). Scale: width of each image = 14.5 cm.

Measureable deposits of AquaGate+PACTM could be seen at 12 stations, while 7 stations showed only traces of the AquaGate particles in the upper oxidized layer of sediment (Figure 8). At those stations where the cap material could be detected, the average thickness ranged from trace layers to 17.1 cm, with an overall site average of 4.0 cm. The footprint of the cap is shown in Figure 9.

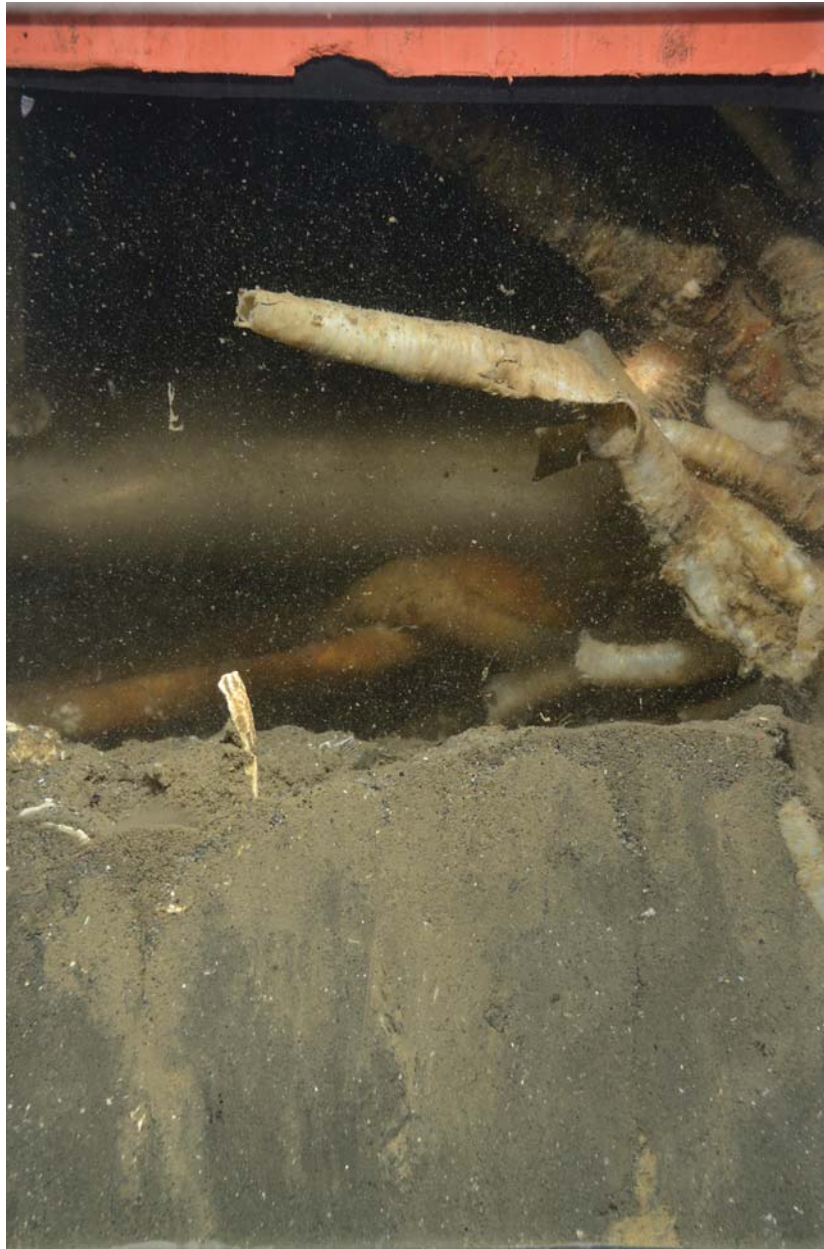
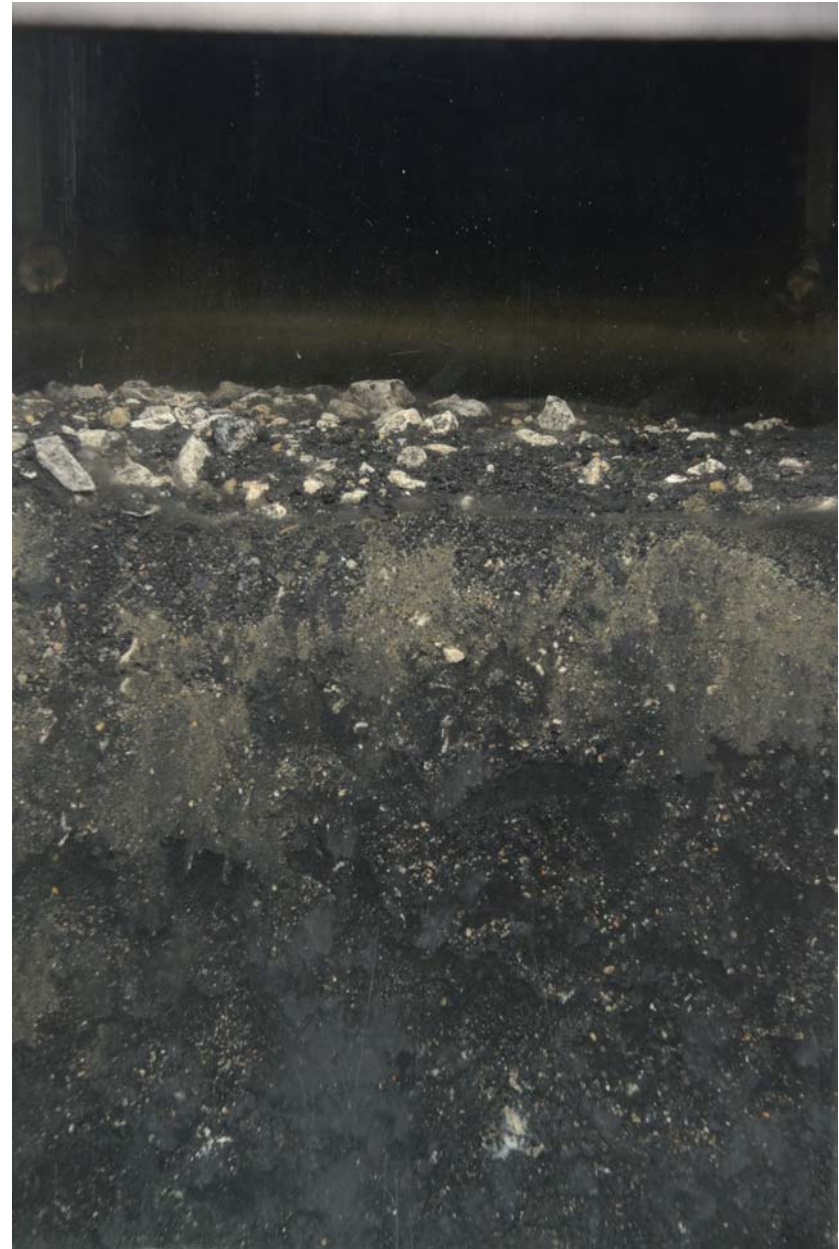
Figure 12: These profile images from Station 5-4 taken before (left) and after (right) cap placement show how placement of the cap material eliminated the assemblage of large sabellid polychaete tubes that were present during the baseline survey. Scale: width of each image = 14.5 cm.

The mapped distribution of infaunal successional stages is shown in Figure 11; while there was a noticeable change in biological community status compared to baseline conditions because of the recent disturbance to the area from the cap placement, presence of Stage 3 taxa (infaunal deposit feeders) was evident at 19 of the 42 stations. Three of the stations outboard of the pier (Stations 3-4, 4-4, and 5-4) that formerly had dense assemblages of tubes from large sabellid polychaetes in the baseline survey were now devoid of any of these assemblages after cap placement (Figure 12).

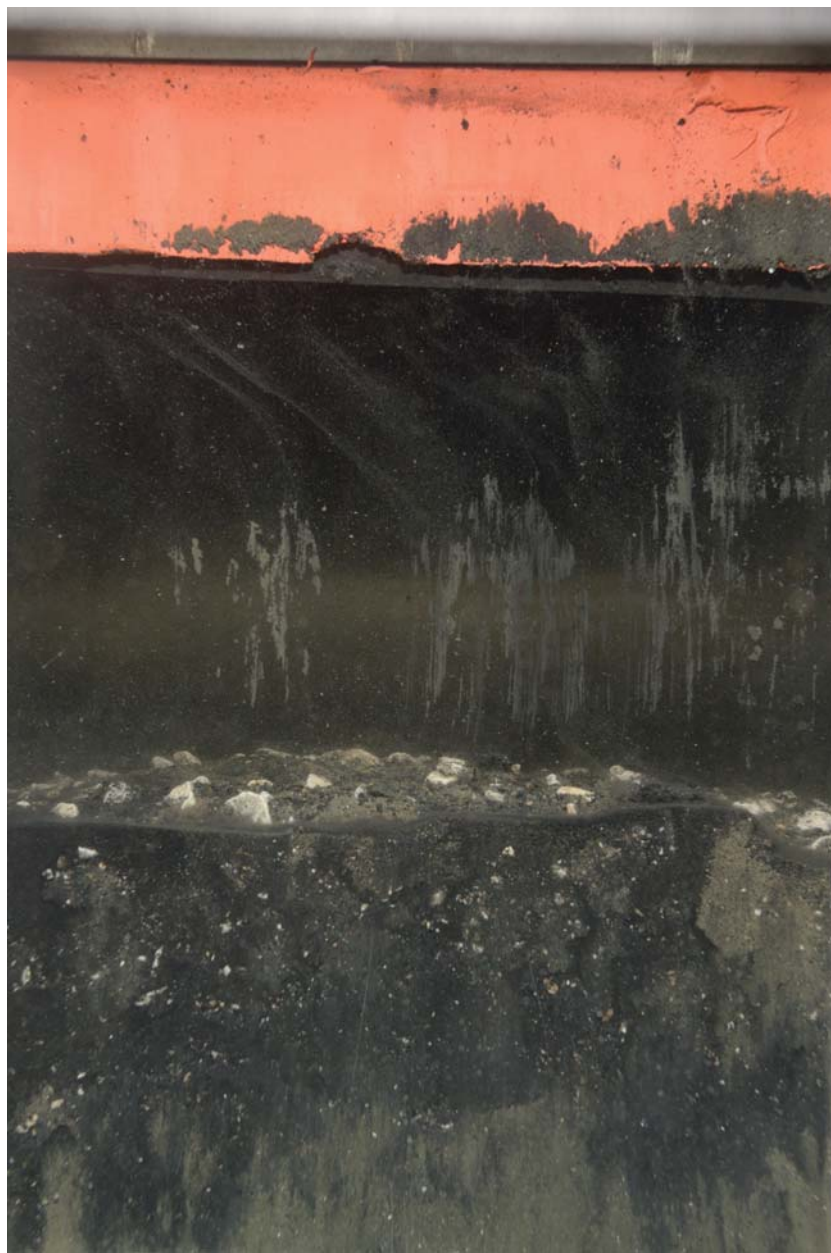
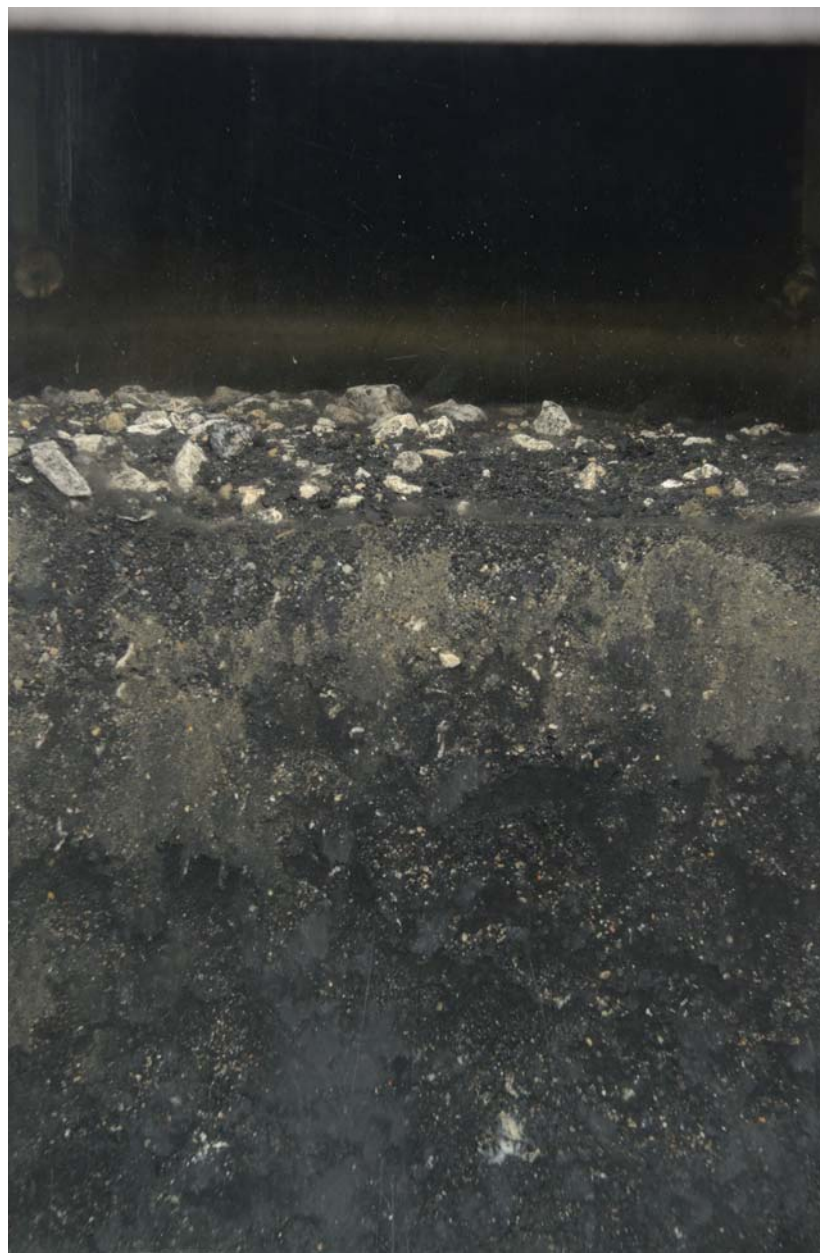
Figure 14: These profile images from Stations 3-4 (left) and 5-4 (right) show how the activated carbon covering on the carrier particles for the AquaGate+PAC™ has dissolved off the carrier granules, leaving a surface armoring of white pebbles while the carbon particles are being re-worked throughout the underlying sediment column. Scale: width of each image = 14.5 cm.

As predicted after the baseline survey was completed, we did not have any difficulty detecting the presence of the AquaGate+PACTM particles in the profile images; even though the SPI survey was conducted only two weeks after the material had been placed, the covering of activated carbon particles had already dissolved off the underlying carrier granules (leaving what looked like white gravel on the sediment surface; see Figure 14) and was being worked into the underlying sediment by the burrowing activities of resident infauna. While some of the stations had the dense colonies of sabellid polychaetes eliminated from the cap placement, future surveys will determine whether or not they re-establish themselves at the 3 locations where they had previously existed but were buried by the capping operations.
