Sediment Profile Imaging Report

Demonstration of *in-situ* Treatment of Contaminated Sediments with Reactive Amendments: Post-Cap Survey #2

Germano & Associates, Inc.
12100 SE 46th Place
Bellevue, WA 98006

January, 2014

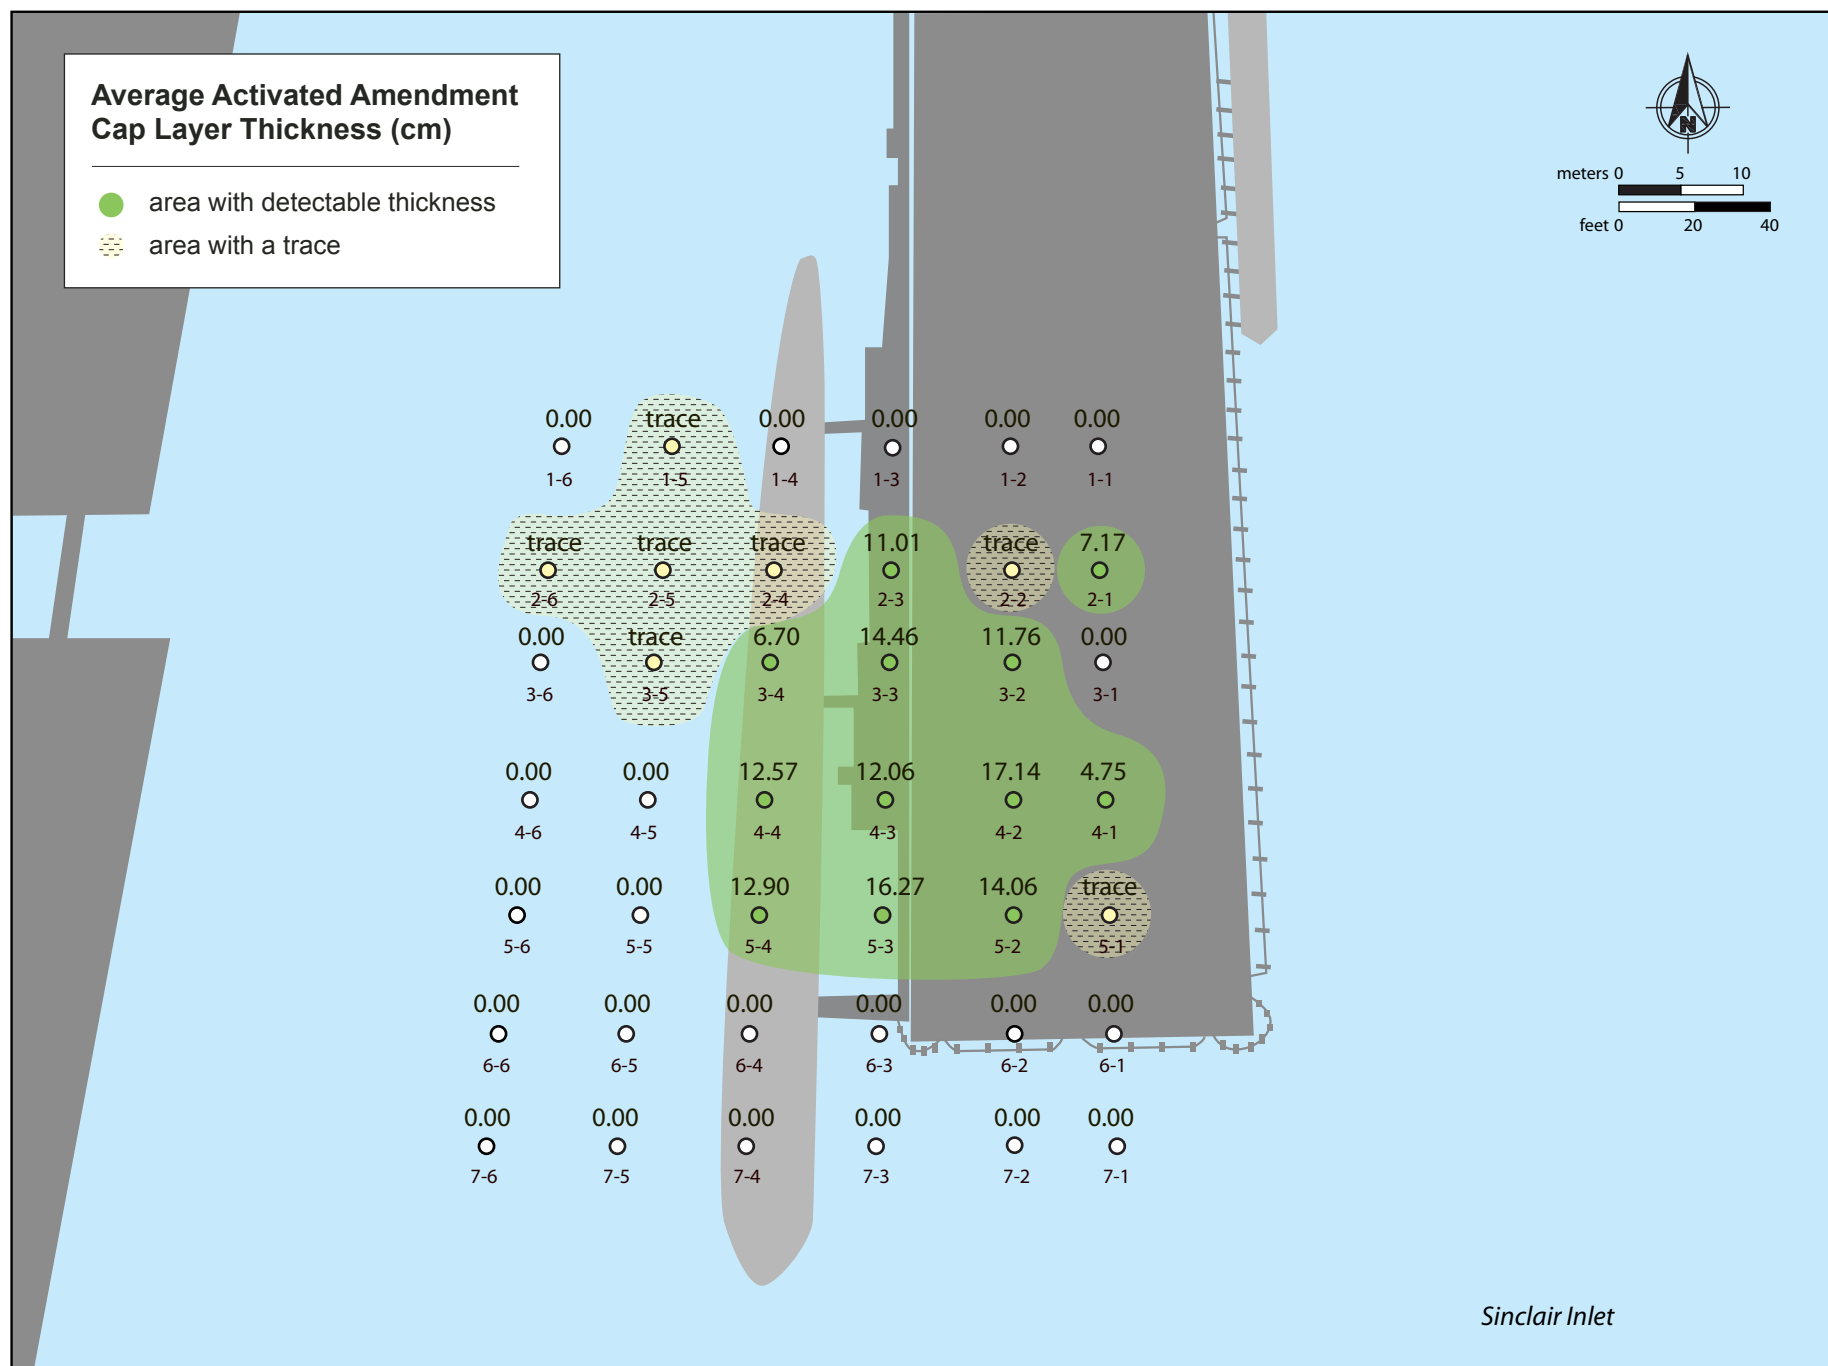
Figure 1: Spatial distribution and average depositional thickness (cm) of the AquaGate +PACTM material placed at locations in and around Pier 7 at the PSNS & IMF Bremerton site in October, 2012.

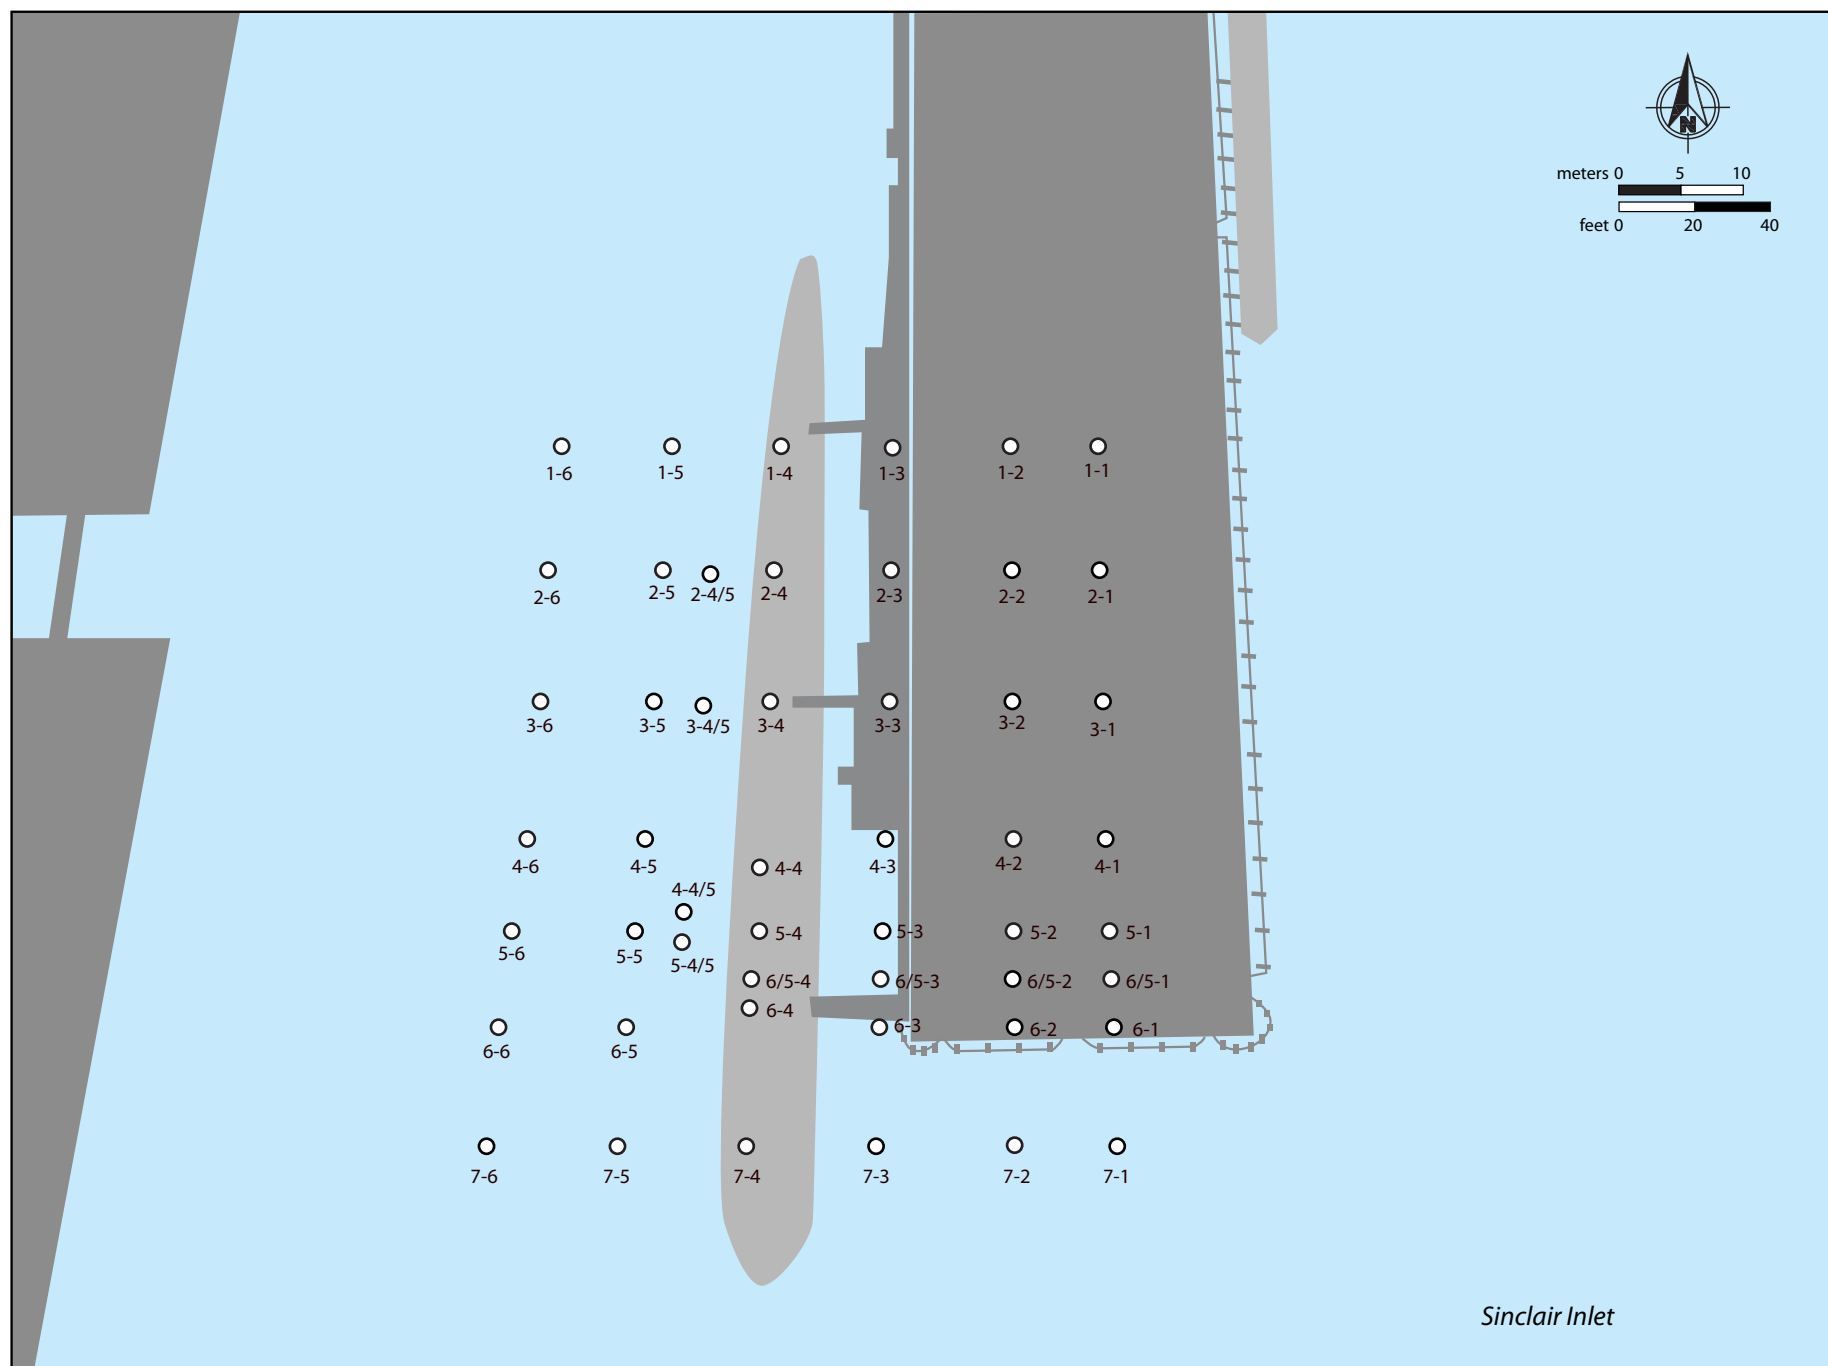
Figure 2: Location of SPI stations sampled under and around Pier 7 at PSNS & IMF, Bremerton site in August 2013.

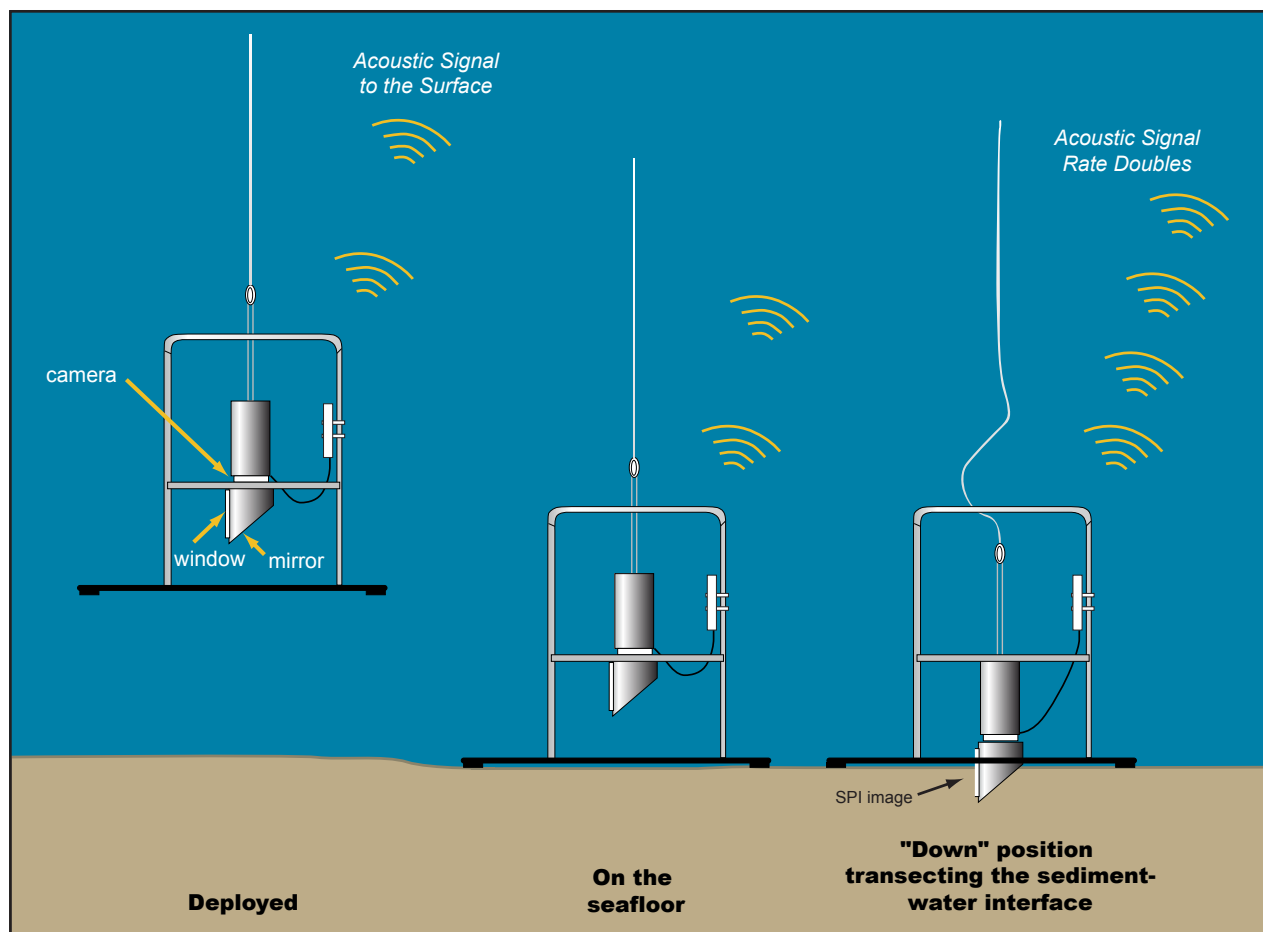
Figure 3: Deployment and operation of the SPI camera system.

SPI was developed almost four decades ago as a rapid reconnaissance tool for characterizing physical, chemical, and biological seafloor processes and has been used in numerous seafloor surveys throughout North America, Asia, Europe, and Africa (Rhoads and Germano 1982, 1986, 1990; Revelas et al. 1987; Diaz and Schaffner, 1988; Valente et al. 1992; Germano et al. 2011). The sediment profile camera works like an inverted periscope. A Nikon D7000 16.2-megapixel SLR camera with two 8-gigabyte secure digital (SD) cards is mounted horizontally inside a watertight housing on top of a wedge-shaped prism. The prism has a Plexiglas[®] faceplate at the front with a mirror placed at a 45° angle at the back. The camera lens looks down at the mirror, which is reflecting the image from the faceplate. The prism has an internal strobe mounted inside at the back of the wedge to provide illumination for the image; this chamber is filled with distilled water, so the camera always has an optically clear path. This wedge assembly is mounted on a moveable carriage within a stainless steel frame. The frame is lowered to the seafloor on a winch wire, and the tension on the wire keeps the prism in its “up” position. When the frame comes to rest on the seafloor, the winch wire goes slack (see Figure 3) and the camera prism descends into the sediment at a slow, controlled rate by the dampening action of a hydraulic piston so as not to disturb the sediment-water interface. On the way down, it trips a trigger that activates a time-delay circuit of variable length (operator-selected) to allow the camera to penetrate the seafloor before any image is taken. The knife-sharp edge of the prism transects the sediment, and the prism penetrates the bottom. The strobe is discharged after an appropriate time delay to obtain a cross-sectional image of the upper 20 cm of the sediment column. The resulting images give the viewer the same perspective as looking through the side of an aquarium half-filled with sediment. After the first image is obtained at the first location, the camera is then

raised up about 2 to 3 meters off the bottom to allow the strobe to recharge; a wiper blade mounted on the frame removes any mud adhering to the faceplate. The strobe recharges within 5 seconds, and the camera is ready to be lowered again for a replicate image. Surveys can be accomplished rapidly by “pogo-sticking” the camera across an area of seafloor while recording positional fixes on the surface vessel.

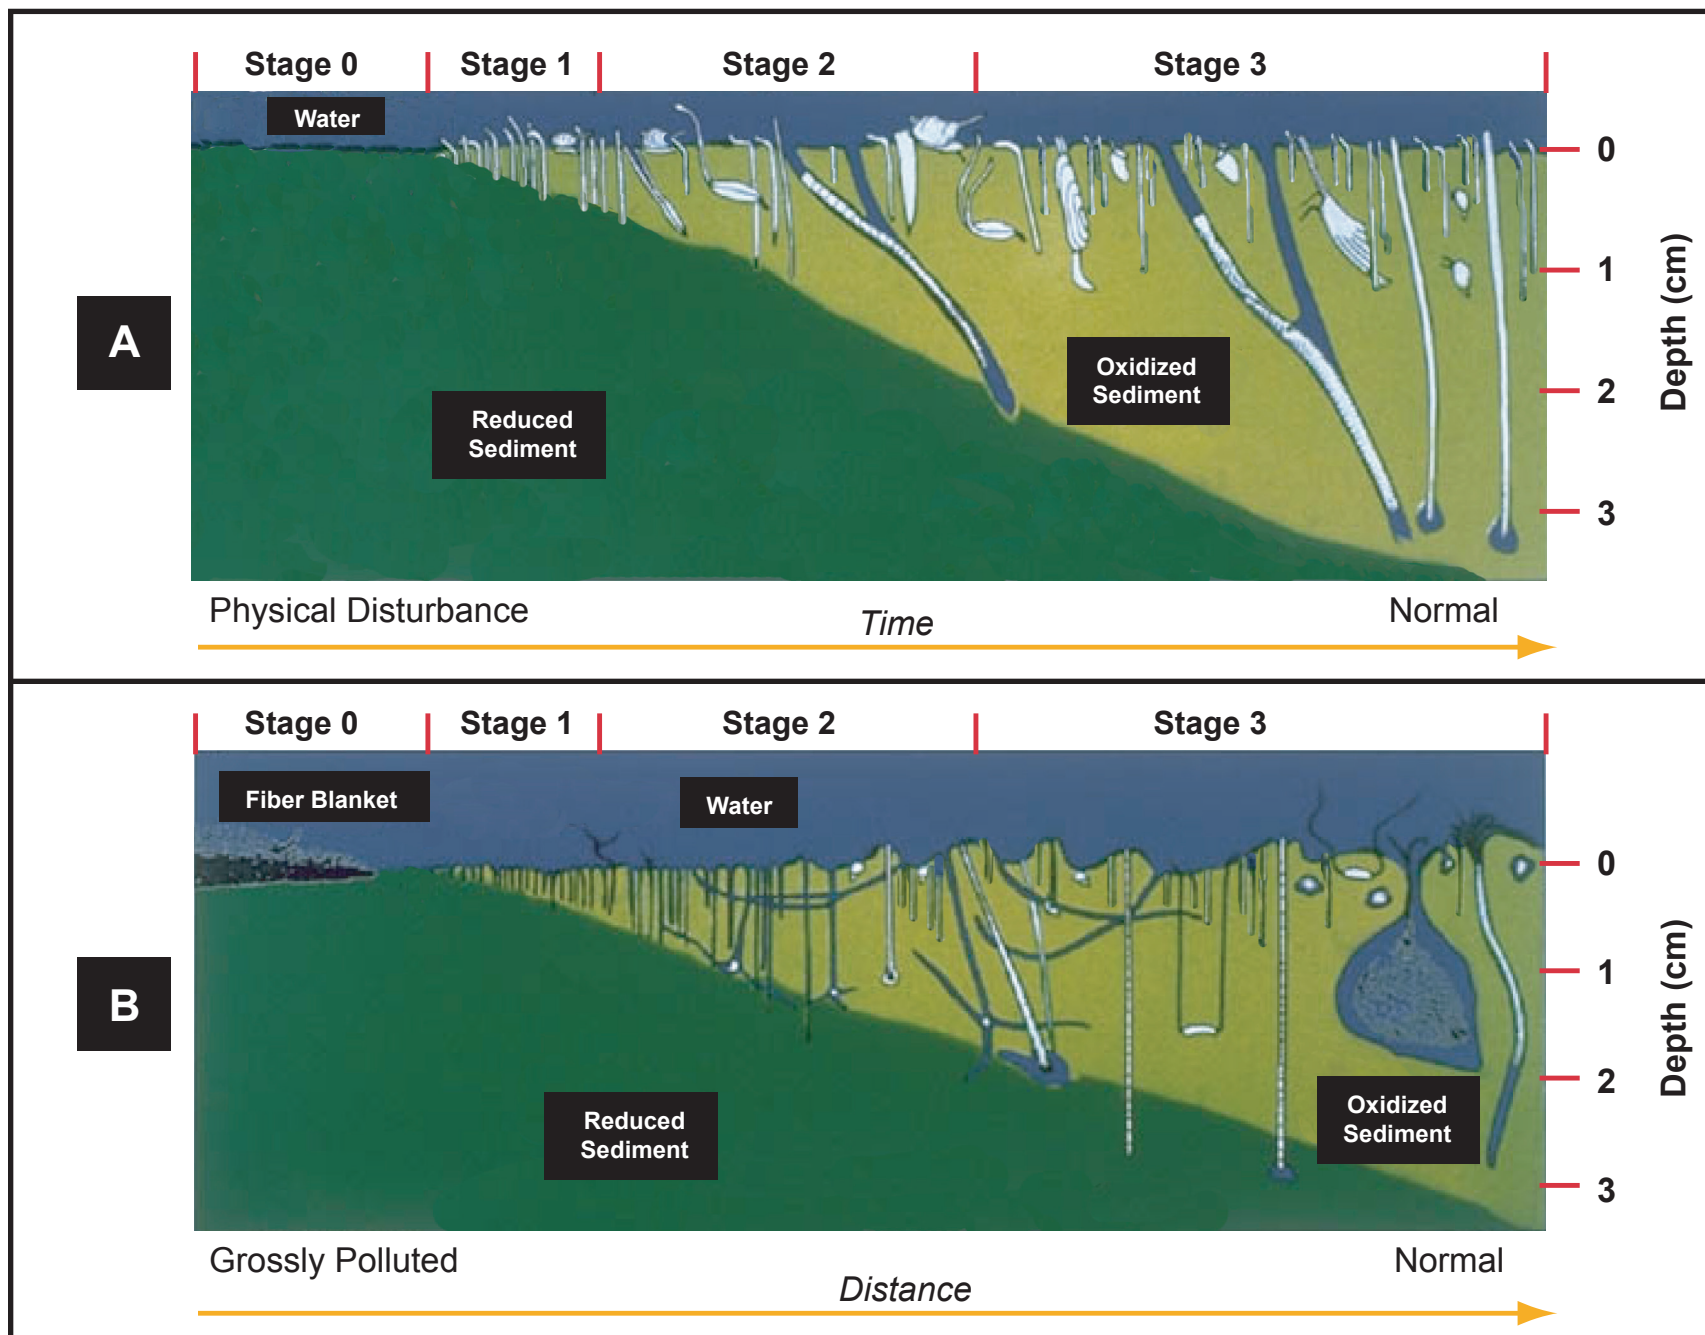
Figure 5: The stages of infaunal succession as a response of soft-bottom benthic communities to physical disturbance (top panel) or organic enrichment (bottom panel). From Rhoads and Germano, 1982.

This continuum of change in animal communities after a disturbance (primary succession) has been divided subjectively into four stages: Stage 0, indicative of a sediment column that is largely devoid of macrofauna, occurs immediately following a physical disturbance or in close proximity to an organic enrichment source; Stage 1 is the initial community of tiny, densely populated polychaete assemblages; Stage 2 is the start of the transition to head-down deposit feeders; and Stage 3 is the mature, equilibrium community of deep-dwelling, head-down deposit feeders (Figure 5).

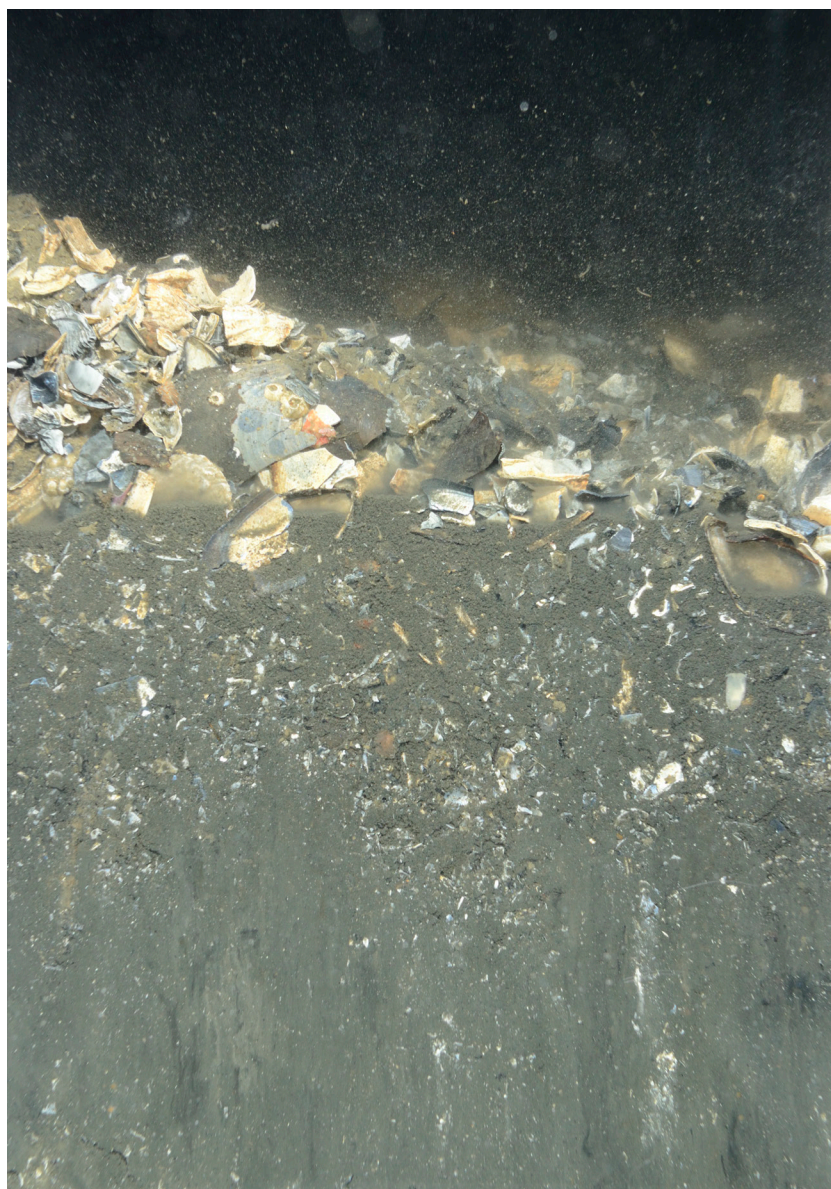
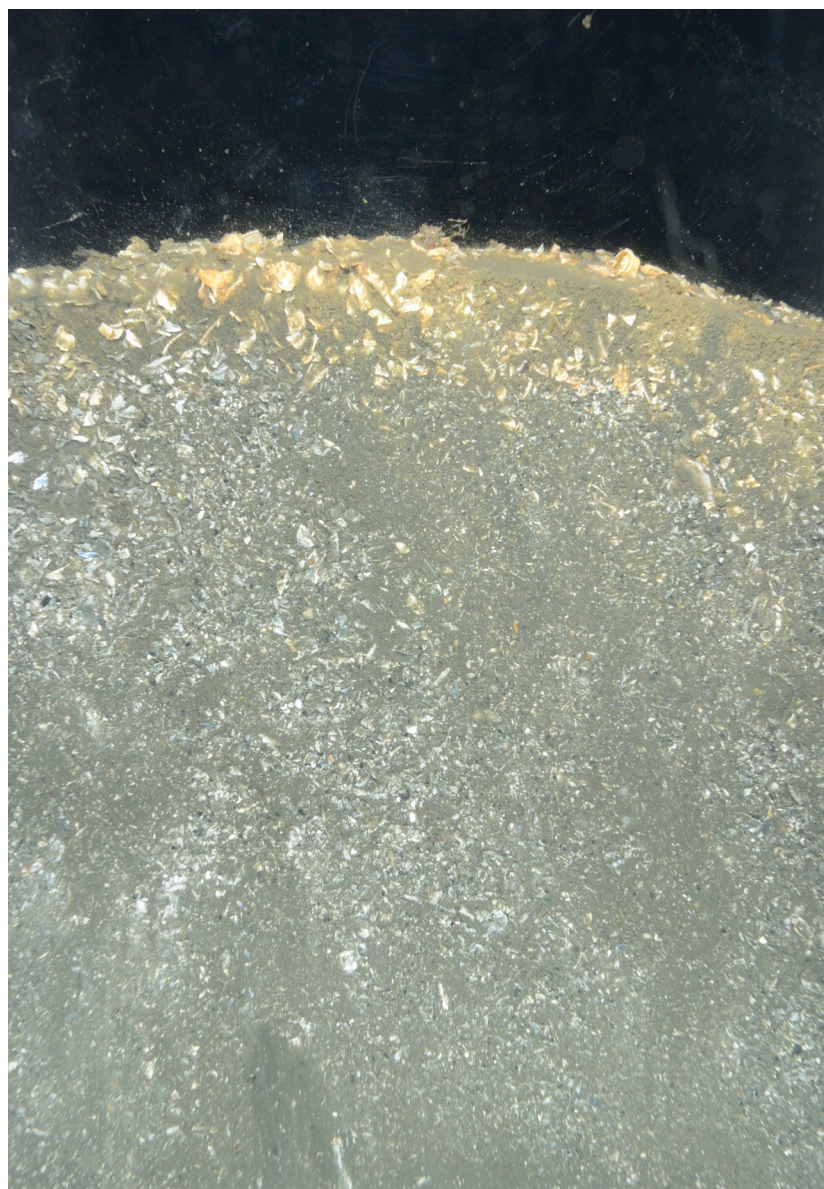
Figure 6: These profile images taken with the hand-held camera under the pier from Station 01-1 (left) and Station 06-1 (right) show the unusually high percentage of shell fragments mixed in with the silt-clay sediments; the high shell content was typical for the majority of stations under Pier 7. Scale: width of each profile image = 14.6 cm.

Sediments throughout the site ranged from sandy silt to muds with minor fractions of very fine to fine sand with high percentages of shell hash (stations under Pier 7; see Figure 6) to pebble and cobble armoring over silty sands (Figure 7). As noted from the results of the survey done last year in October right after the capping operation, the addition of the AquaGate amendment also provided some surface armoring at select stations which impeded camera prism penetration. There was a noticeable decrease in prism penetration depth at the stations along the western edge of the pier compared with the results from last year; the cobble/shell armoring (Figure 7) appears to have been deposited at some point in the last 12 months and extends in a linear fashion from Station 1-3 south to Station 4-3 (Figure 8). The mean prism penetration depth in the study area ranged from 1.6 to 20.4 cm, with an overall site average of 12.1 cm; the spatial distribution of mean penetration depth at all stations sampled is shown in Figure 9.

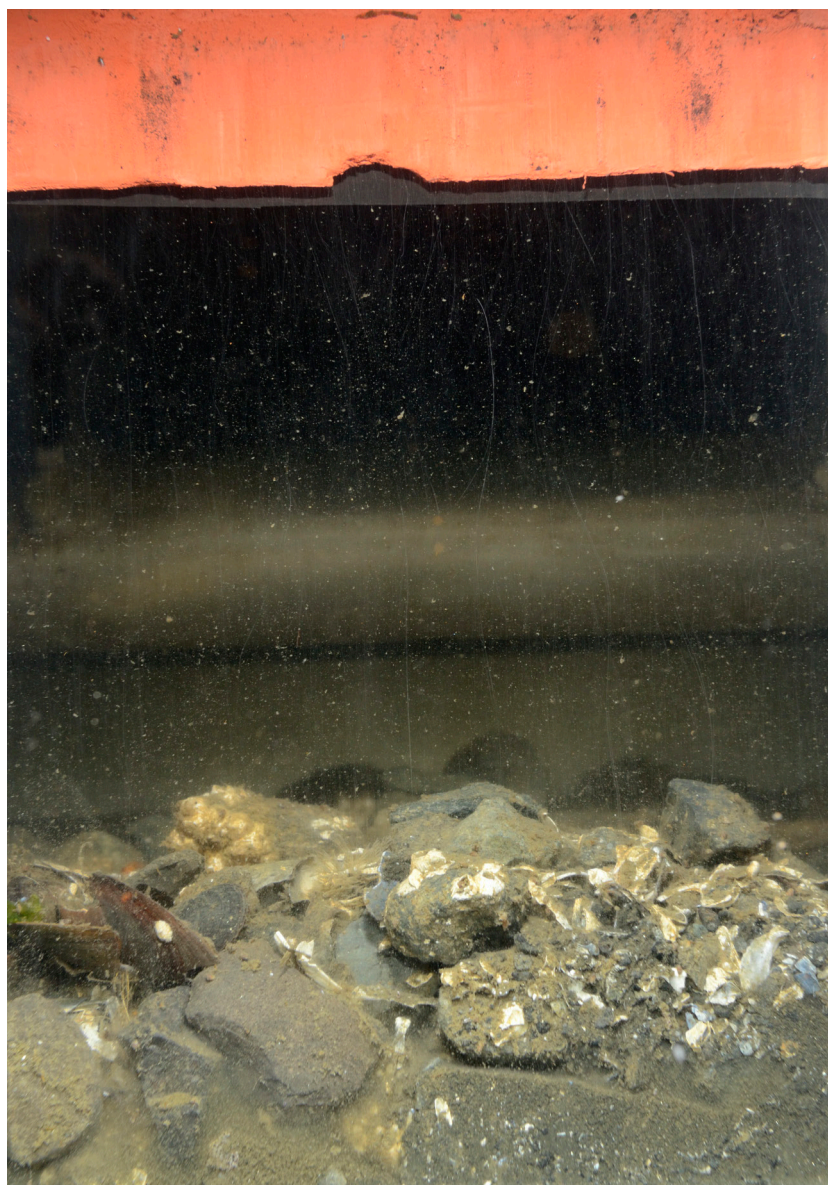
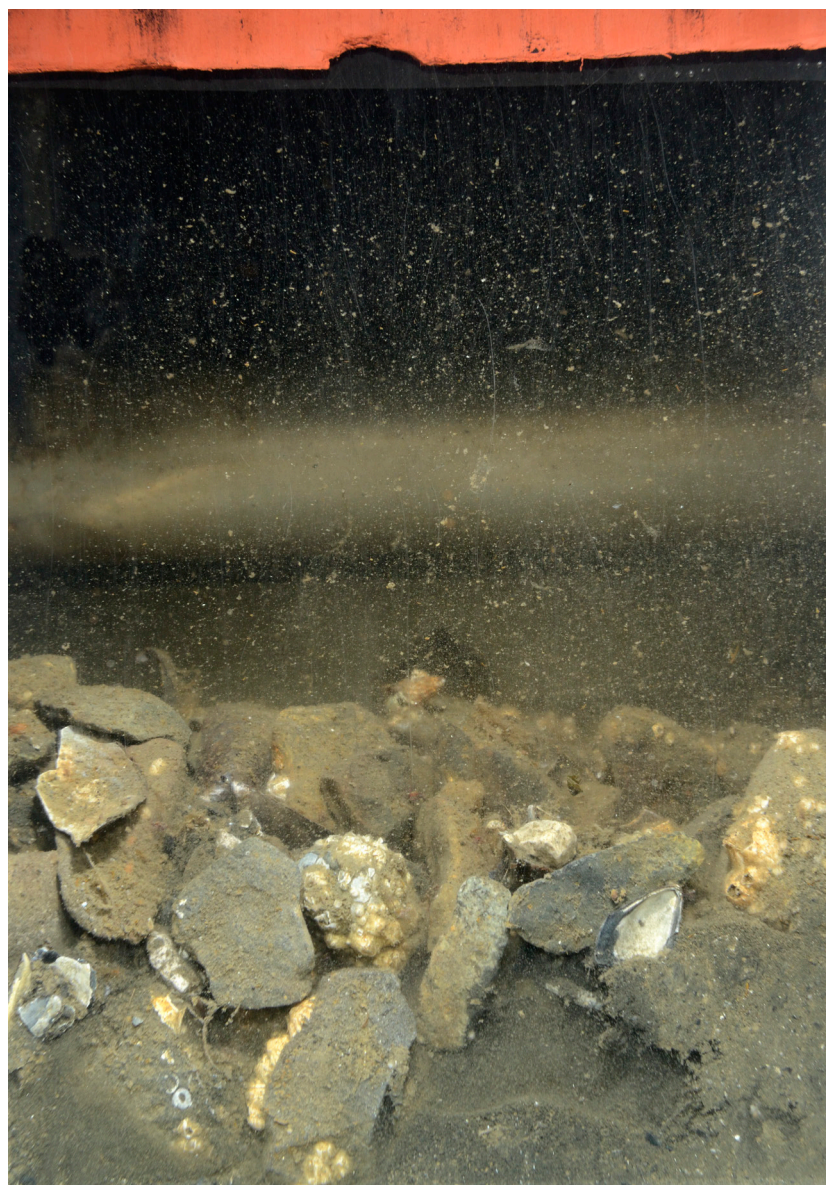
Figure 7: These profile images from Stations 1-3 (left) and 3-3 (right) show a shell and cobble armoring layer over the ambient fine sediments. Scale: width of each profile image = 14.6 cm.

There were some substantial change to seafloor conditions compared with those from last October (Germano & Associates 2013). While the appearance of the cobble armoring layer (Figures 7-8) just to the western outboard edge of Pier 7 was somewhat unexpected, it was particularly gratifying to obtain visual evidence of the reactive amendment being re-worked into the bottom sediments by bioturbation as originally planned (Figure 15). Another unexpected result was the apparent small-scale heterogeneity in some of the mapped patterns of reactive amendment from 2012 (Figure 1) to 2013 (Figure 11). There were some locations where the layer that was obvious in 2012 was no longer visible in 2013 (Figure 16), and conversely where there was no detectable layer in 2012 appeared to be present in 2013 (Figure 17).

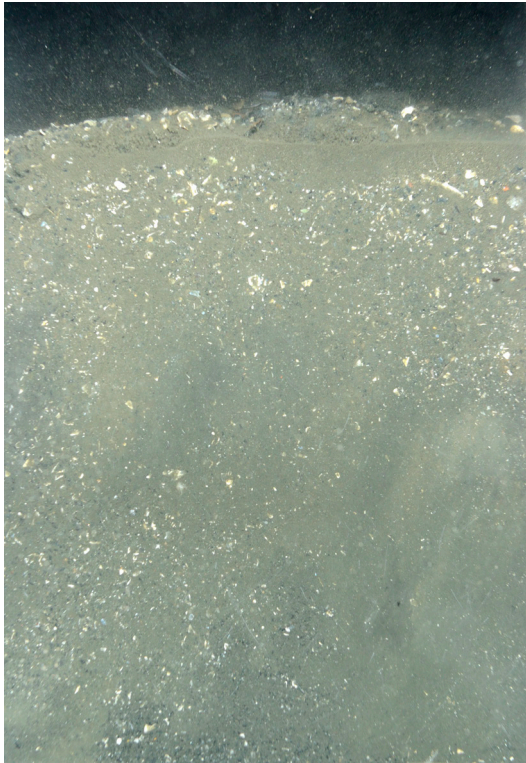
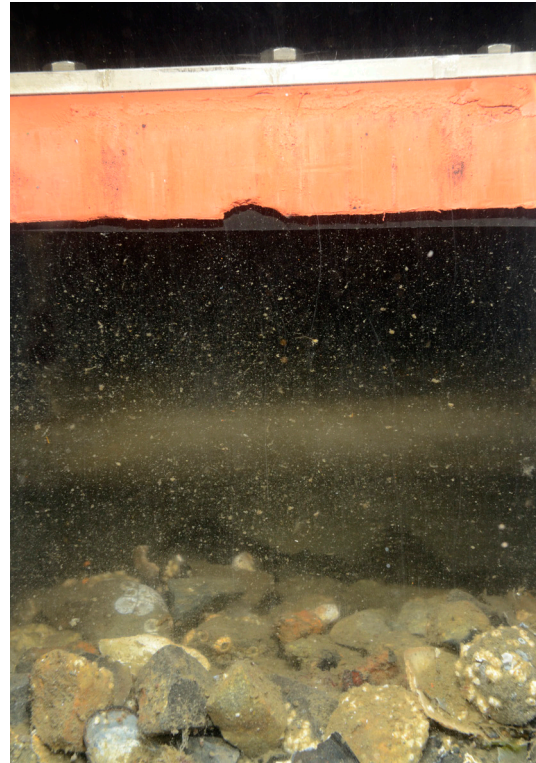
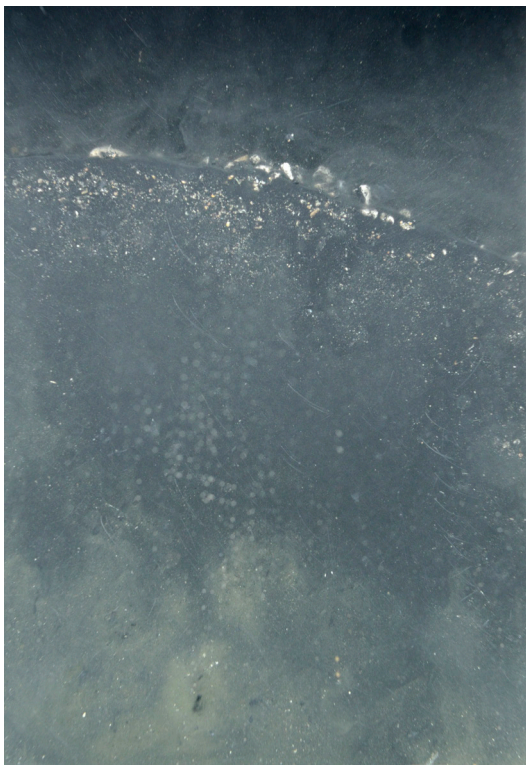
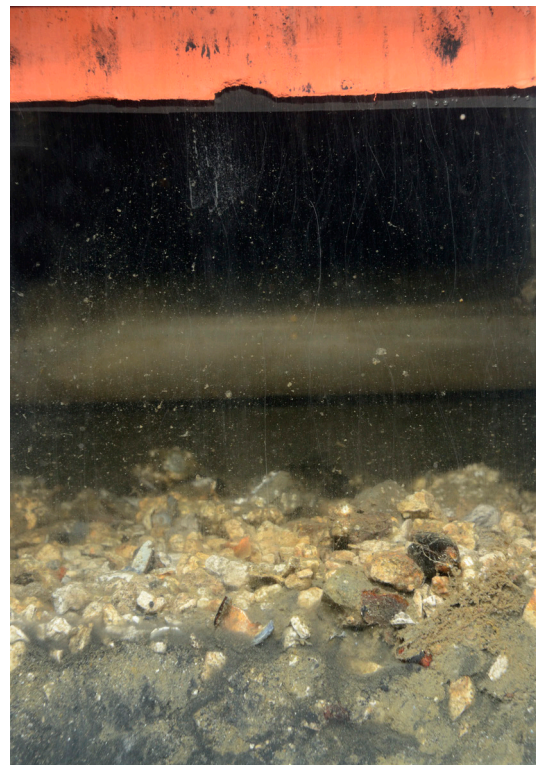
Figure 8: These profile images from the same stations taken in 2012 and 2013 show the radical change in sediment type because of the appearance of the surface armoring of cobble and shell; compare the differences in images from Station 1-3 (top) and 4-3 (bottom). Scale: width of each profile image = 14.6 cm.

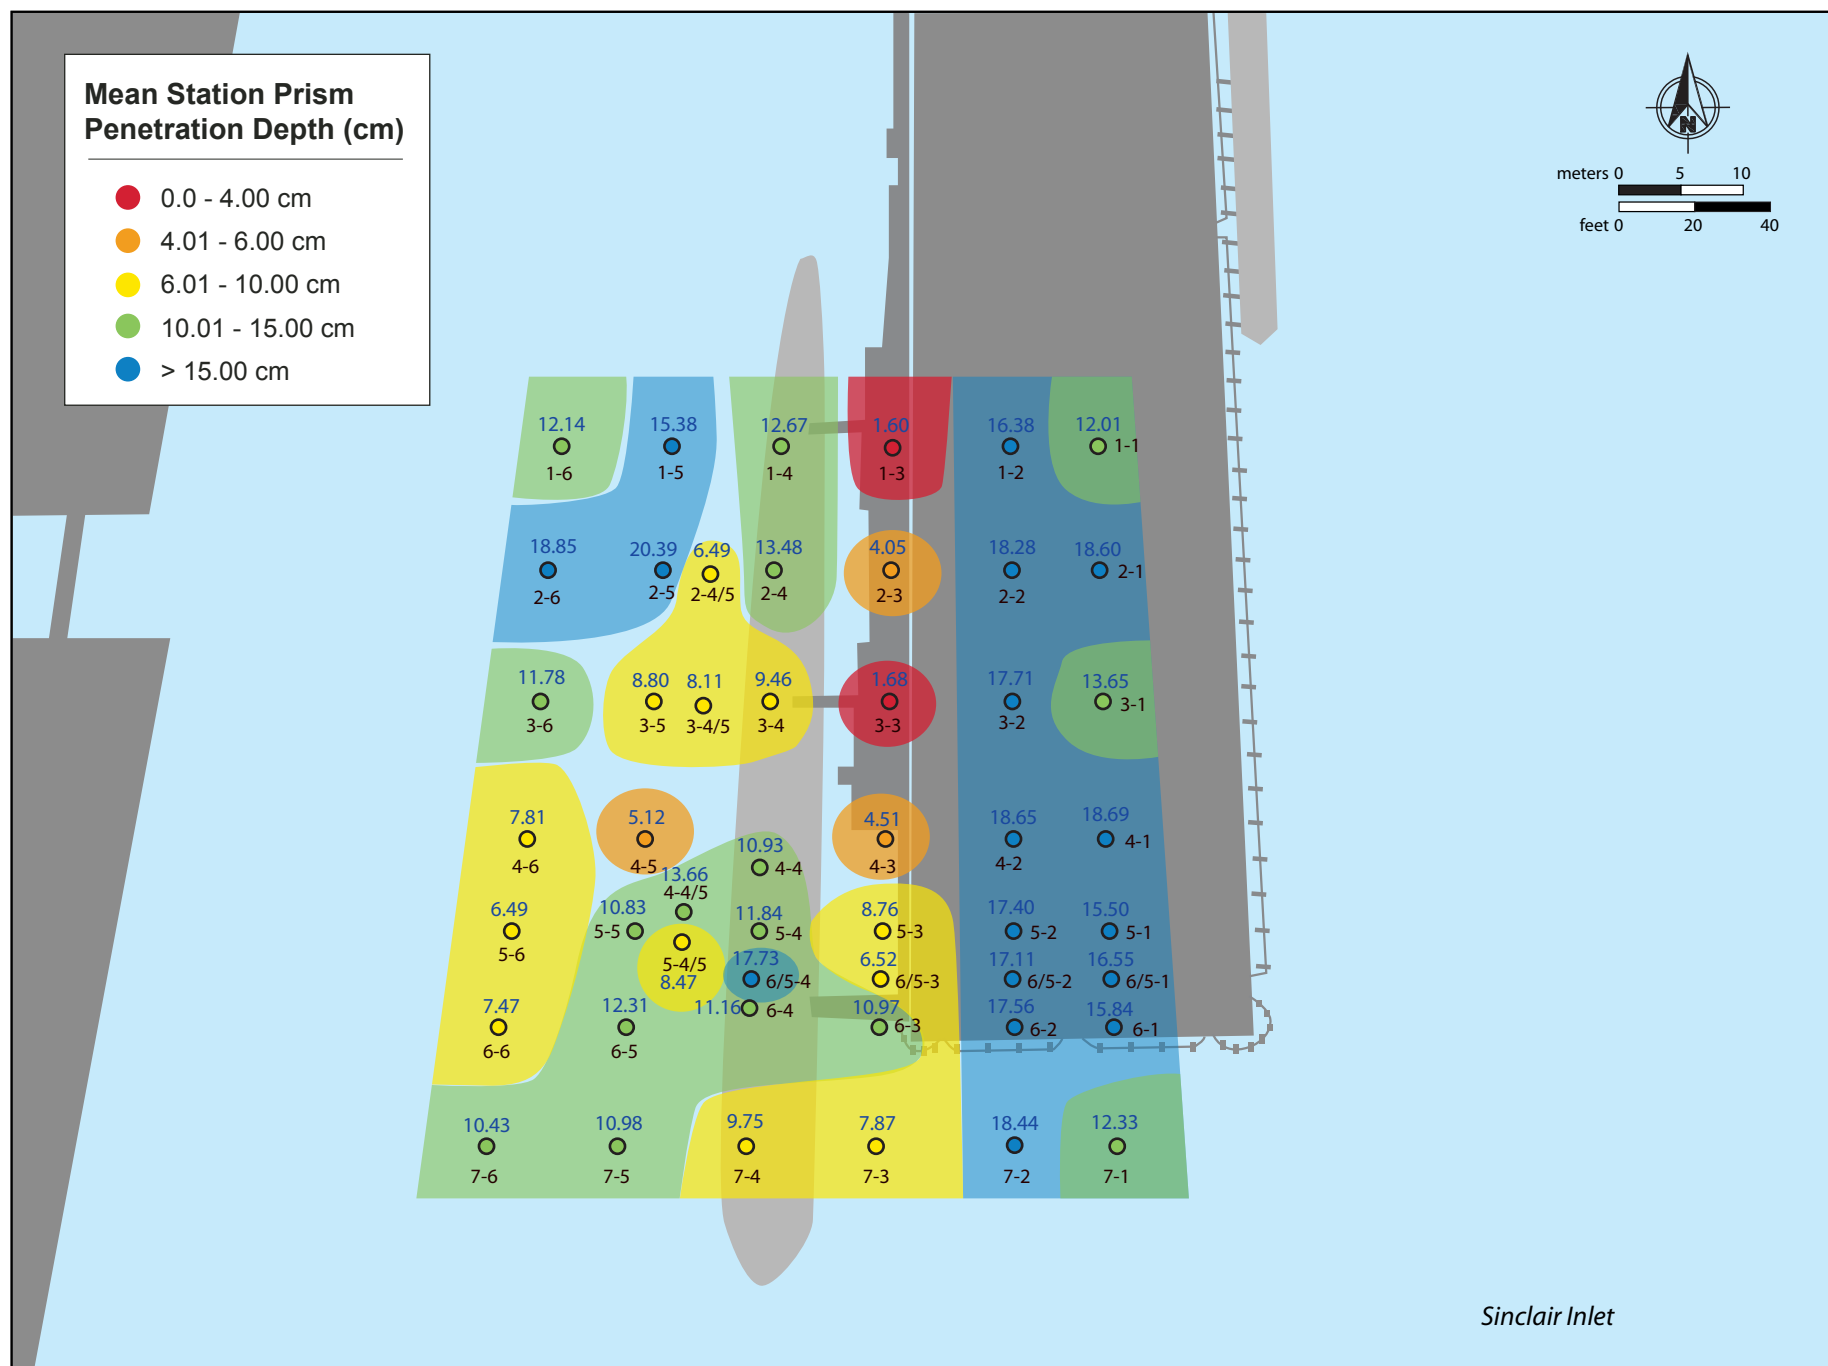
Figure 9: Spatial distribution of mean camera prism penetration depth (cm) at Pier 7 at the PSNS & IMF Bremerton site in August, 2013.

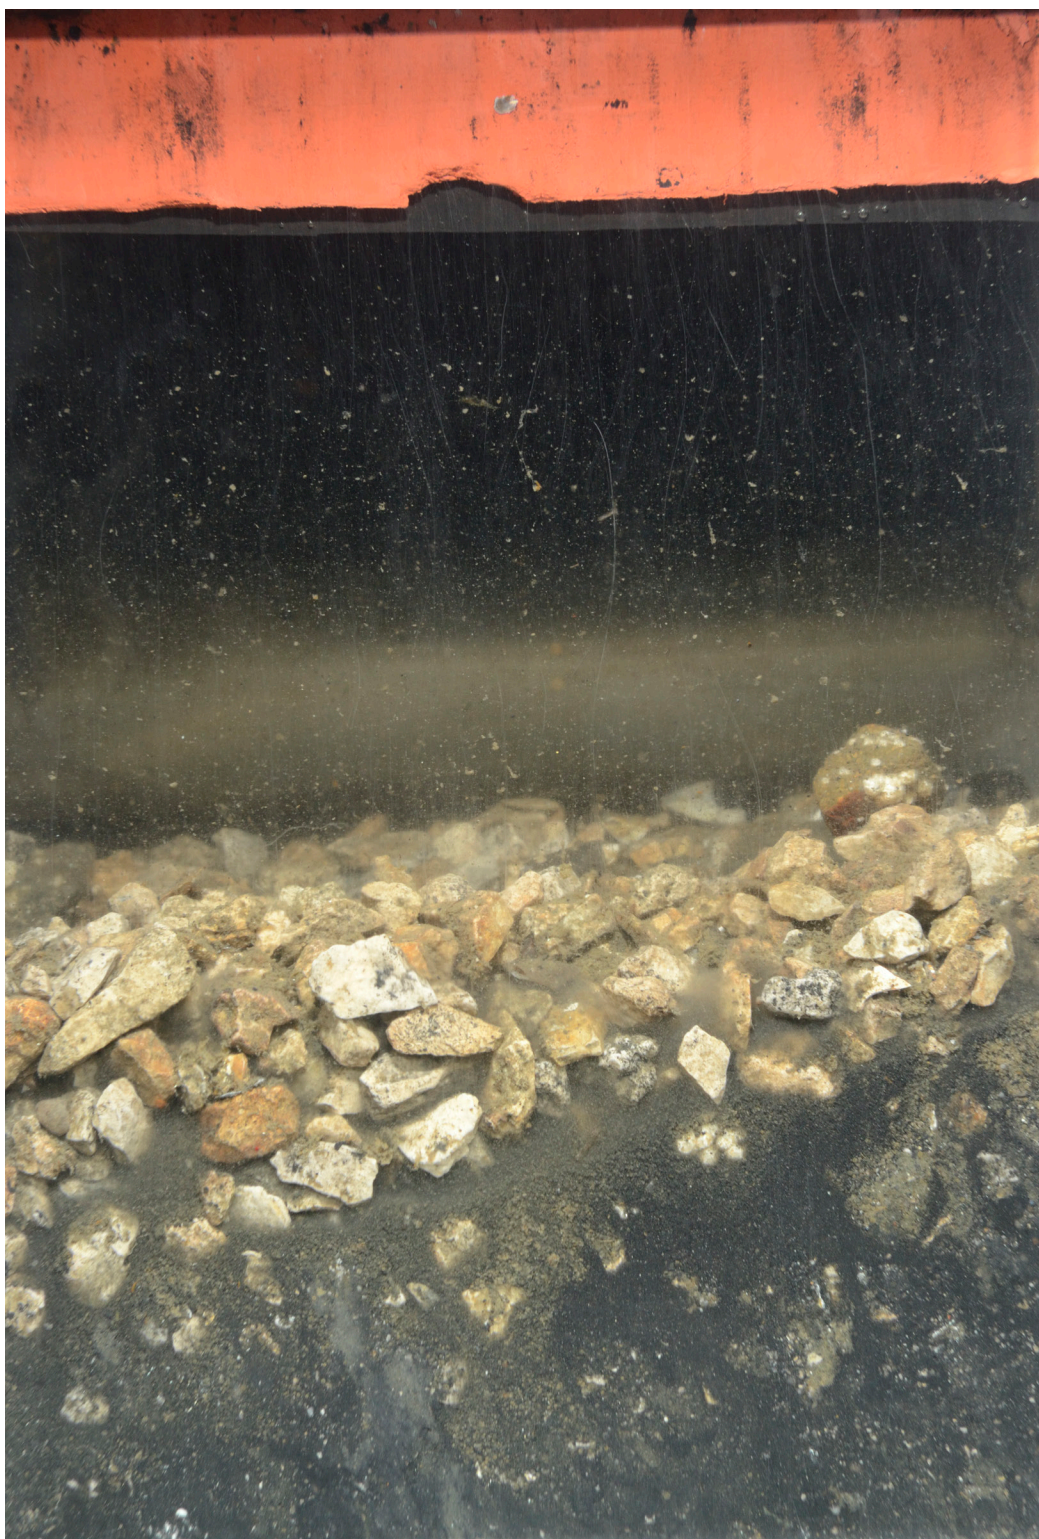
Figure 10: This profile image from Station 5-3 shows a distinct layer of the white pebbles that were coated with the reactive amendment and used as a carrier to get the material to the bottom sediments; particles of activated carbon are still visible in the subsurface profile. Scale: width of profile image = 14.6 cm.

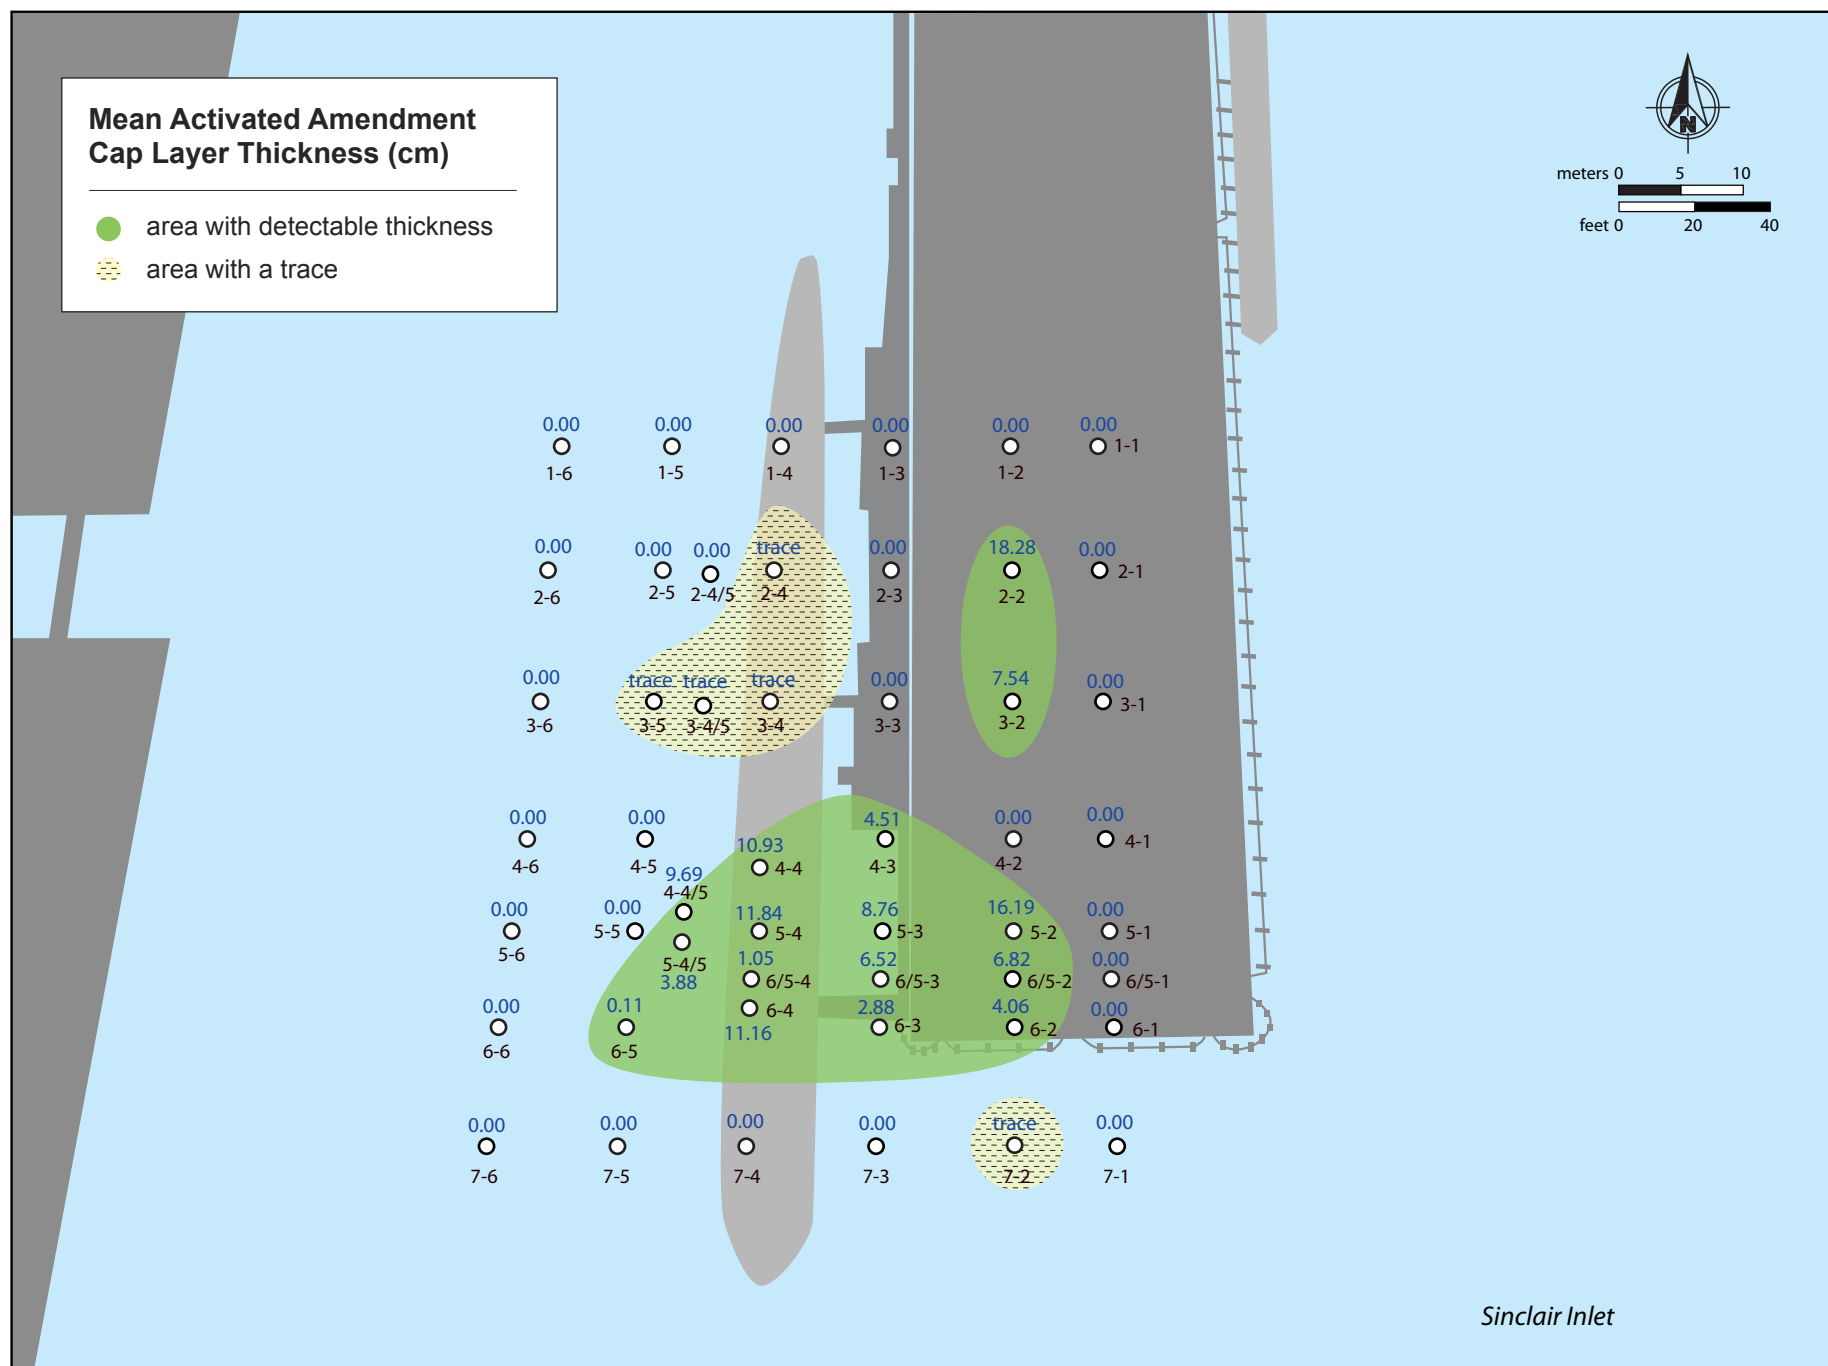
Figure 11: Spatial distribution and mean depositional thickness (cm) of the AquaGate +PACTM material placed at locations in and around Pier 7 at the PSNS & IMF Bremerton site.

Measureable deposits of AquaGate+PACTM could be seen at 16 stations, while 5 stations showed only traces of the AquaGate particles in the upper oxidized layer of sediment (Figure 10). At those stations where the cap material could be detected, the mean thickness ranged from trace layers to 18.3 cm, with an average thickness of 8.0 cm at those 16 stations where a distinct layer could be measured. The footprint of the cap is shown in Figure 11.
