Sediment Profile Imaging Report

Demonstration of *in-situ* Treatment of Contaminated Sediments with Reactive Amendments: Post-Cap Survey #2

Germano & Associates, Inc.
12100 SE 46th Place
Bellevue, WA 98006

January, 2014

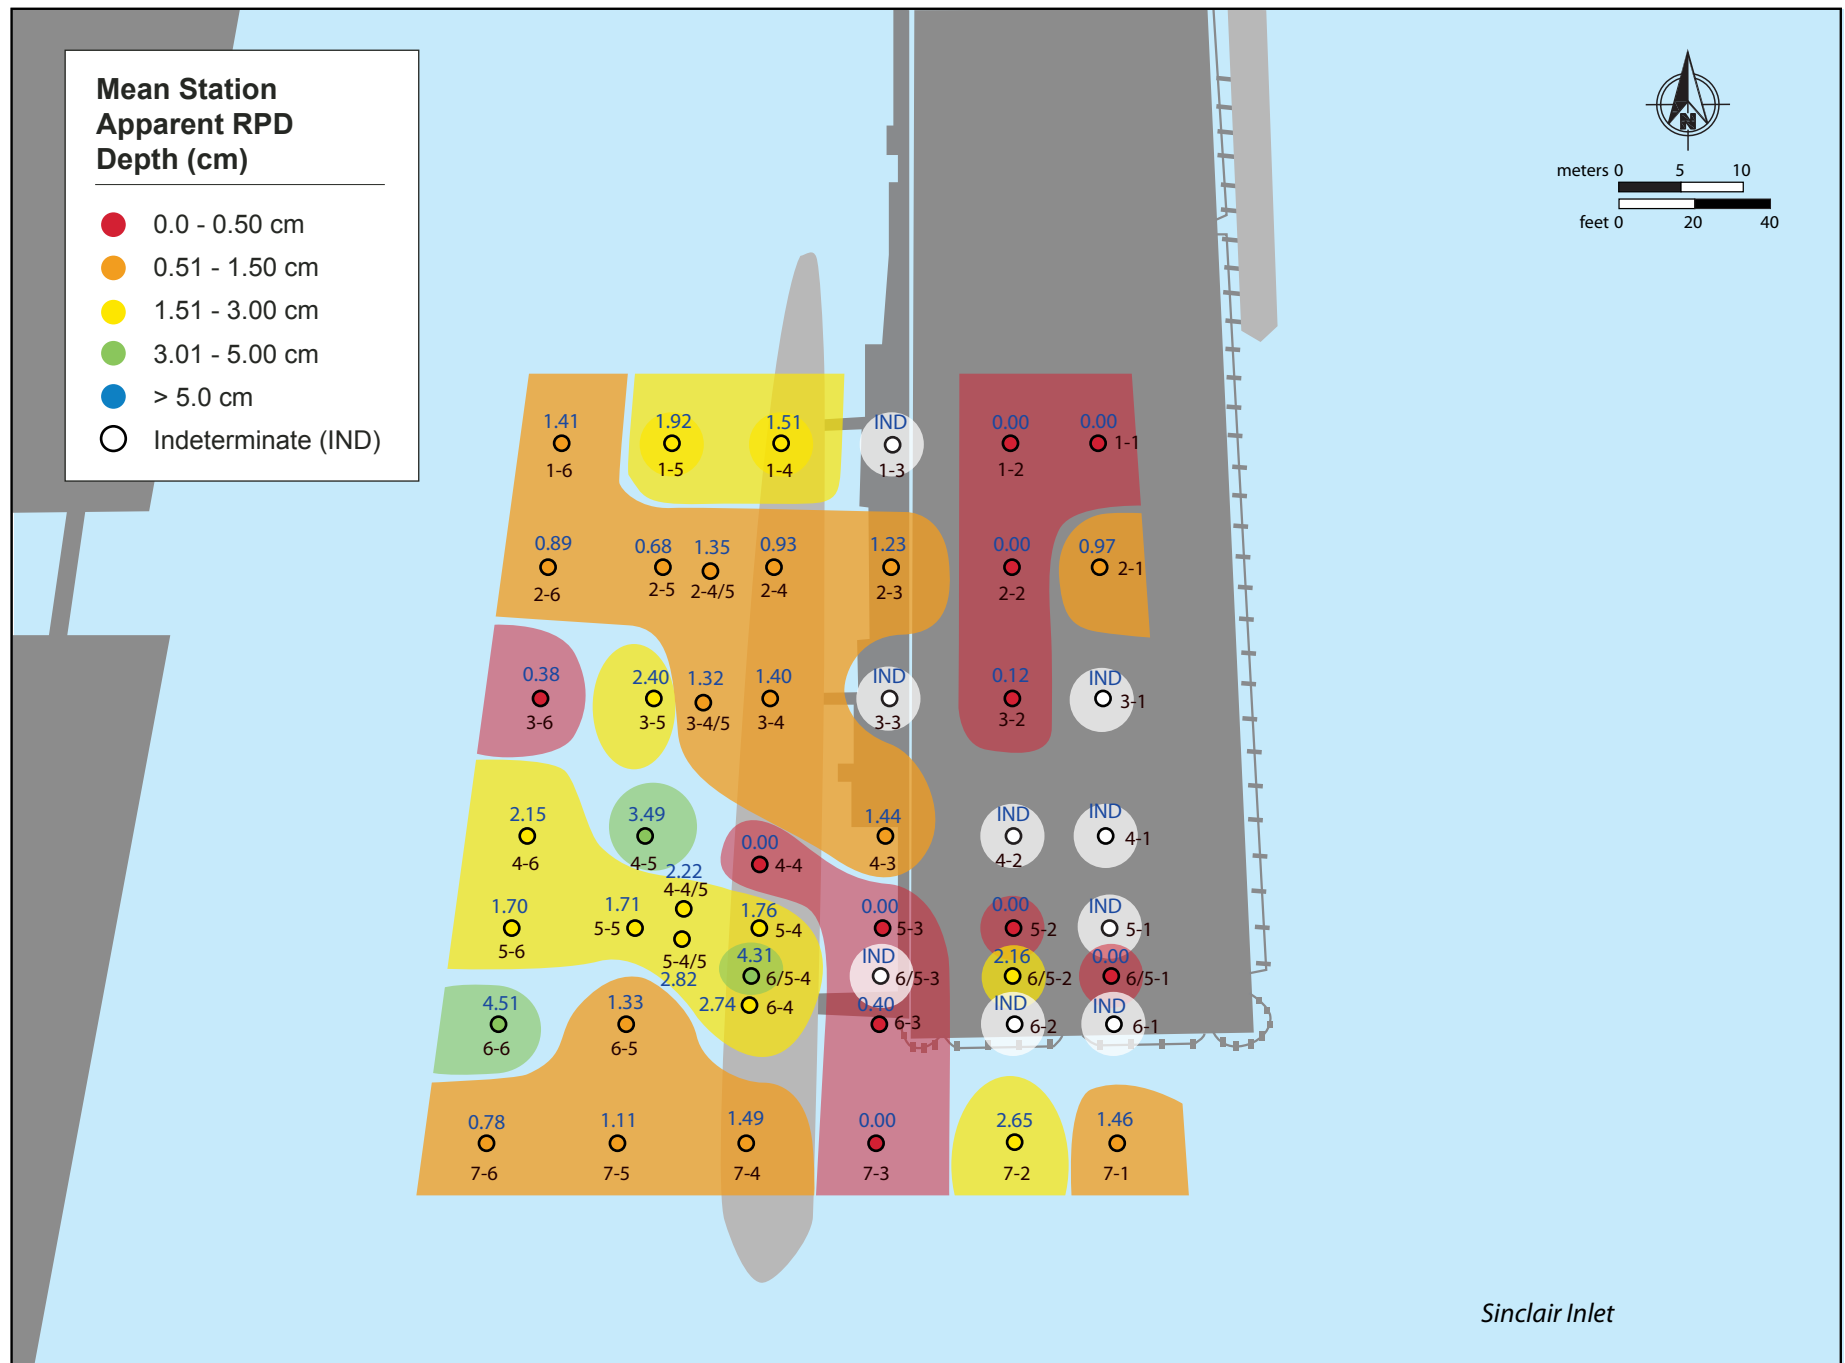
Figure 12: Spatial distribution of mean apparent RPD depth (cm) at Pier 7 in August, 2013.

The distribution of mean apparent RPD depths is shown in Figure 12; mean aRPD depths could not be measured at 7 of the stations sampled by divers because of sampling artifacts that caused distortions to the sediment profile and eliminated the possibility of any accurate measurements; cobble/shell at two of the stations (Stations 1-3 and 3-3) prevented sufficient prism penetration to get an aRPD measurement. While eight of the stations still had no detectable aRPD present, the remaining stations had values ranging from 0.1 to 4.5 cm (Figure 12; Appendix A), with an overall site average of 1.4 cm.

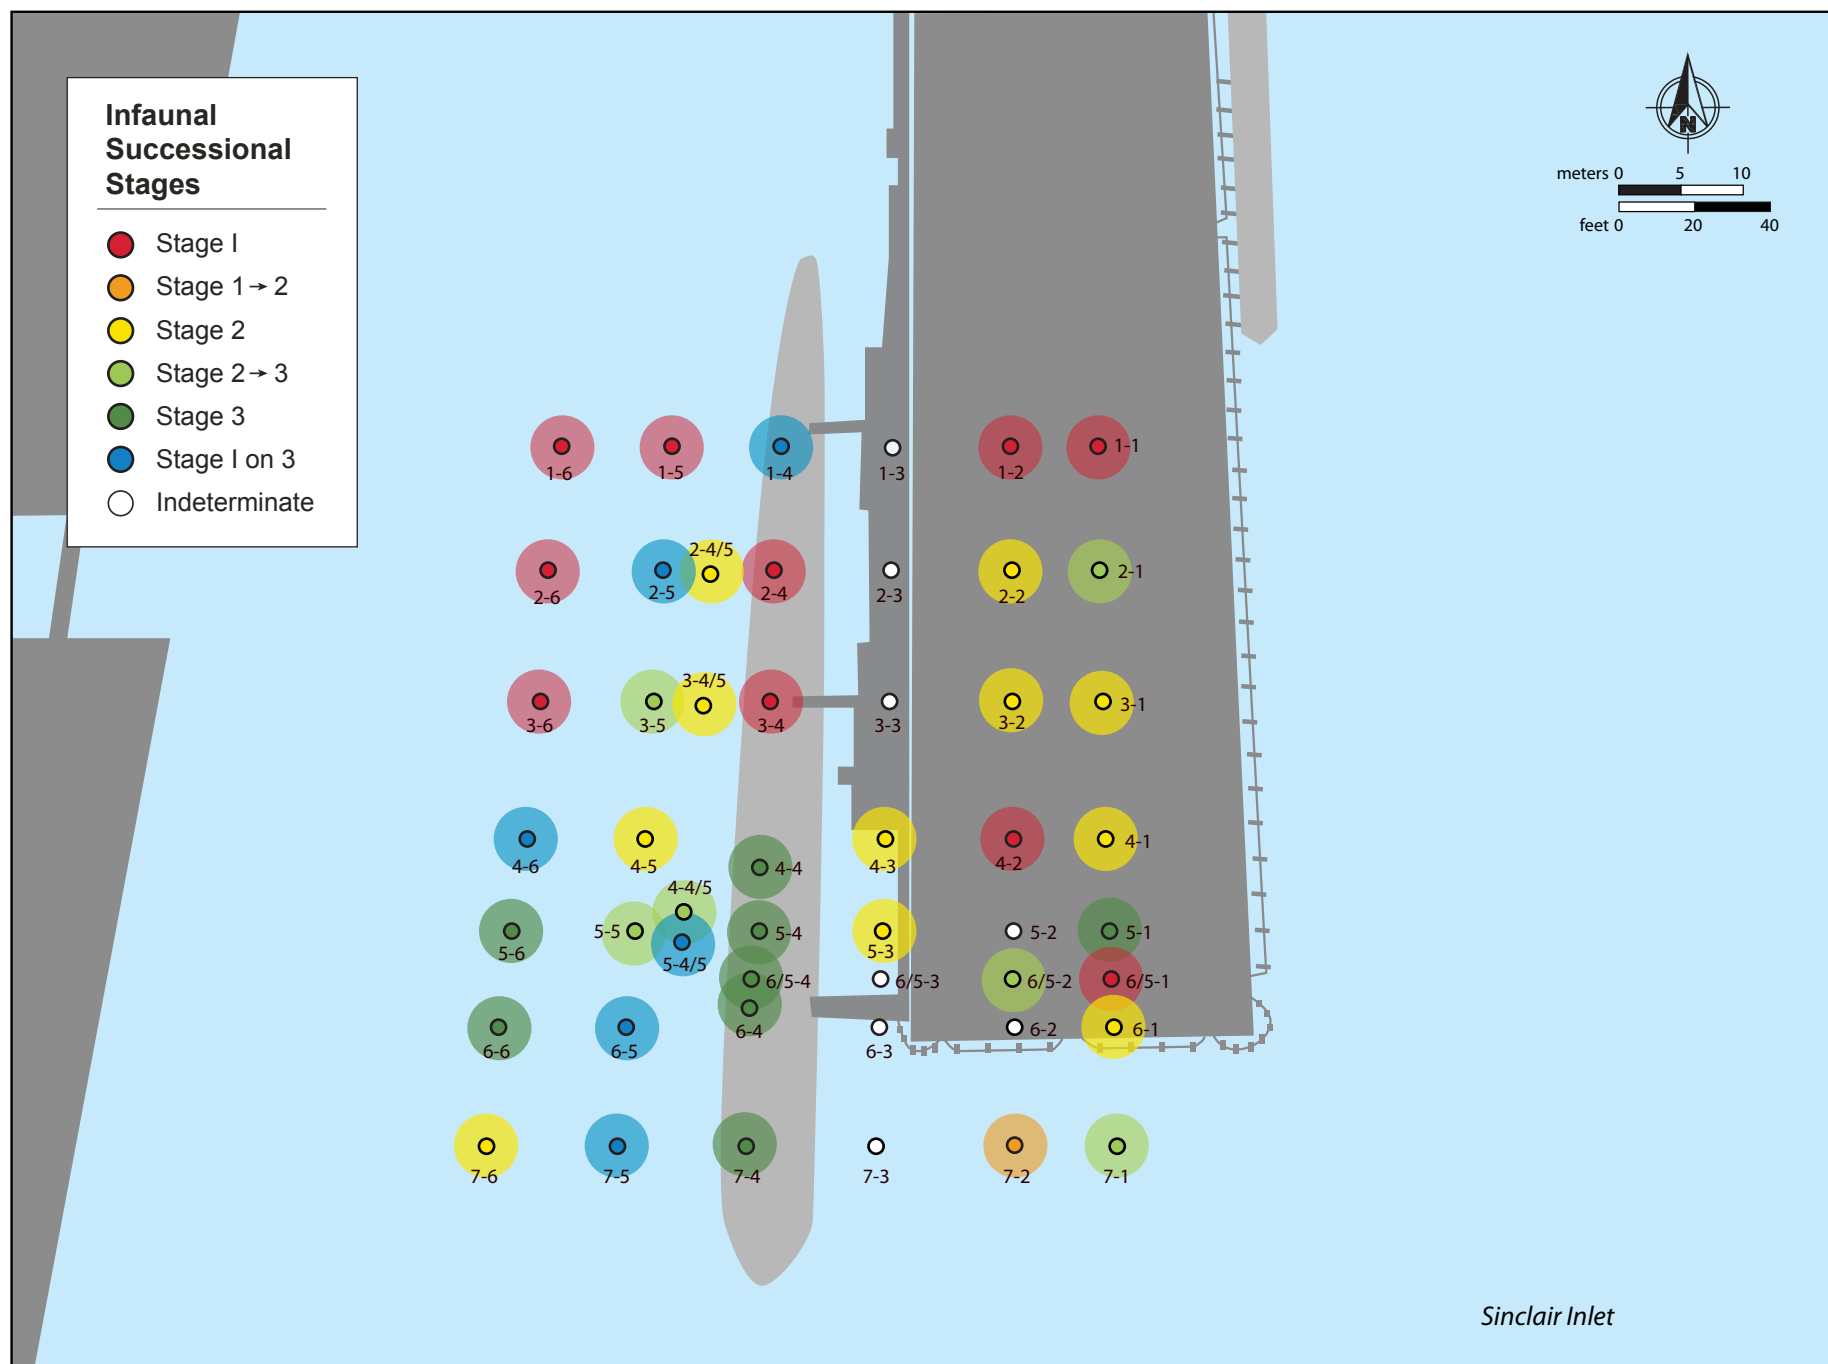
Figure 13: Spatial distribution of infaunal successional stages at Pier 7 in August, 2013.

The mapped distribution of infaunal successional stages is shown in Figure 13; while there was a noticeable improvement in biological community status under the pier compared to the post capping survey last year, there was a retrograde in successional status at some of the stations outboard of the pier (Stations 1-5, 1-6, 2-4, 2-6, 3-4, and 3-

6). However, presence of Stage 3 taxa (larger infaunal deposit feeders) was evident at 18 of the 50 stations.

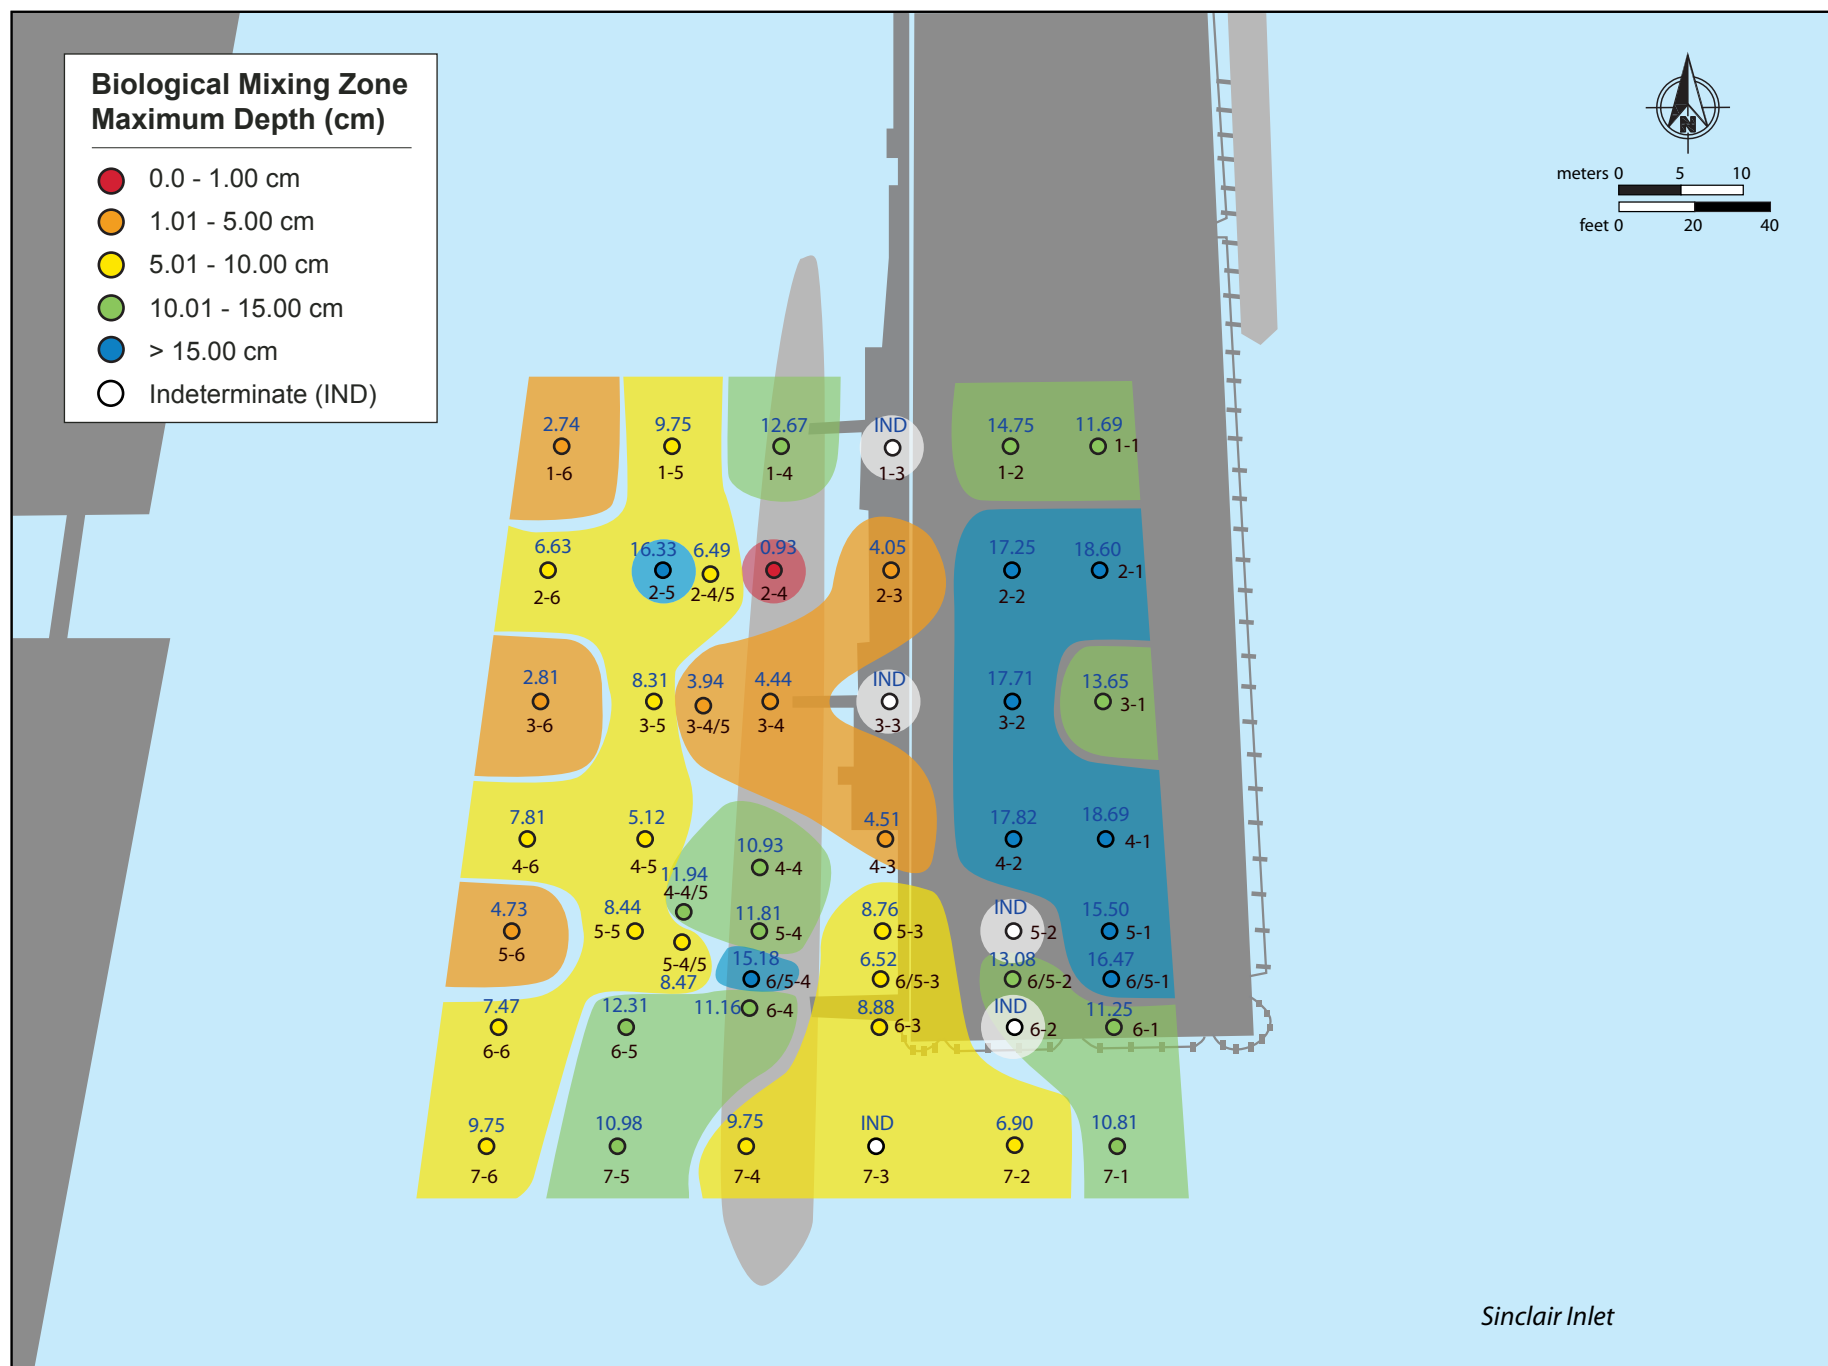
Figure 14: Spatial distribution of maximum biological mixing depth at Pier 7 at the PSNS & IMF Bremerton site in August, 2013.

The spatial distribution of the maximum depth to which any biological activity was seen in the study area is shown in Figure 14. Some of the deepest infaunal burrowing was found at those stations under the pier where the reactive amendment had been placed; maximum depth of biogenic activity ranged from 0.9 to 18.7 cm, with an overall site average of 10.2 cm.

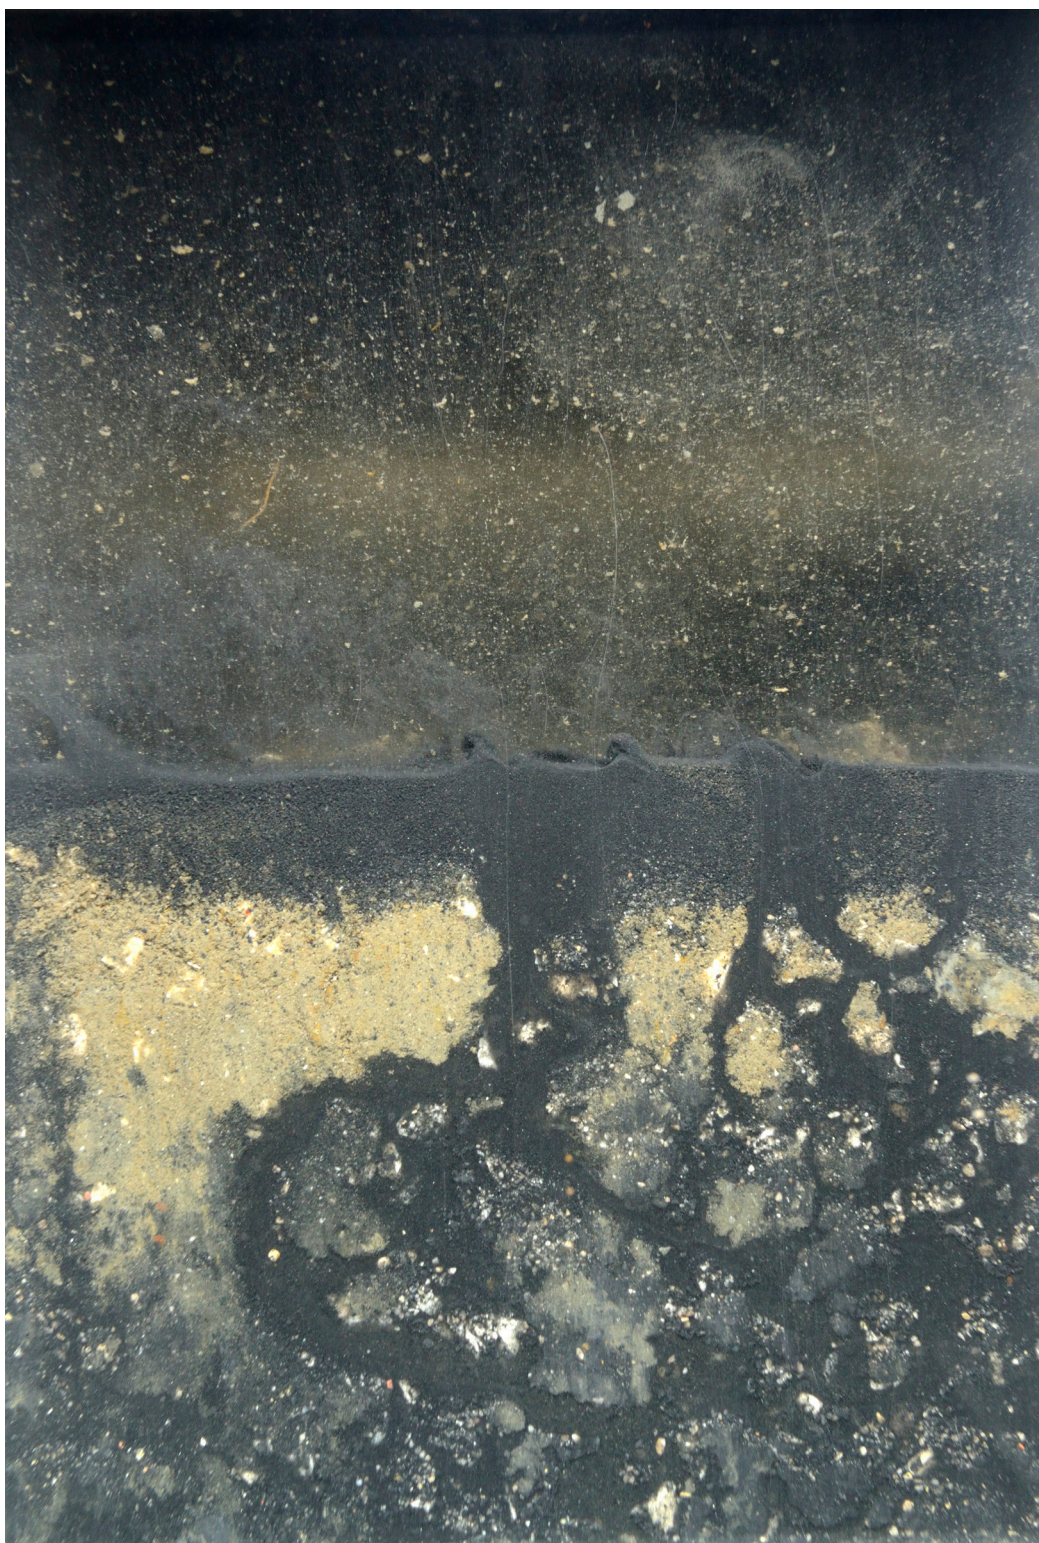
Figure 15: This profile image from Station 4-4 shows active particle transport of the activated carbon particles as well as the development of a surface oxidized layer. Scale: width of profile image = 14.6 cm.

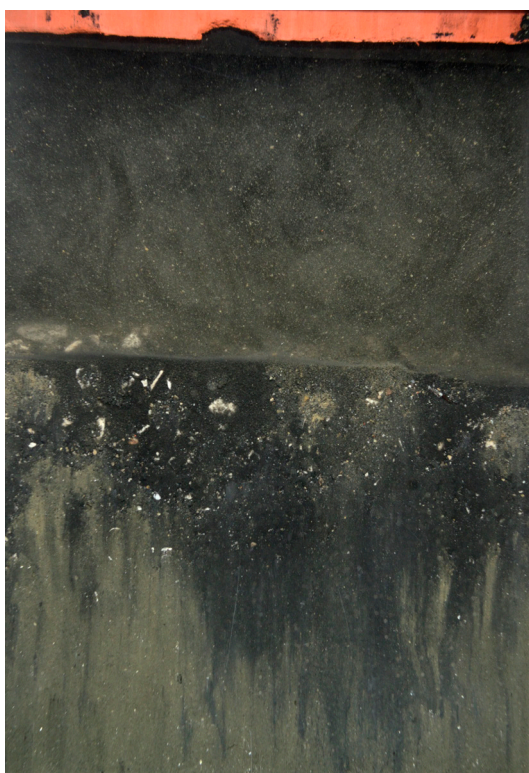
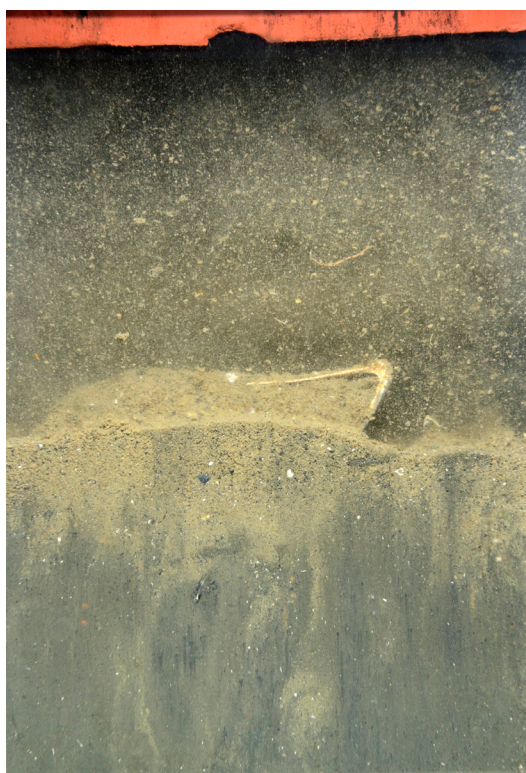
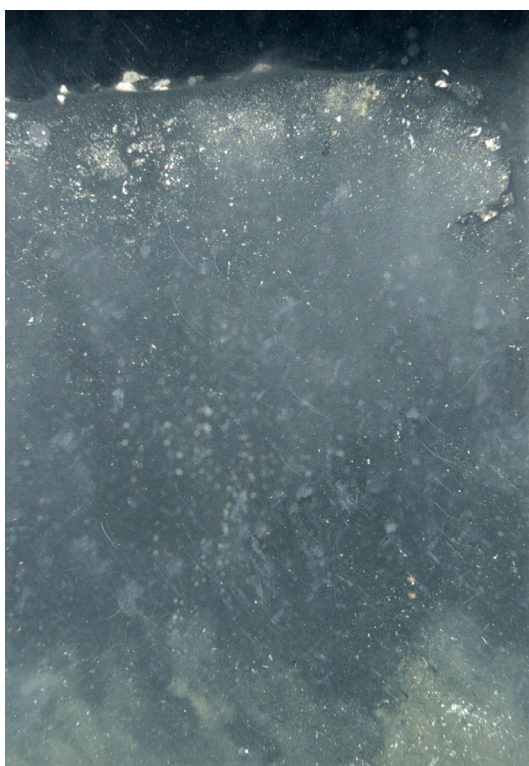
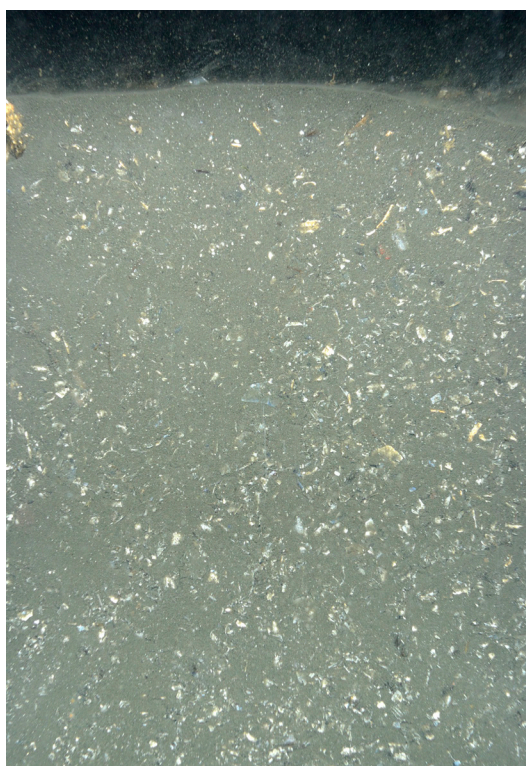
Figure 16: These profile images from Stations 3-4 (top) and 4-2 (bottom) show an obvious presence of the reactive amendment in 2012 that seems to no longer be present in 2013. Scale: width of each image = 14.6 cm.

There were some substantial change to seafloor conditions compared with those from last October (Germano & Associates 2013). While the appearance of the cobble armoring layer (Figures 7-8) just to the western outboard edge of Pier 7 was somewhat unexpected, it was particularly gratifying to obtain visual evidence of the reactive amendment being re-worked into the bottom sediments by bioturbation as originally planned (Figure 15). Another unexpected result was the apparent small-scale heterogeneity in some of the mapped patterns of reactive amendment from 2012 (Figure 1) to 2013 (Figure 11). There were some locations where the layer that was obvious in 2012 was no longer visible in 2013 (Figure 16), and conversely where there was no detectable layer in 2012 appeared to be present in 2013 (Figure 17).

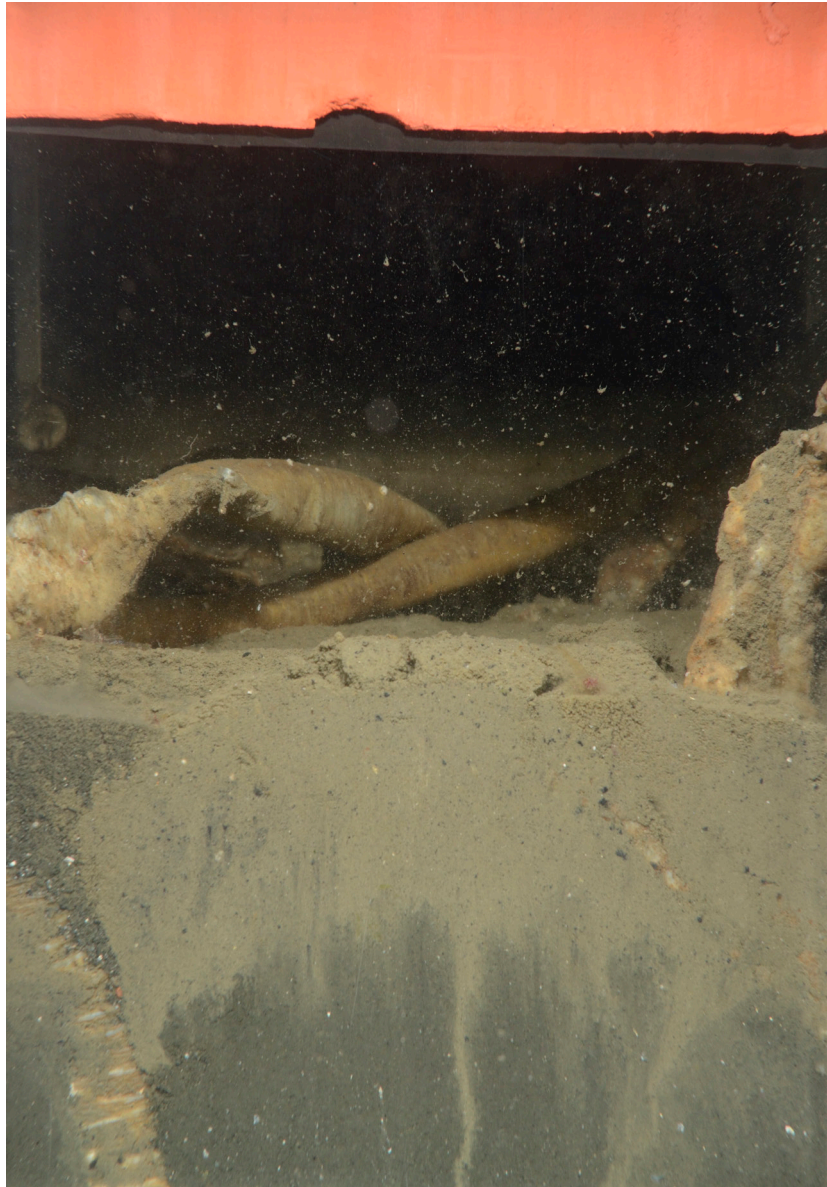
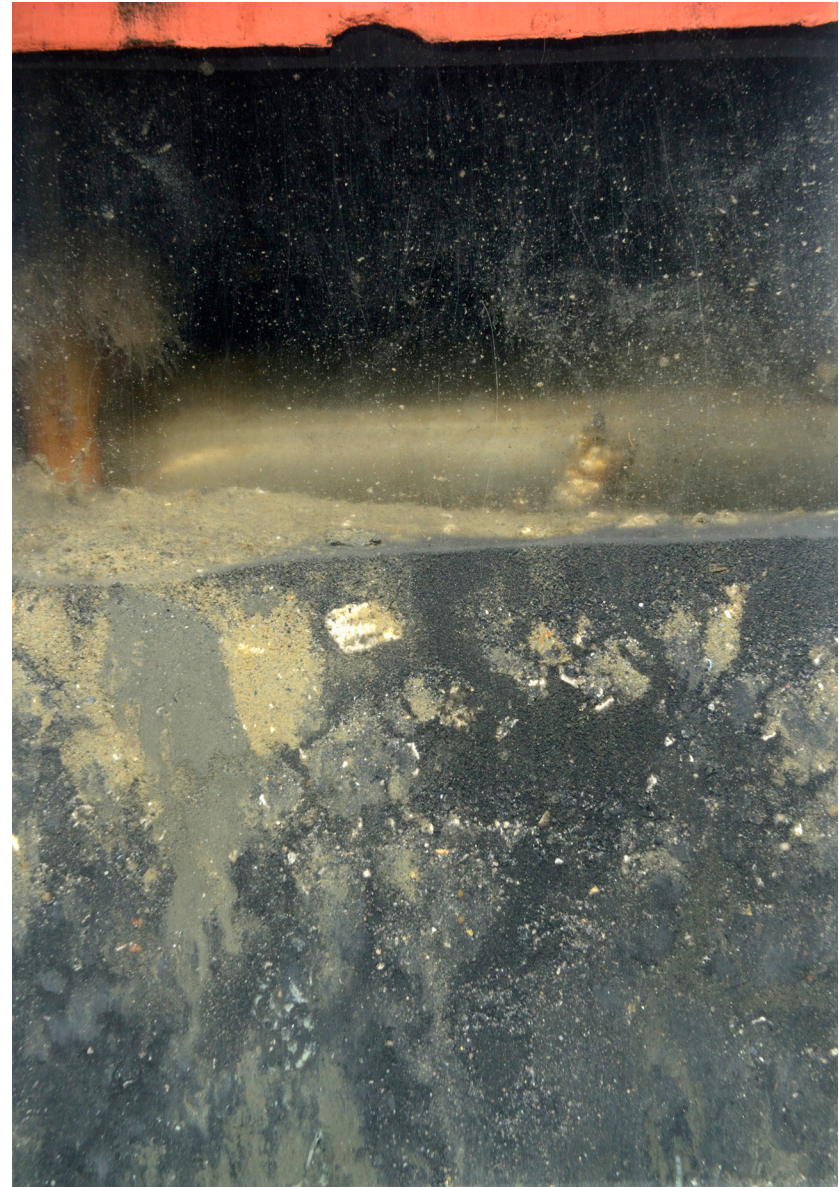
Figure 17: These profile images from 2012 and 2013 at Station 6-4 show the small-scale heterogeneity in the spatial distribution of the reactive amendment added in Oct 2012. Scale: width of each image = 14.6 cm.
