Sediment Profile Imaging Report

Demonstration of *in-situ* Treatment of Contaminated Sediments with Reactive Amendments: Post-Cap Survey #3

December, 2014

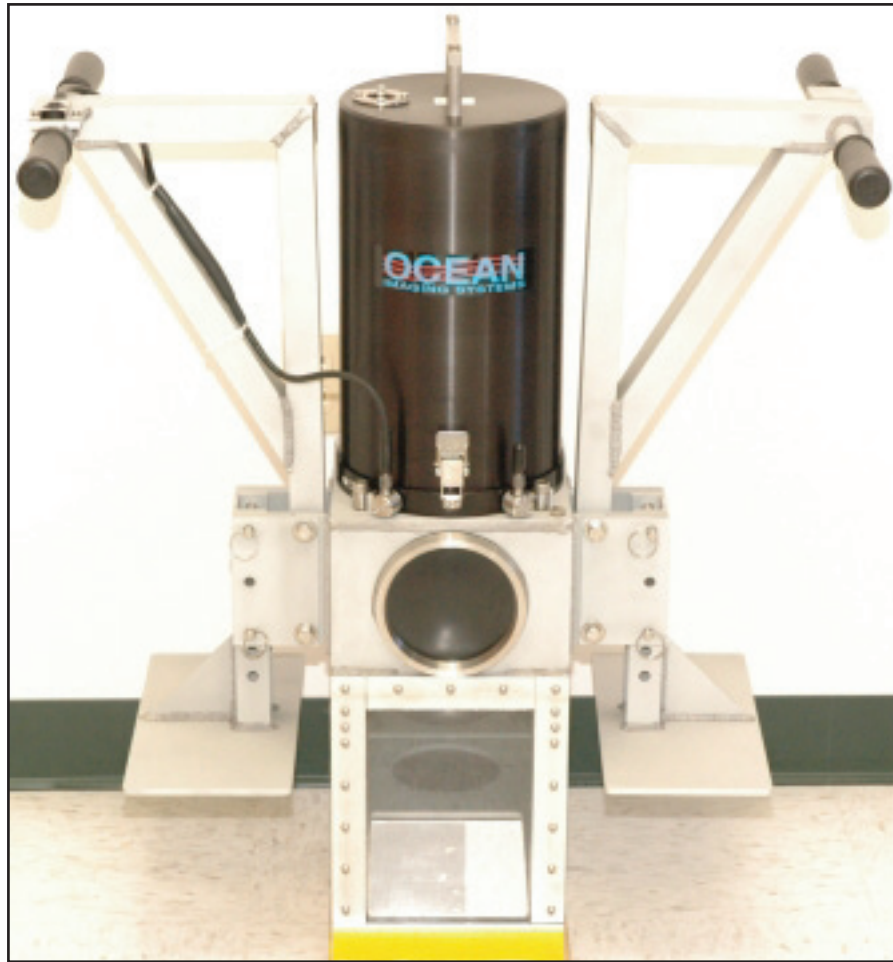
Figure 3: The hand-held SPI system used by divers for all stations that were located underneath Pier 7 at PSNS & IMF, Bremerton site.

The hand-held SPI system (Figure 3) works on the same design, except that there is no time delay once the watertight switch is activated by the diver after the prism is inserted into the sediment. There is no wiper blade on the hand-held system, so the diver needs to clean the faceplate of the camera prism manually with a scrub brush after each image is taken.

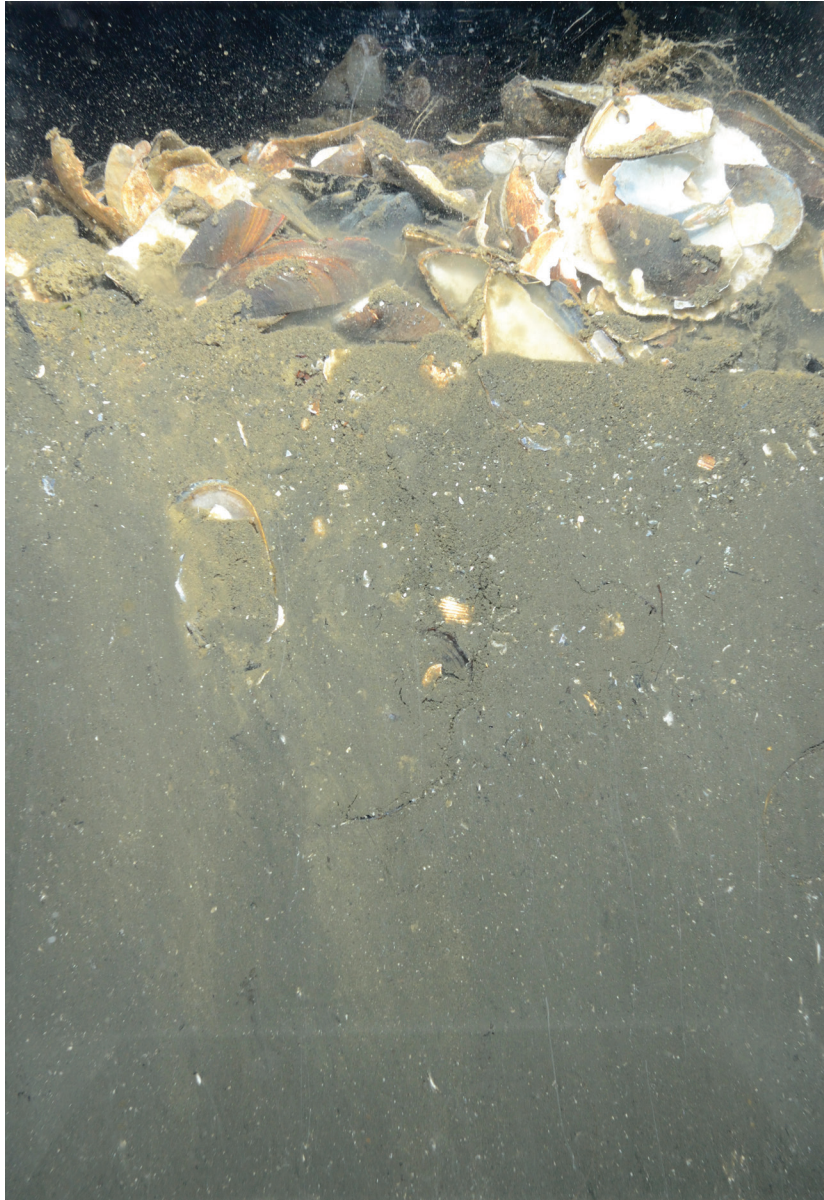
Figure 5: These profile images from Station 1-2 and Station 5-1 show the different forms of surface armoring from shell hash (intact shells at Station 1-2 versus pulverized fragments at Station 5-1) found at many of the under pier stations. Scale: width of each profile image = 14.5 cm.

Sediments throughout the site ranged from sandy silt to muds with minor fractions of very fine to fine sand with high percentages of shell hash (stations under Pier 7; see Figure 5) to pebble and cobble armoring over silty sands (Figure 6). As noted from the results of the past two surveys, the addition of the AquaGate amendment also provided some surface armoring at select stations which impeded camera prism penetration (Figure 7). The overall site prism penetration depth was similar to the values measured in 2013 (T = 10 months), with values ranging from 2.3 to 20.0 cm, with an overall site average of 12.2 cm; the spatial distribution of mean penetration depth at all stations sampled is shown in Figure 8.

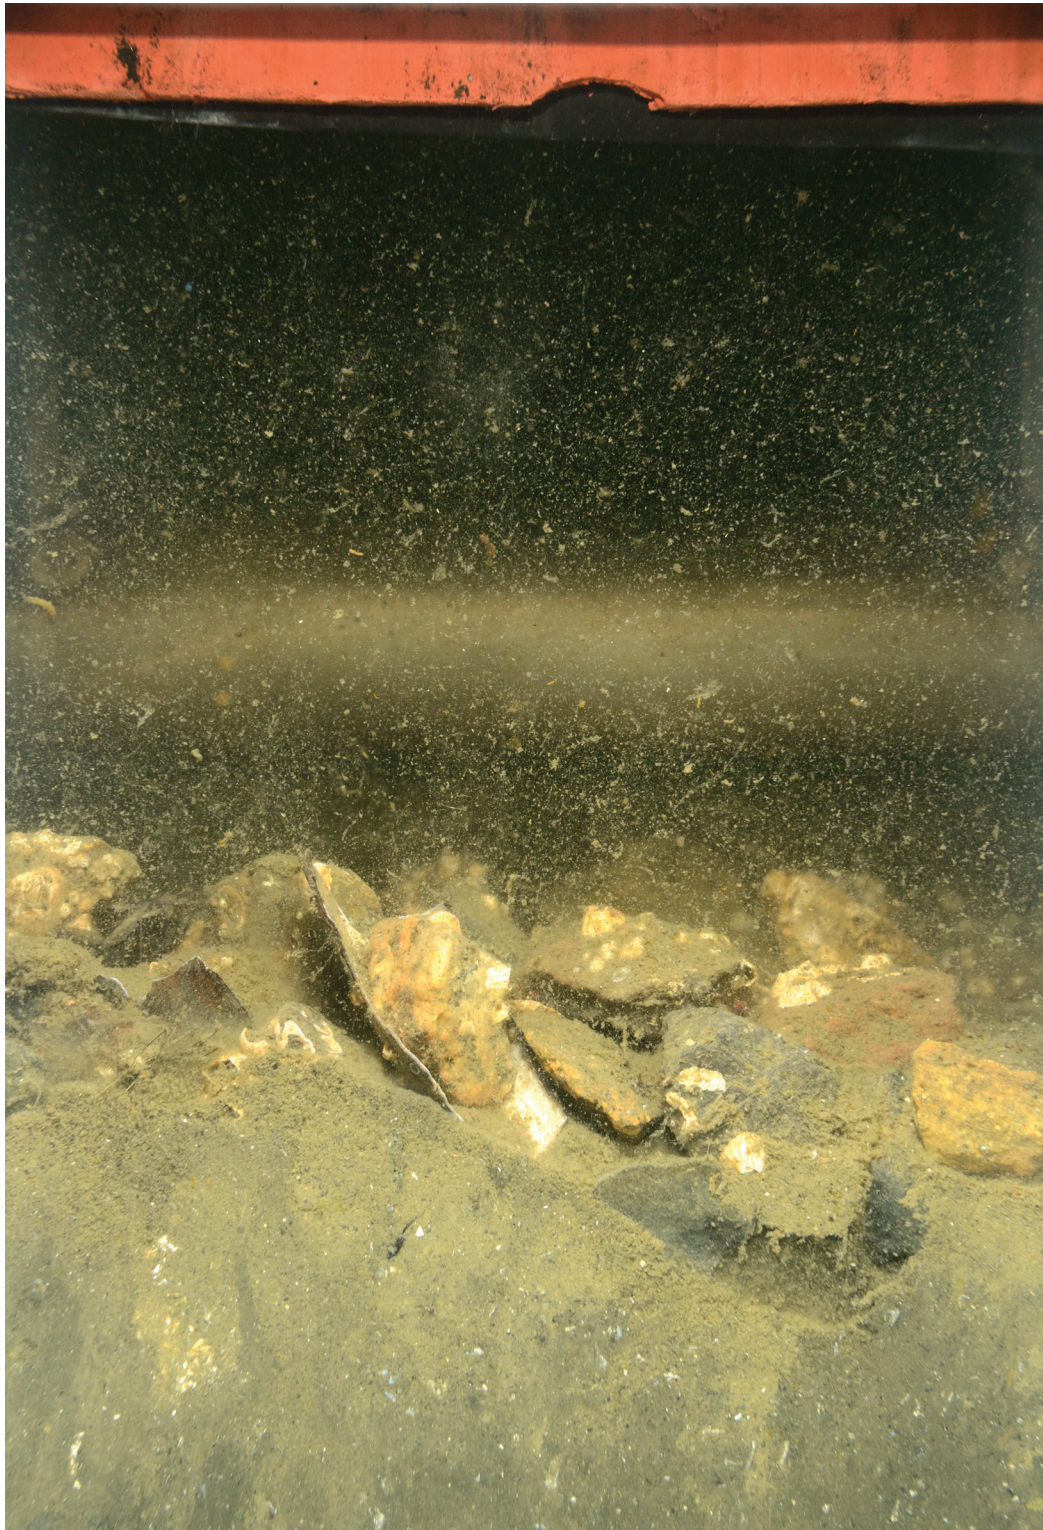
Figure 6: As in past surveys, the SPI photos from Station 1-3 show an armoring of pebble and cobbles over silty very fine sand. Scale: width of profile image = 14.5 cm.

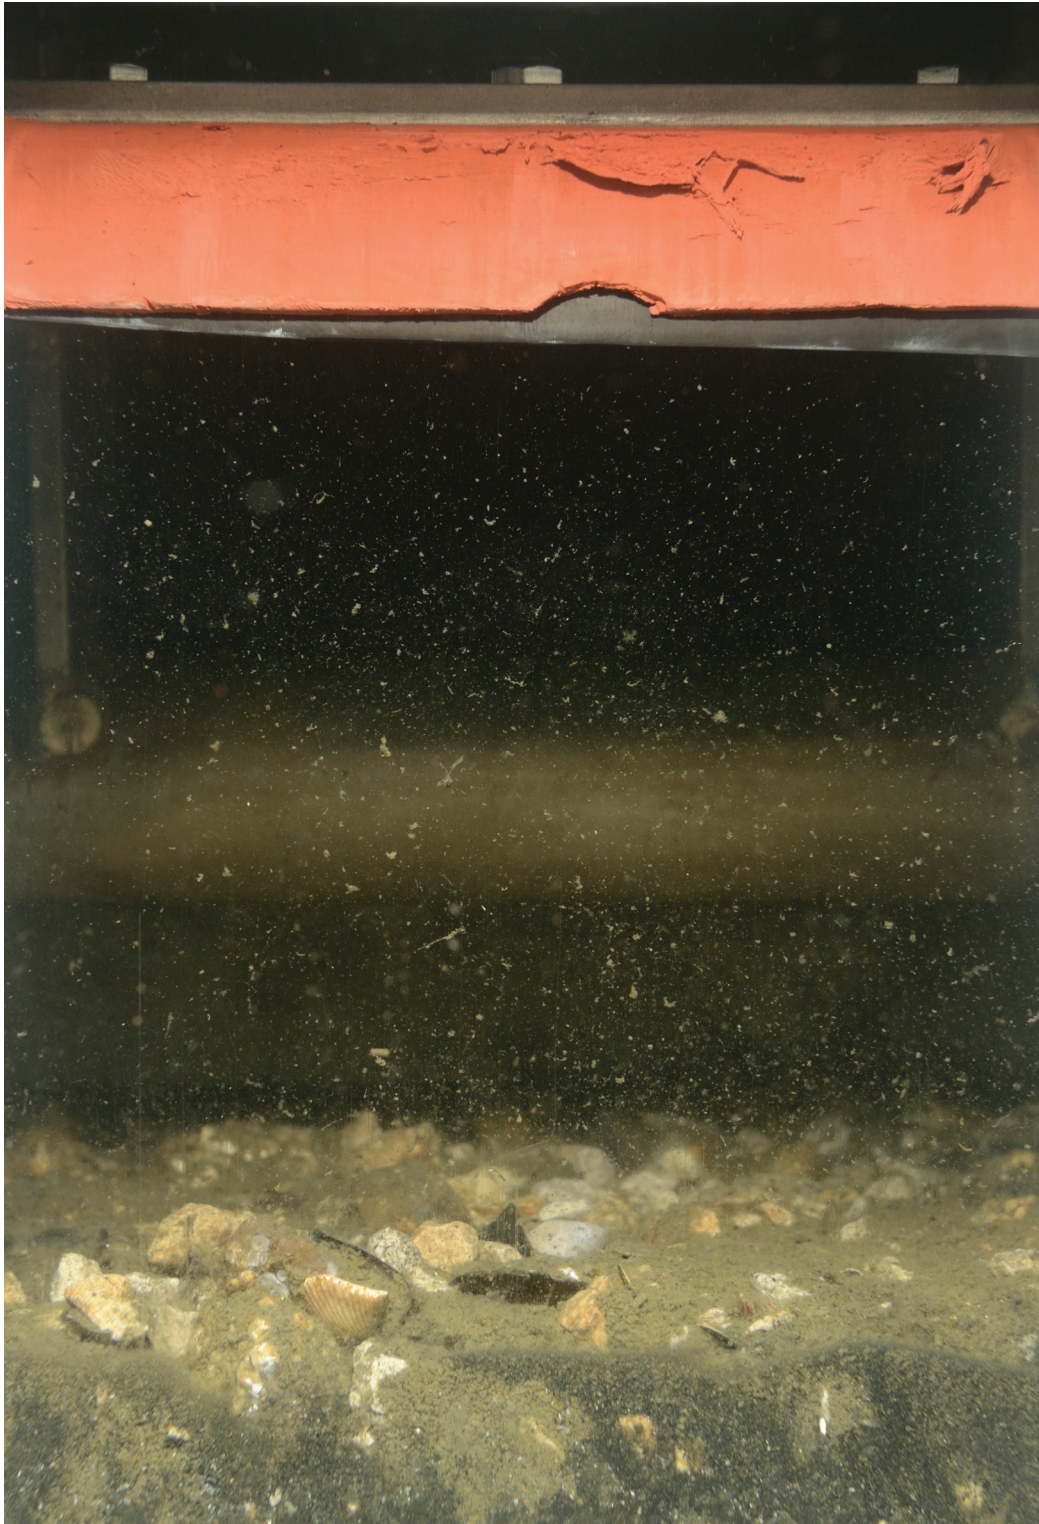
Figure 7: This profile image from Station 5-3 shows surface armoring from the pebbles used as a carrier vehicle for the activated carbon in the AquaGate amendment that was placed under and around Pier 7. Scale: width of profile image = 14.5 cm.

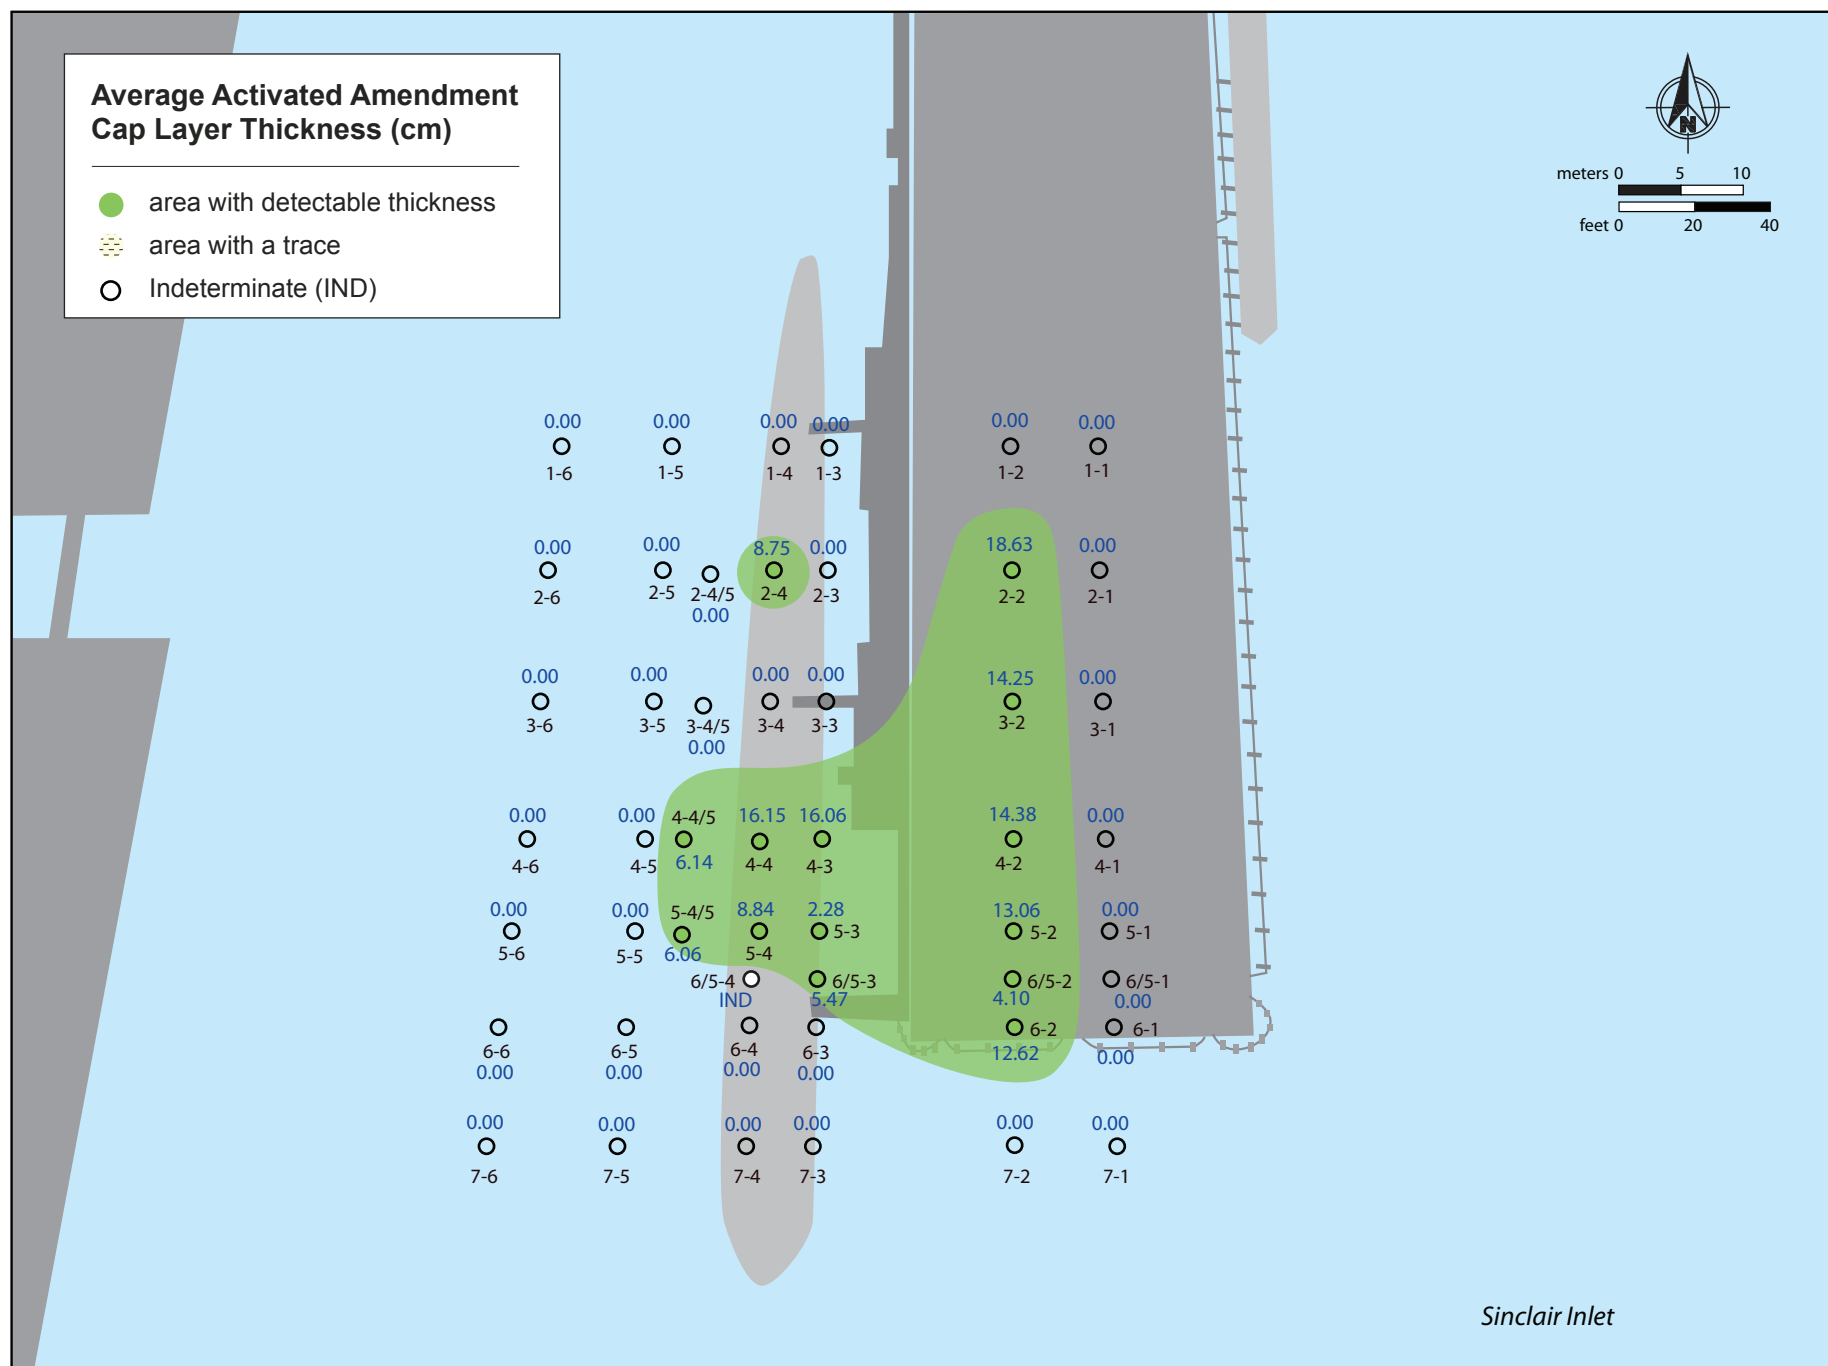
Figure 9: Spatial distribution and mean depositional thickness (cm) of the AquaGate +PAC™ material placed at locations in and around Pier 7 at the PSNS & IMF Bremerton site.

Measureable deposits of AquaGate+PACTM could be seen at 14 stations this year as compared to 16 stations last year; natural depositional processes and bioturbation of the sediments by the resident infauna will mask the signature of this depositional layer over time. At those stations where the cap material could be detected, the mean thickness ranged from trace layers to 18.6 cm, with an average thickness of 10.5 cm at those 14 stations where a distinct layer could be measured. The footprint of the visible cap is shown in Figure 9.

The pattern of the optical signature of the reactive amendment slowly “disappearing” through natural depositional processes and bioturbational activity of the infaunal community that was documented in the 2013 survey continued in this survey; initially, the presence of the reactive amendment could be detected at 19 stations. After 10 months post placement (2013 survey), the layer was only visible at 16 stations, and in this most recent survey (22 months post placement), the layer could only be detected at 14 stations (Figure 9).

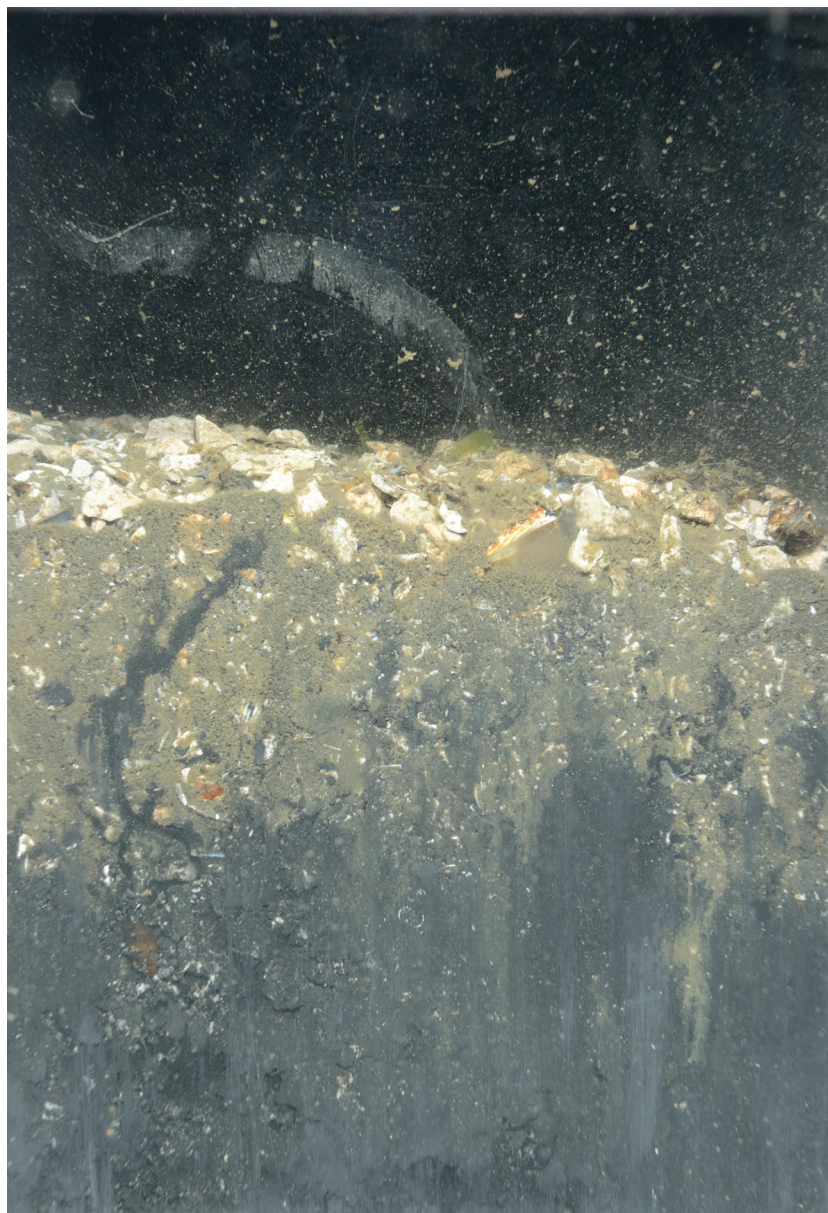
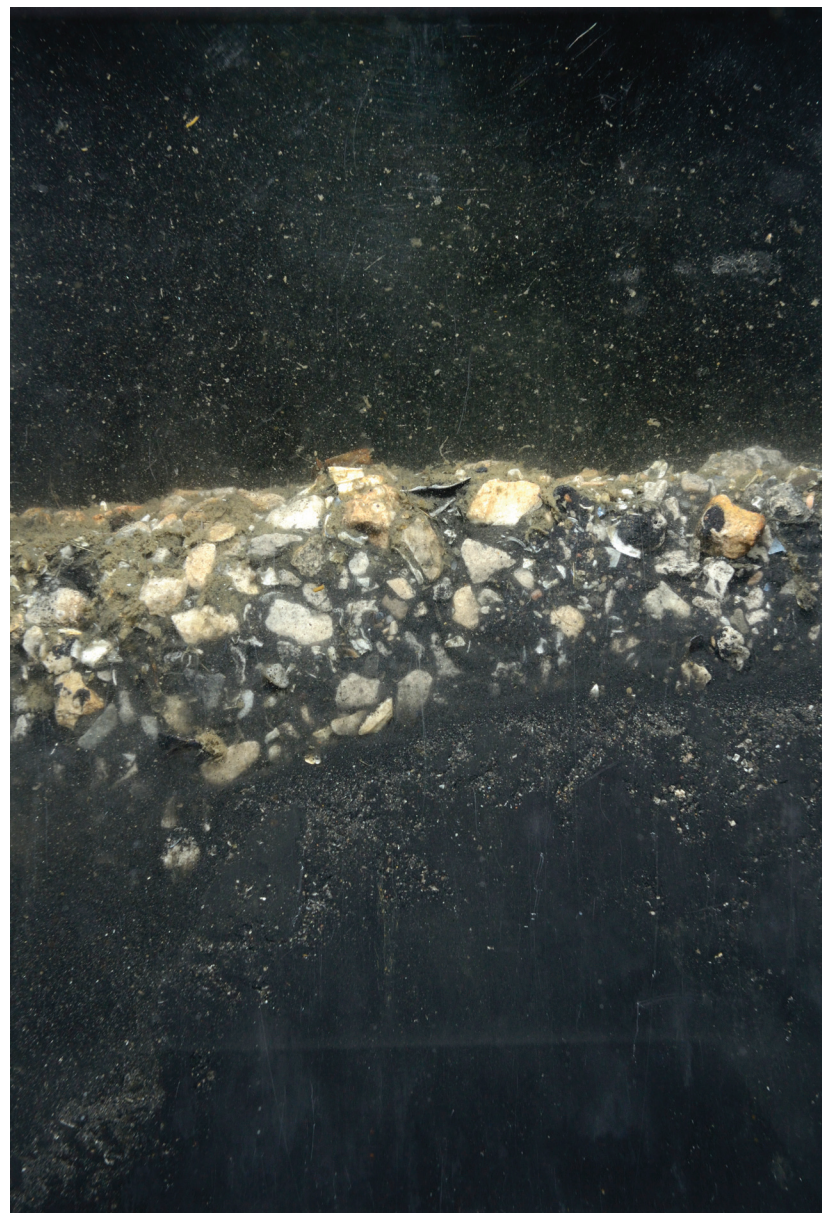
Figure 12: These profile images from Station 6-2 from 2013 (left) and 2014 (right) show a degradation in habitat conditions for the benthic infaunal community. Scale: width of each profile image = 14.5 cm.

artifacts where infaunal successional status could not be determined, and there was one station under the pier (Figure 12) where there were retrograde habitat conditions compared to 2013 (Station 6-2). However, the presence of Stage 3 taxa (larger infaunal deposit feeders) was evident at 34 of the 50 stations (compared to only 18 stations in 2013 where Stage 3 taxa were evident).
